August 9, 2024

Project/File: 111700815

Reference: Gates Lake Flood, Debris Flood, and Geohazard Preliminary Hazard Assessment

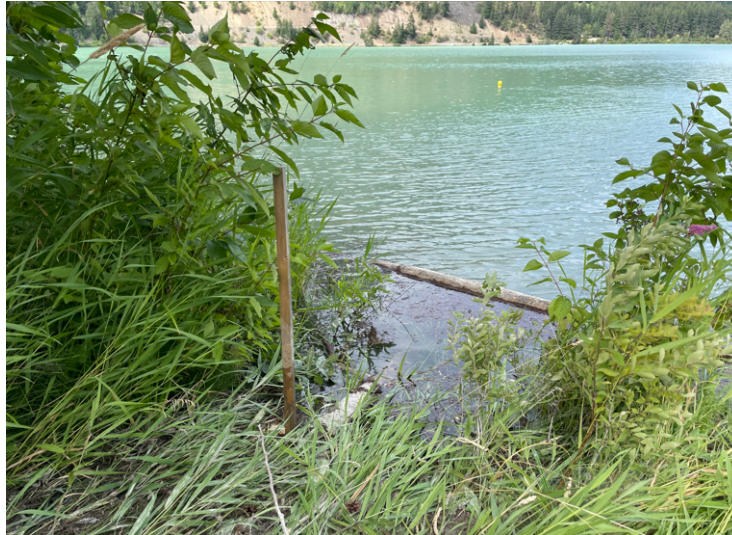
Following the outburst and realignment of Place Creek, Gates Lake water level rose and overtopped the natural boundary (Figure 8, Figure 9).

Figure 8 - Gates Lake Water Level Post-Event (Stantec, July 23, 2024)

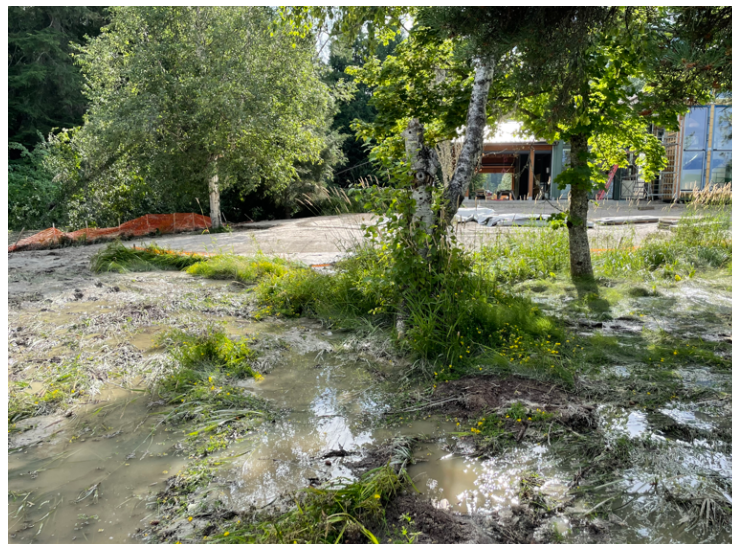
Figure 9 - Flooded Overbank Above Natural Boundary (Stantec, July 24, 2024)

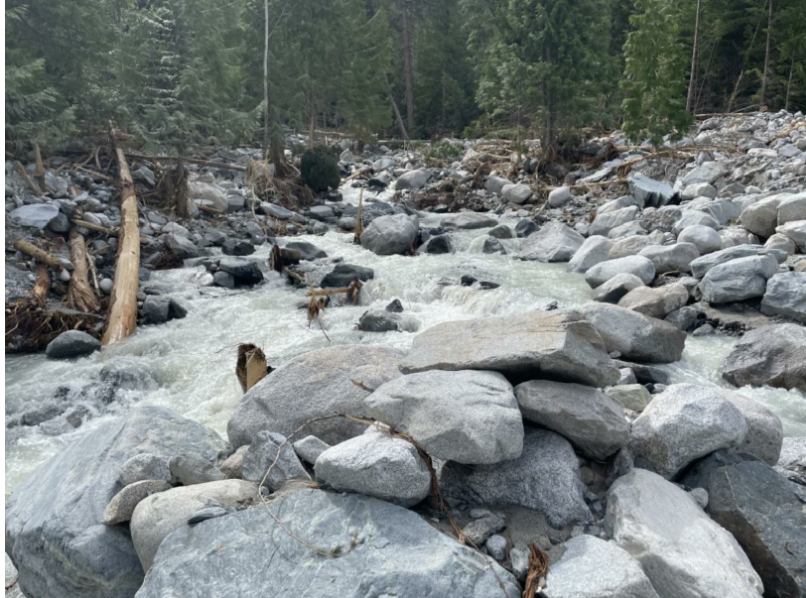
Upstream of the avulsion location the channel is steep exiting a confined gully reach comprised of erodible, near vertical banks comprised of unconsolidated colluvium. The portion of the channel conveying flow is poorly defined within the active channel width but was observed to be incised into the deposited debris flood material, comprised of well graded cobbles and boulders with large woody debris (Figure 11). The

channel has a boulder step planform and based on observations, is expected to be prone to lateral migration in its current state.

Figure 11 – Looking Upstream Along Place Creek from Avulsion Location

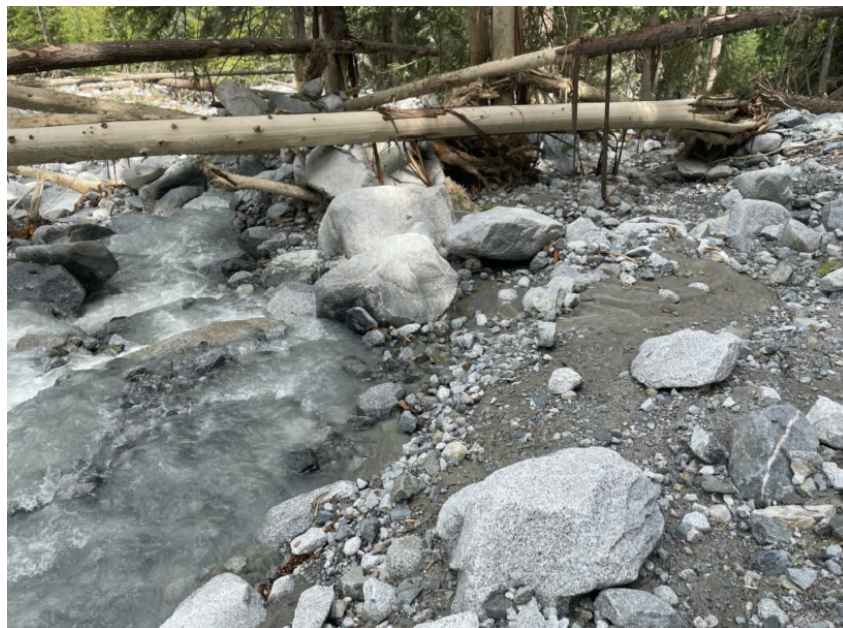
There are two locations approximately 20 m and 50 m upstream of the current avulsion location where the right³ bank is low and poorly defined. The potential for a further avulsion and reconfiguration of the channel at these locations is high in response to higher flows or lateral migration of the channel (Figure 12).

Figure 12 – Looking Downstream at Low Right Bank Upstream from Avulsion Location

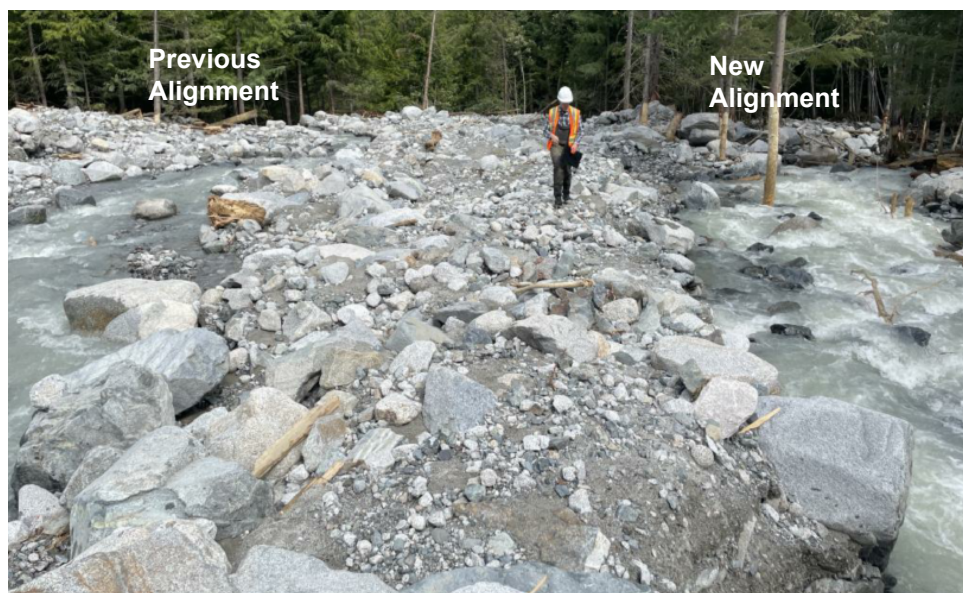
At the avulsion location approximately 10% to 20% of flow is being conveyed by the previous Place Creek alignment while 80% to 90% of flow is being conveyed by the new alignment (Figure 12). Based on conversations with local Gates Lake and Poole Creek residents, Lílwat Nation members, and the SLRD all pre-Event Place Creek flow was conveyed by the previous alignment. The previous Place Creek channel alignment is perched above the new Place Creek alignment. Further lowering of the new Place Creek alignment may result in the majority of flow being conveyed through the new alignment.

Figure 13 – Looking Downstream At New (Right) and Previous (Left) Place Creek Alignments

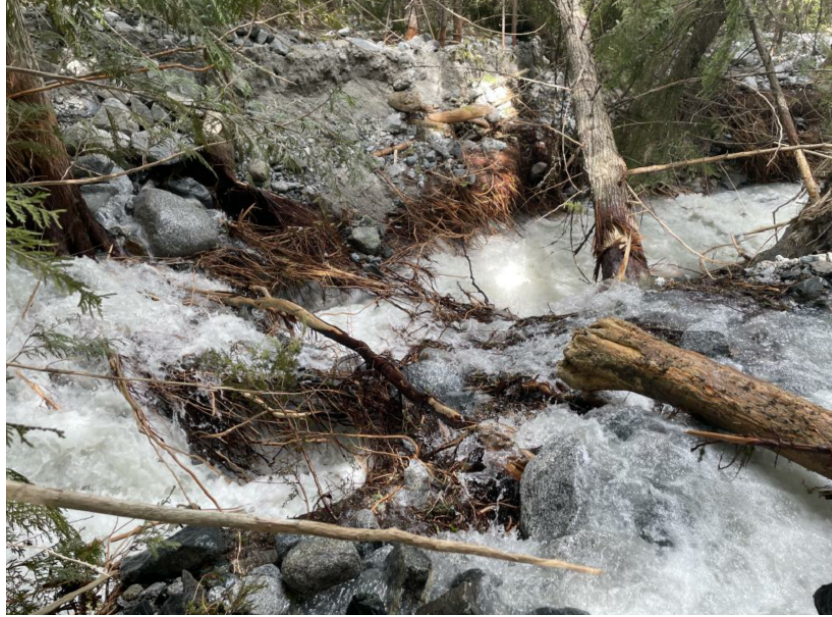
The portion of the new channel extending approximately 20 m downstream of the avulsion has similar geometry and characteristics to the upstream portion. At this location the channel grade abruptly lowers by 2 m (Figure 14) and transitions to a well defined, incised channel approximately 2 to 3 m wide and 1 to 1.5 m deep with near vertical banks (Figure 15). The location of the grade change (also referred to as a “headcut”) is being temporarily held in place by tree roots and boulders – if these tree roots were to fail the grade change will continue to retrograde upstream to the avulsion point. Once it reaches this point the previous Place Creek alignment will become fully perched and no longer convey flow.

Figure 14 – Looking Downstream Towards the Grade Change Within the New Place Creek Alignment

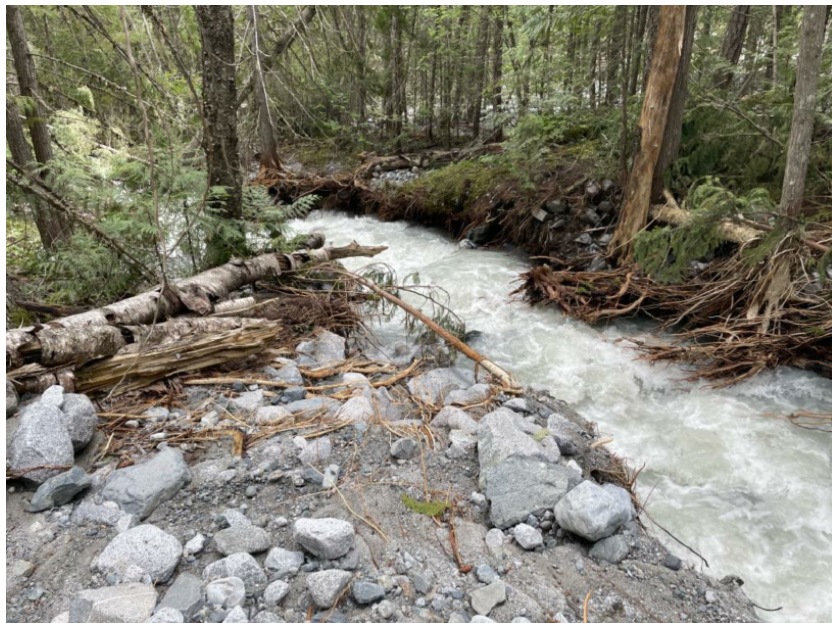
Figure 15 – Looking Downstream at the Incised Channel Downstream of the Grade Change

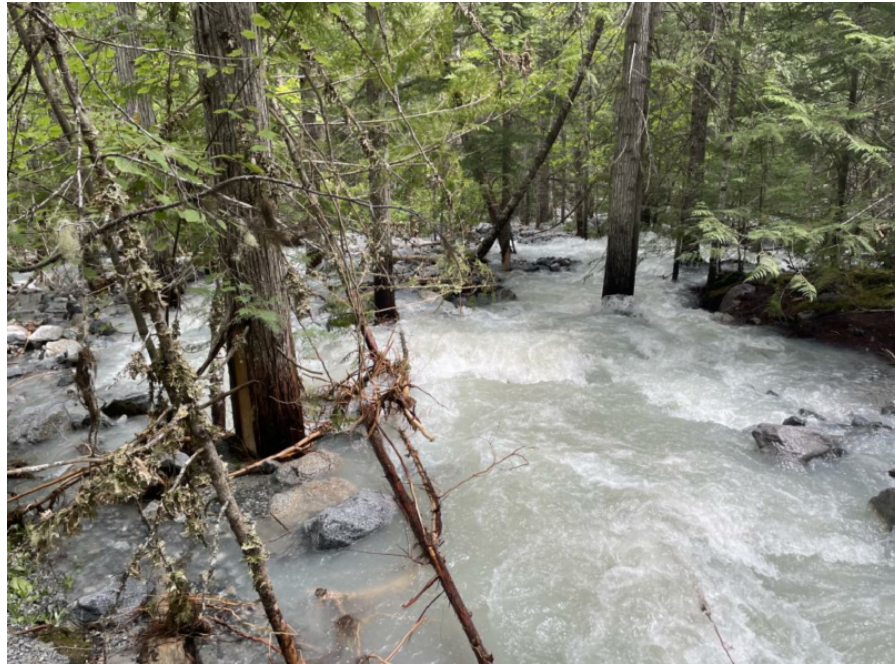
This incised channel continues downstream until the grade flattens out where it transitions to a braided, multi-thread, poorly defined channel through the finer sediments deposited by the Event (Figure 16). It is uncertain whether the incised channel has reached a quasi-equilibrium state; however, as more of Place Creek flow may eventually be conveyed through this channel and the channel has not experienced a mean annual flow it is likely that further incising and widening/bank slumping is anticipated.

Figure 16 – Looking Downstream from Incised Channel Reach Towards Braided Reach.

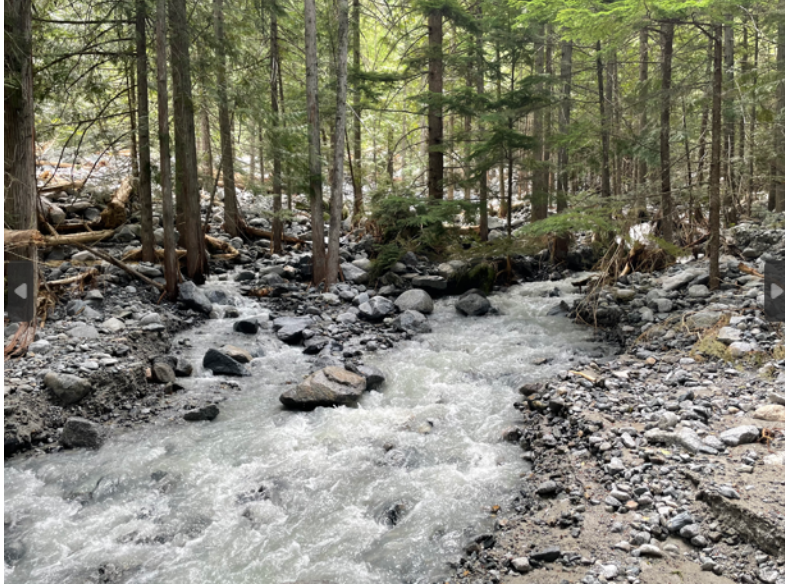
Downstream of the avulsion location the previous Place Creek alignment is poorly defined as it incises down into the deposited debris flood boulder, cobbles, and gravel material (Figure 17). The channel transitions from a single thread to a double thread channel sporadically along this mountainous reach. As the channel approaches the BC Hydro ROW the slope flattens out and the channel becomes less defined (Figure 18) for approximately 100 m before reforming into a single channel, approximately 7 to 10 m wide with 1 to 2 m high steep banks within the defined active width of the previous Place Creek Alignment (Figure 19). These channel characteristics are maintained for a further 400 m – the channel then transitions to a steep, cascading section along bedrock before flattening out and flowing into Poole Creek. Just upstream of the cascade section two large woody debris (LWD) jams, approximately 1 to 2 m high and 10 m wide are located within the channel – flow is currently conveyed below the LWD jams but higher flow would be obstructed (Figure 20).

Figure 17 – Looking Upstream Along Previous Place Creek Alignment Downstream of Avulsion Location

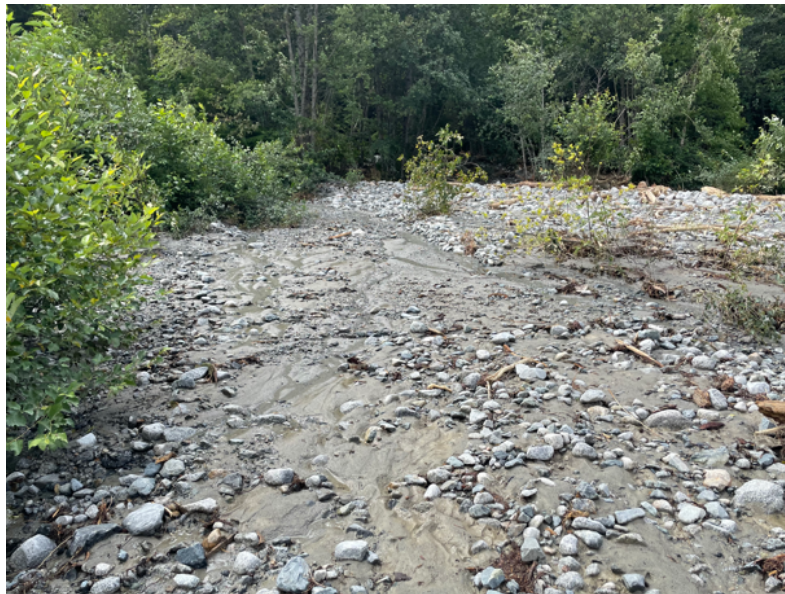
Figure 18 – Looking Upstream Towards Poorly Defined Channel Reach of Previous Place Creek Alignment

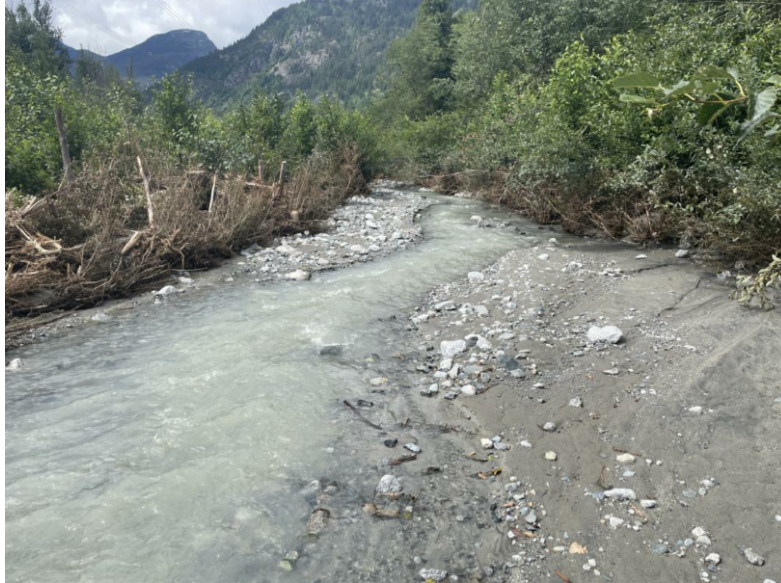
Figure 19 – Looking Downstream Along Channelized Portion of Previous Place Creek Alignment Through BC Hydro ROW

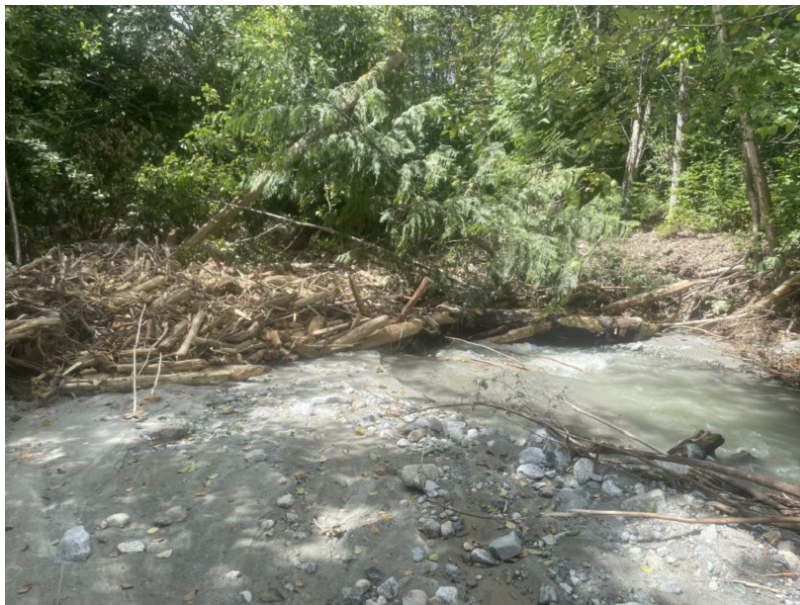
Figure 20 – Looking Downstream at LWD Jams

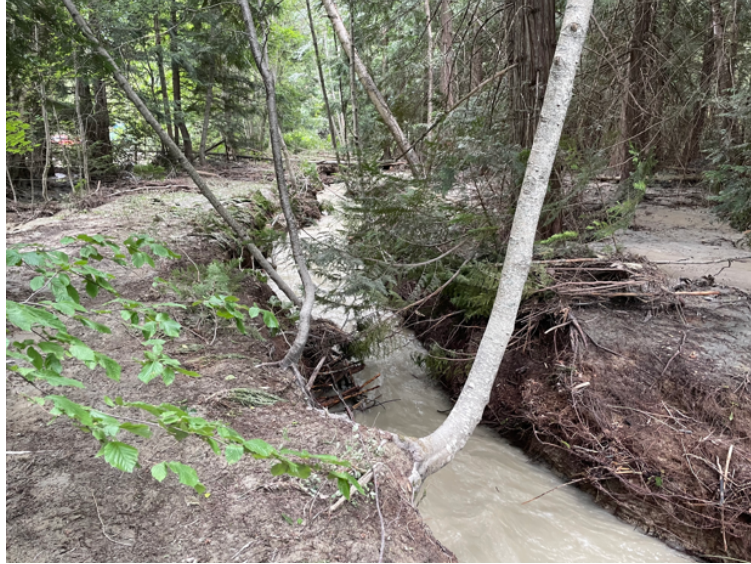
Figure 21 – Looking Downstream Along Previous Constructed Ditch now Incised Upstream of New Place Creek Outlet into Gates Lake

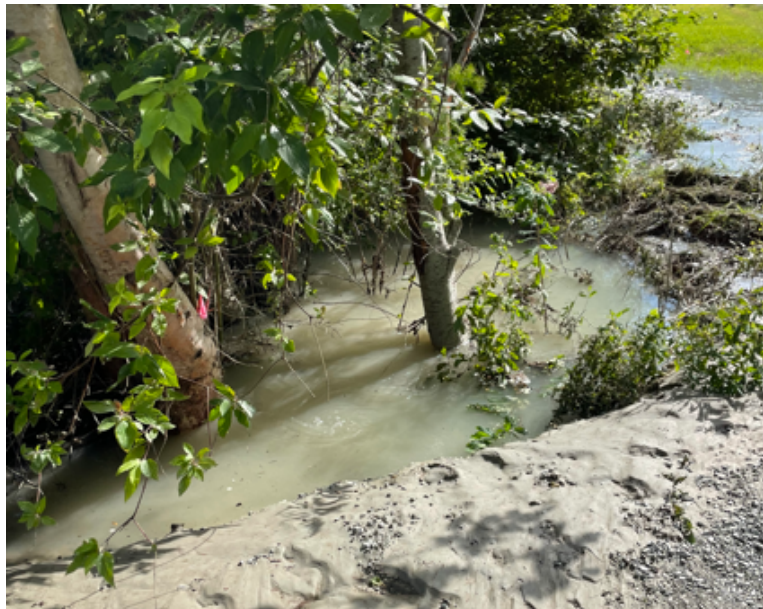
Figure 22 – Overland Flooding Due to Undersized Constructed Ditch Conveying Place Creek Flow

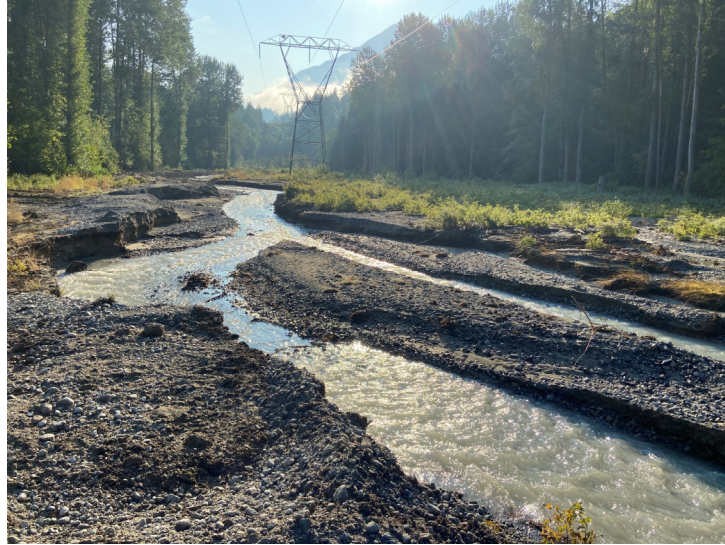
Figure 24 – Overland Flow Along New Place Creek Alignment Through BC Hydro ROW Following Aug 4/5 Rainfall Event.

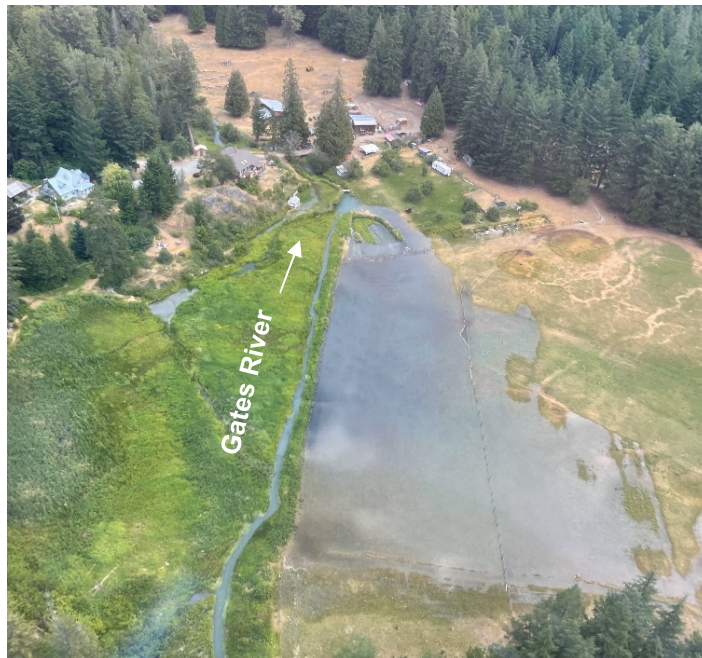
Along Gates River overland flooding was noted within the agricultural fields of 9234 Pemberton Portage Rd. The extents of the flooding appear to be stable with the property owner noting slight fluctuations in response to the July 29 and Agu 4/5 rainfall events (Figure 25).

Figure 25 – Overland Flooding of 9234 Pemberton Portage Road Downstream of Gates Lake

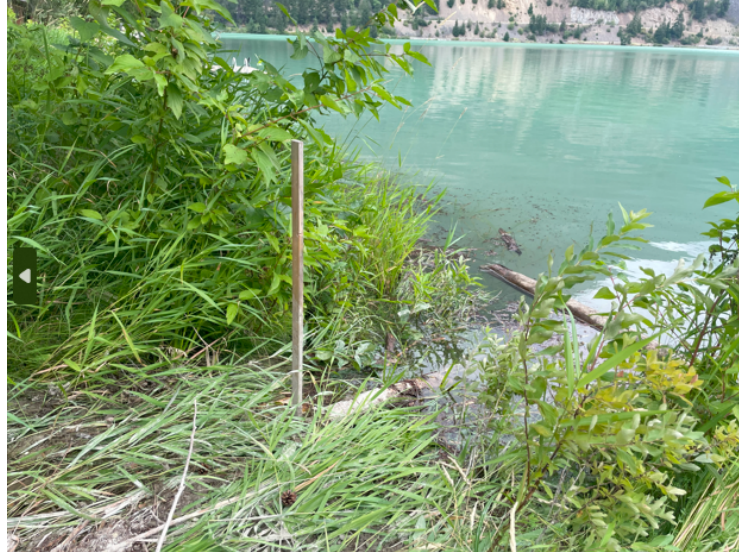
In response to the Event the water level within Gates Lake increased by approximately 0.3 m to 0.5 m (per conversation with owner of 9118 Pemberton Portage Rd) overtopping the existing natural boundary. On July 23rd, 2024 Stantec noted that the water level was still at or slightly above the natural boundary – a wooden monitoring stake was installed at the observed Gates Lake edge of water (Figure 26) to assess the change in water levels between each site visit.

Figure 26 - Gate Lake Edge of Water with Monitoring Stake (July 24, 2023)

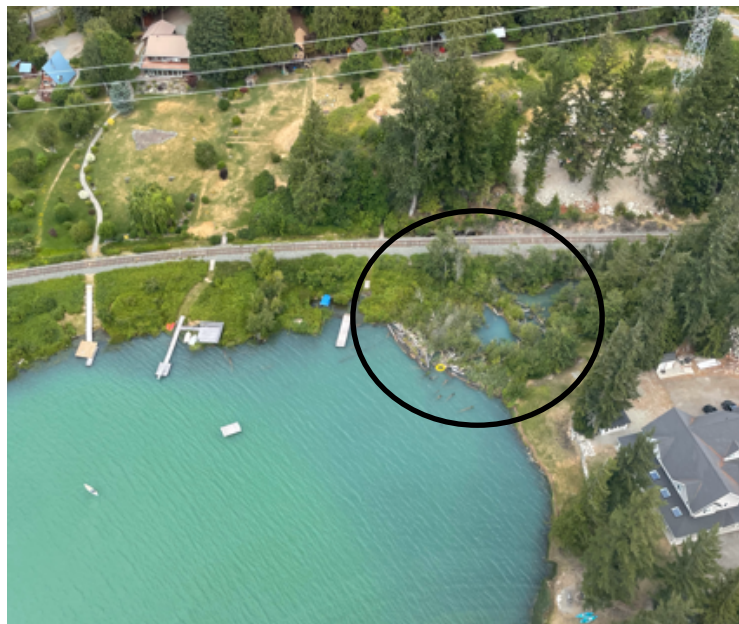
The outlet of Gates Lake in Gates River is naturally regulated by LWD (Figure 27) that has collected within the outlet. A sudden failure of the LWD may cause a pulse of water to be conveyed downstream exacerbating ongoing flood conditions and erosion potential. Condition of the LWD blockage and relationship between lake storage and flow within Gates River associated with the outlet is unknown.

Figure 27 - LWD (Black Circle) Naturally Regulating Outlet Flow from Gates Lake (July 24, 2023).

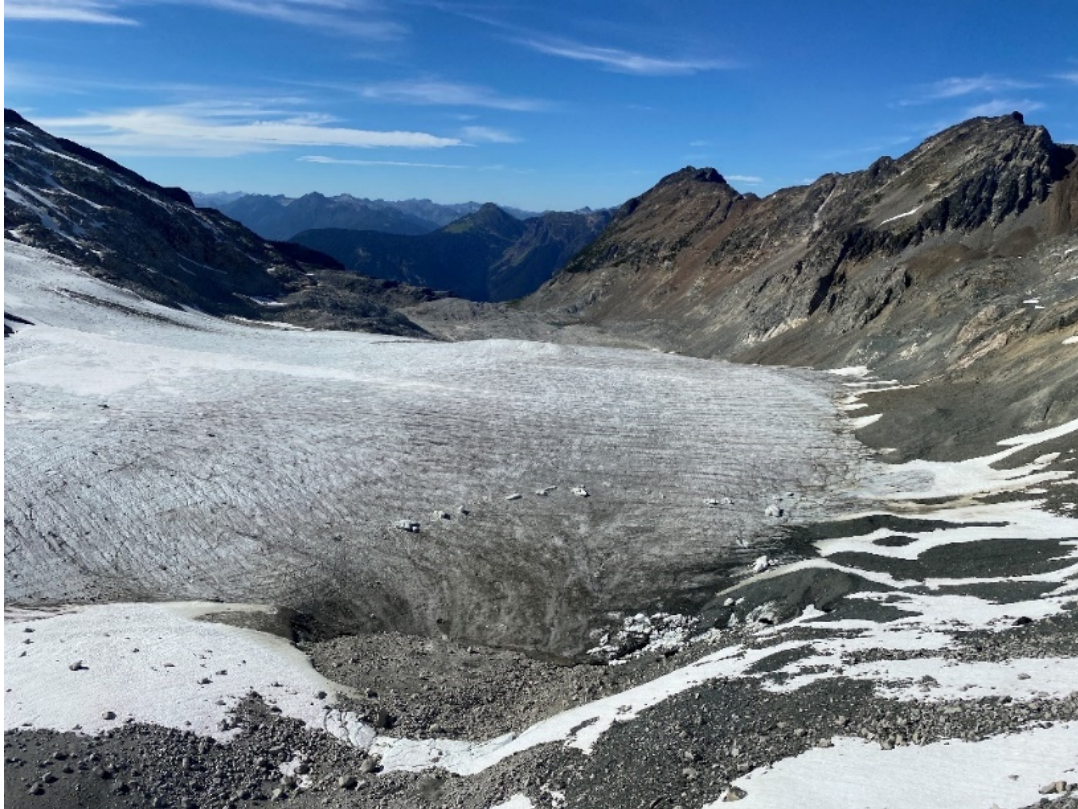
During the aerial assessment, collapsed cavity openings along the basal ice surface in the dried upper lakebed were observed. No evidence of overland flow along the ice surface was observed. Based on these observations, in conjunction with the satellite imagery, it was inferred that the lake drained along the basal surface of the ice to the lower lake causing the outburst event. At the time of the inspection, no flow into the dried upper lakebed was observed (i.e., the lake was not visibly recharging). The lower lake in the cirque was full relative to levels identified in Figure 5. Based on the extent and volume of ice remaining on the Place Glacier, it is possible for the upper lake to impound water again over time.

Figure 28. Photo taken of the drained remnant of the upper glacial lake. Blocks of ice (formerly icebergs) can be seen on the glacier surface in this image.

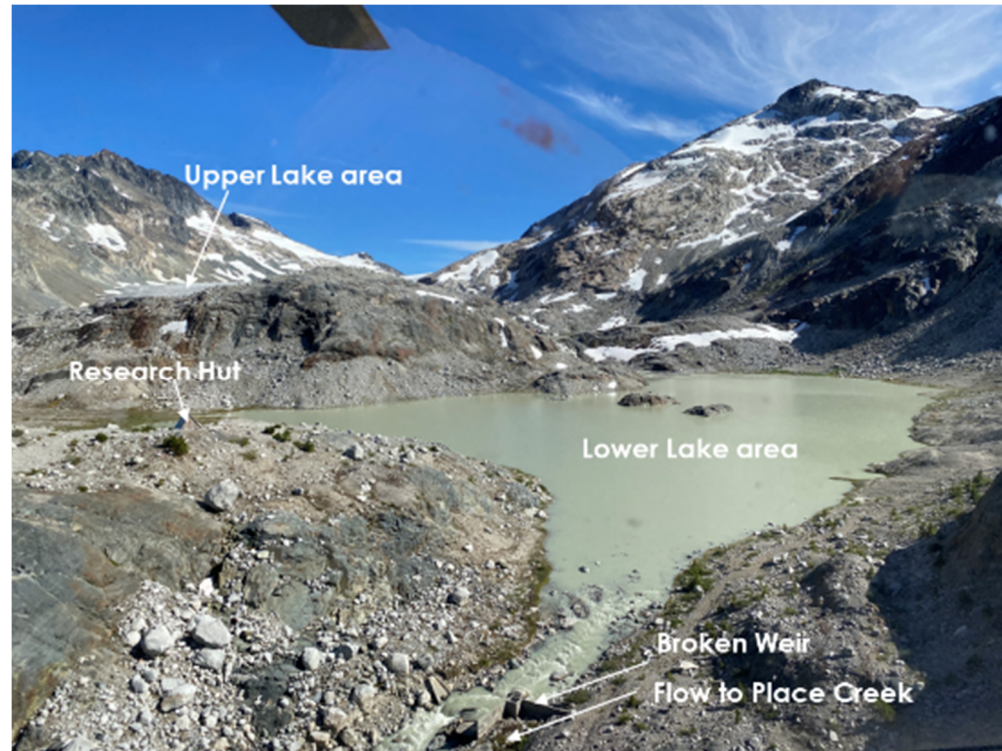
In the lower cirque lake, remnants of a broken cement weir were identified at the mouth of Place Creek and unobstructed flow from the lake was entering stream. Evidence of imminent glacial calving (i.e., large fractures in the ice, or ice overhangs) into the lower lake was not observed.

Some evidence of mass wasting along the steep slopes of the cirque, including rockfall and rockslides, were observed upslope of the lower lake. Most observed mass wasting events appeared to be low volume rockslides and fall events which deposit on well established talus deposits – no large colluvial blocks were observed in the area. Based on these observations, no immediate landslide threat that could trigger wave runoff in the lower lake was observed. Figure 29 shows pertinent features in the lower lake.

Figure 29. Viewing the lower glacial lake, where uncontrolled flow to Place Creek through the broken weir was observed.

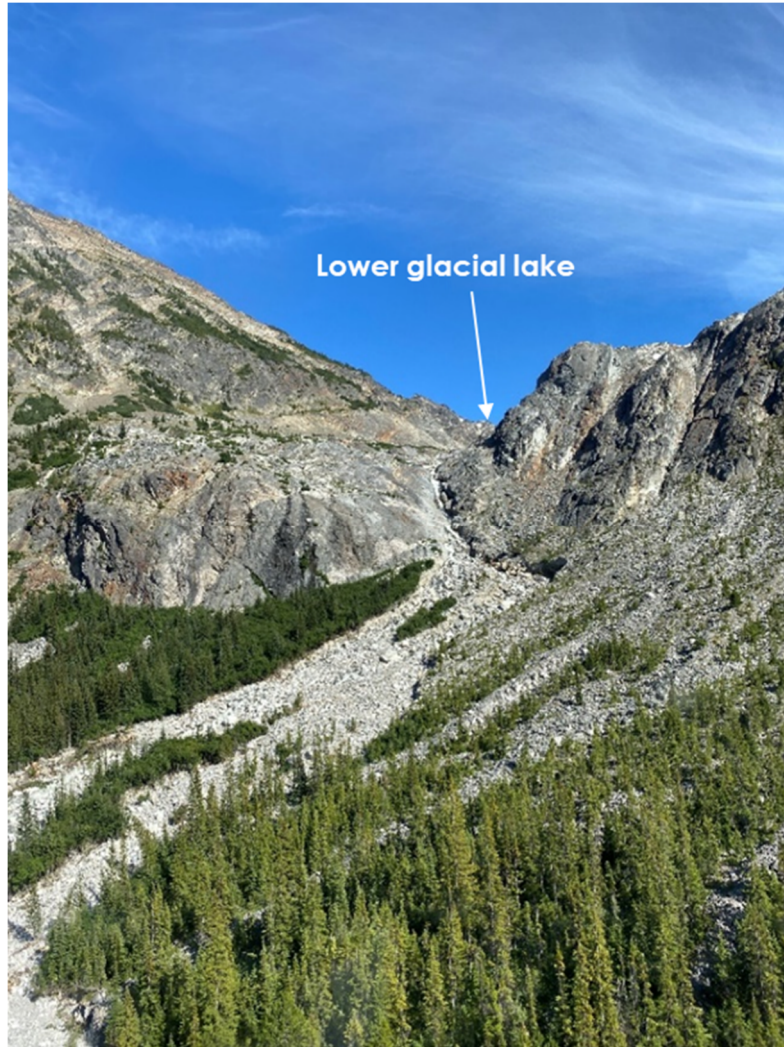
Figure 30. Looking upslope at the bedrock lip of the Place Glacier cirque, where flow from Place Creek begins. Debris and colluvial deposits from the Event, and prior events, are visible down slope.

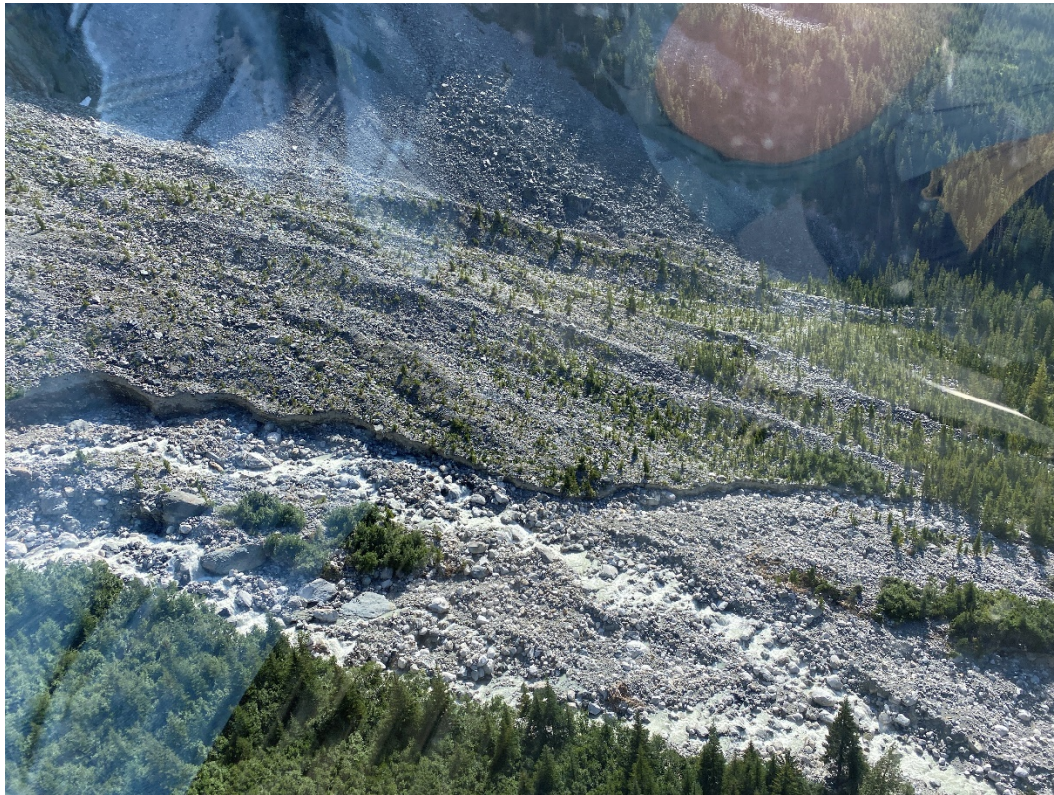
Figure 31. Bank undercutting along the upper reaches of Place Creek. Levees along the adjacent slopes are visible in this image from other historic mass wasting events.

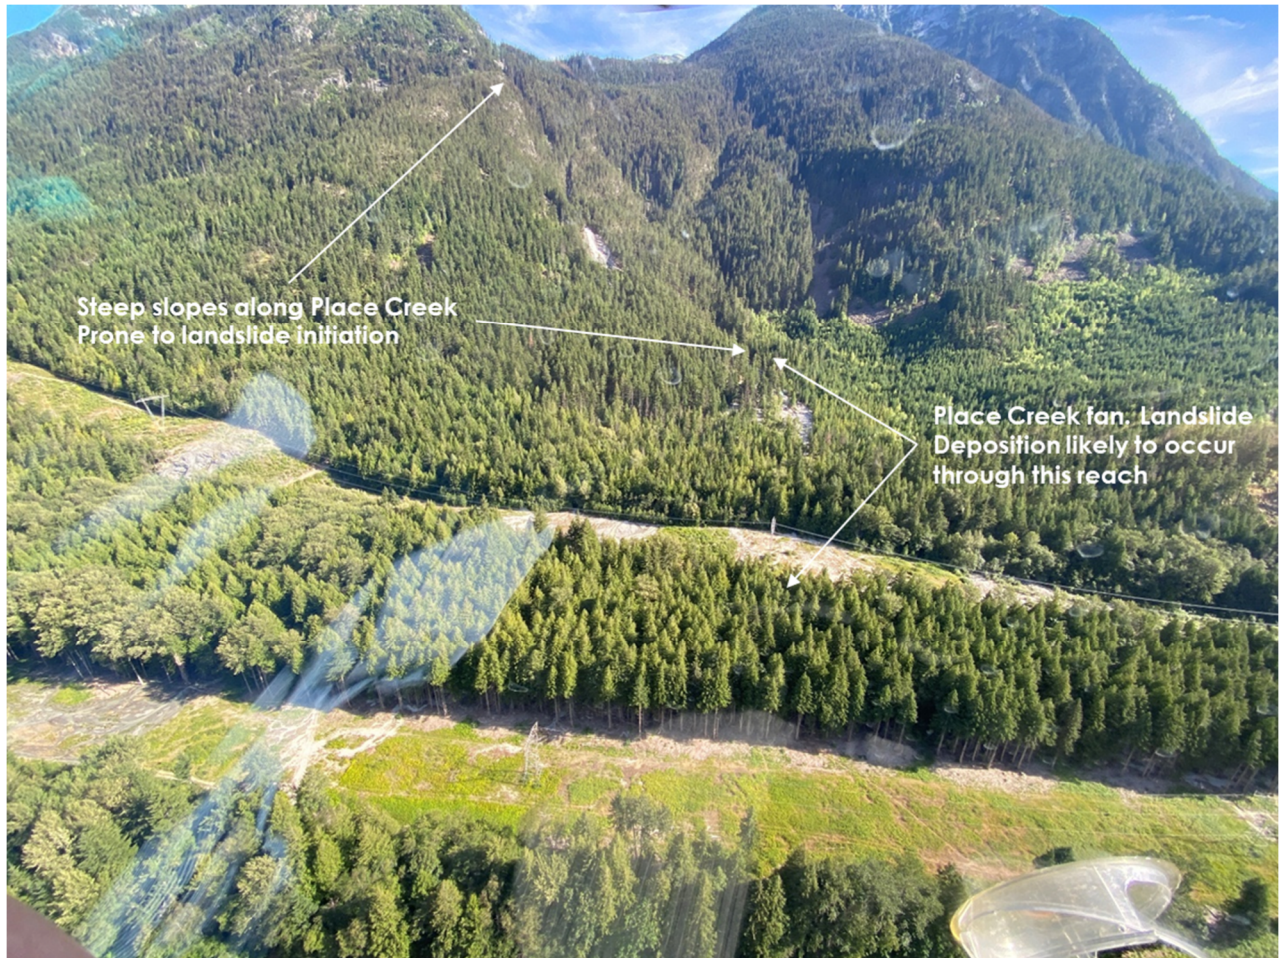
Figure 32. Viewing the steep slopes in the mid-slope position of Place Creek. Deposition from mass wasting events is anticipated to occur along the fan deposit indicated in this image.

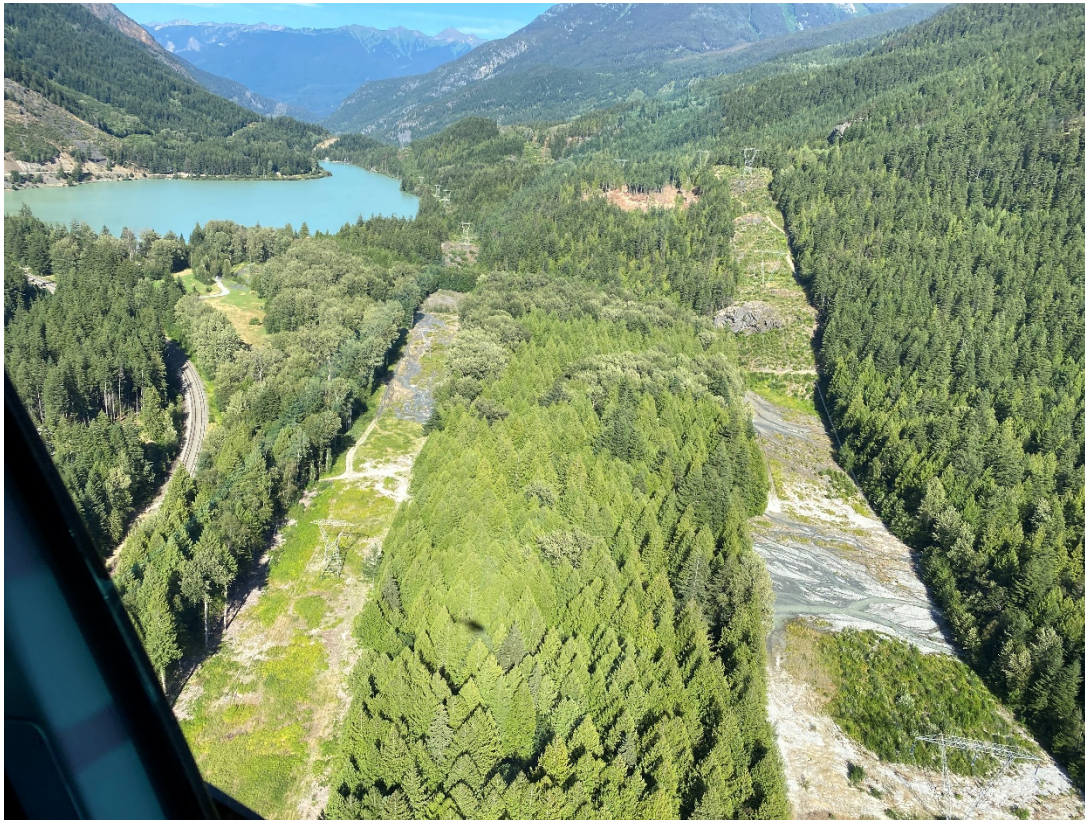
Figure 33. Viewing flood deposits along the upper BC Hydro right-of-way. Landslides occurring upslope of this area are anticipated to deposit along or upslope of the BC Hydro right-of-way (right); however deposits may transport further through flood processes.
