January 31, 2024  
 File: SLRD24001

**Re:** Emergency hazard assessment, Jason Creek at Reid Road, near Pemberton, BC.

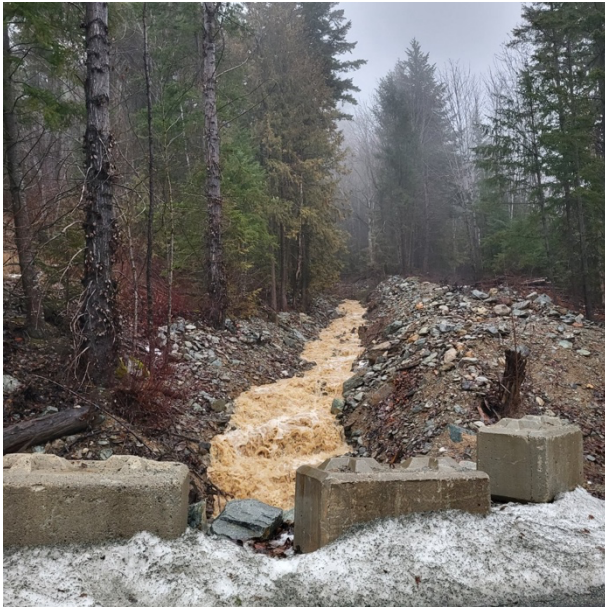
On January 29, 2024 residents on Reid Road noted muddy flows on Jason Creek (Photo 1). Concern was expressed by residents on lots affected by the landslide hazard alert (1782, 1788, 1794, 1802 Reid Road) ongoing from November 2021, and in response SLRD requested a site visit by a qualified professional to review the terrain along Jason Creek between Reid Road and the 2021 debris flow source area (Figure 3).

**Photo 1.** Jason Creek, Monday January 29, ~9 am. Photo by Peter Jean.

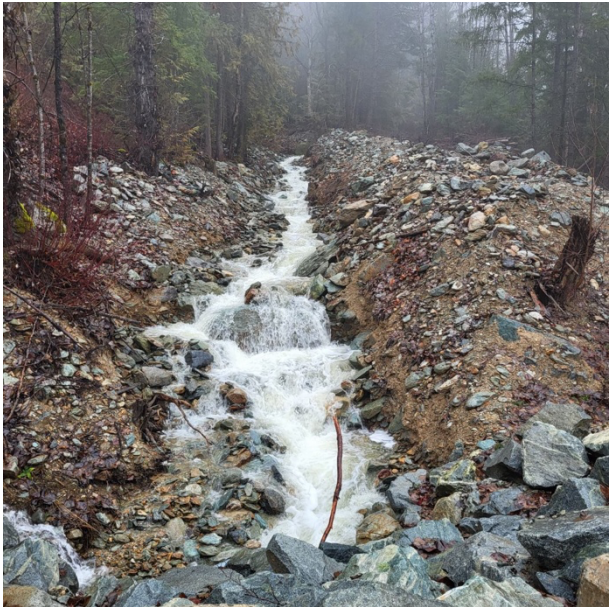
**Photo 2.** Jason Creek, Wednesday January 31, ~12 noon. Photo by Peter Jean.

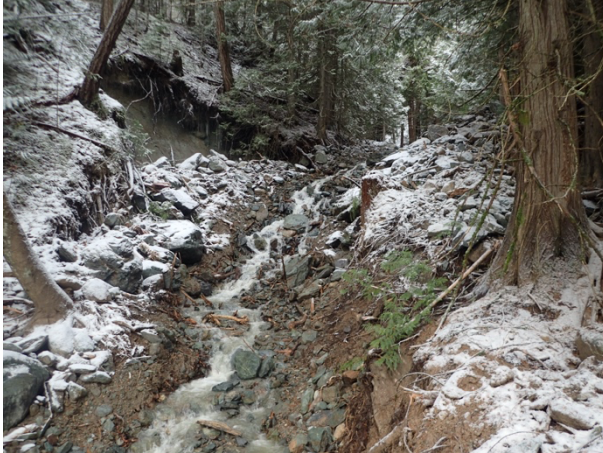
Dec 12, 2021. Right bank erosion site, just above Reid Road. Waypoint 2, Appendix 1.

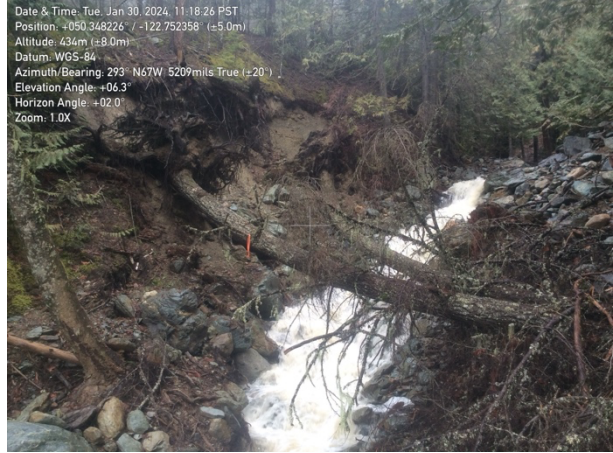
January 30, 2024. Two trees have fallen, but otherwise bank failure has not grown.

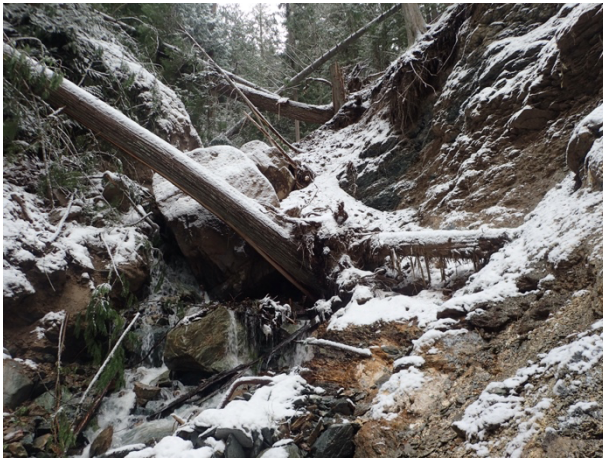
Dec 12, 2021. View upstream. Reach with large boulder resting on fallen cedar tree. Waypoint 4, Appendix 1.

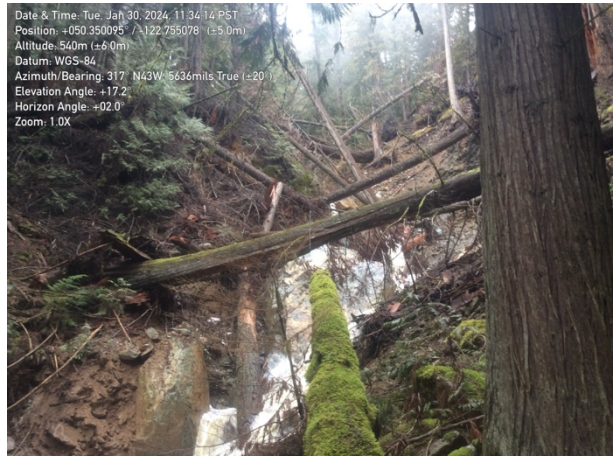
January 30, 2024. More trees fallen across channel.

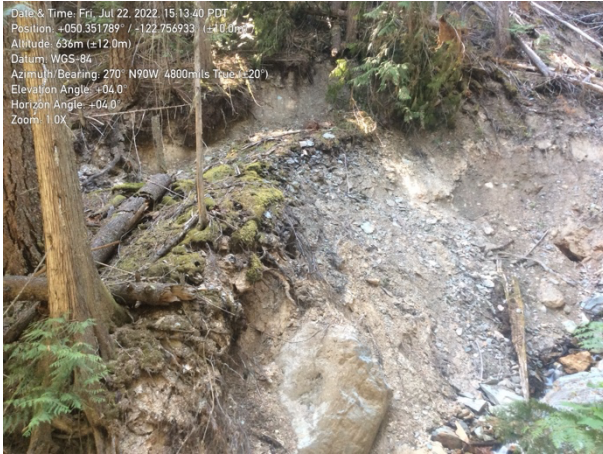
July 22, 2022. Slump on right bank below main failure site. Waypoint 15, Appendix 1.

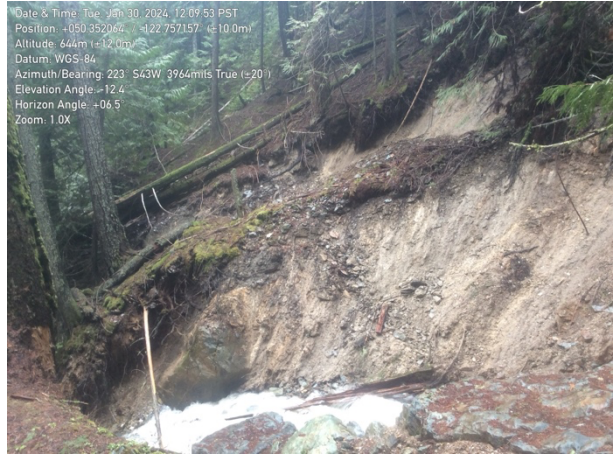
January 30, 2024. No change observed.

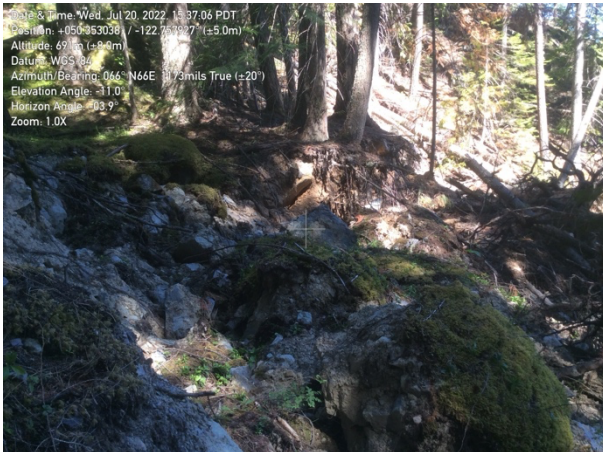
July 20, 2022. Headscarp of main instability. Waypoint 19, Appendix 1.

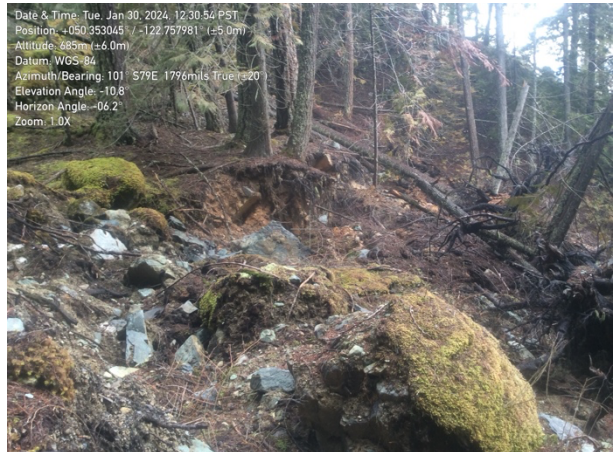
January 30, 2024. No change observed.

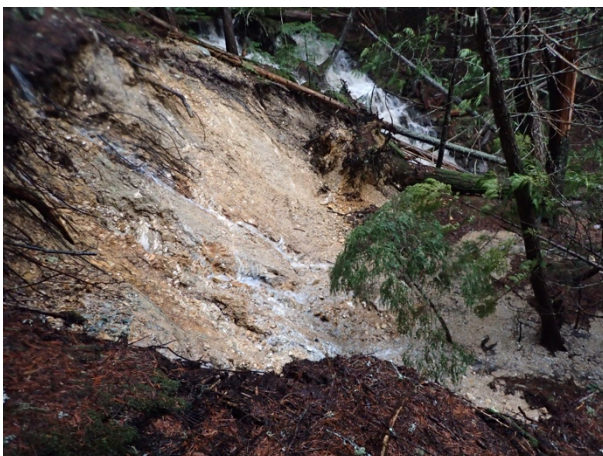
December 1, 2021. Slump on right bank upstream of main instability. Waypoint 23 Appendix 1.

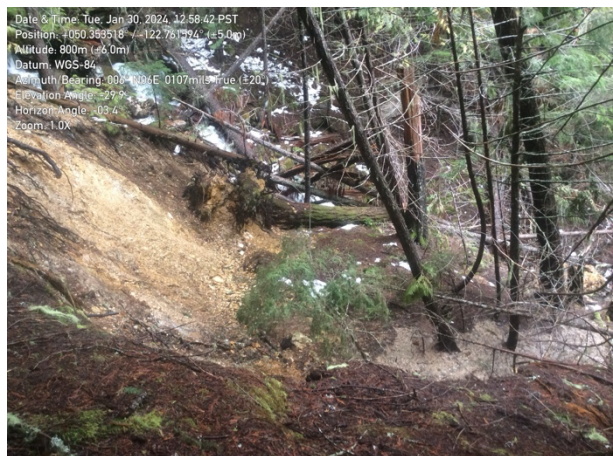
January 30, 2024. No change.
