Place Creek Emergency Response Completion Report

Prepared for:
Squamish-Lillooet Regional District

Prepared by:
Stantec Consulting Ltd.

Project/File:
111700815

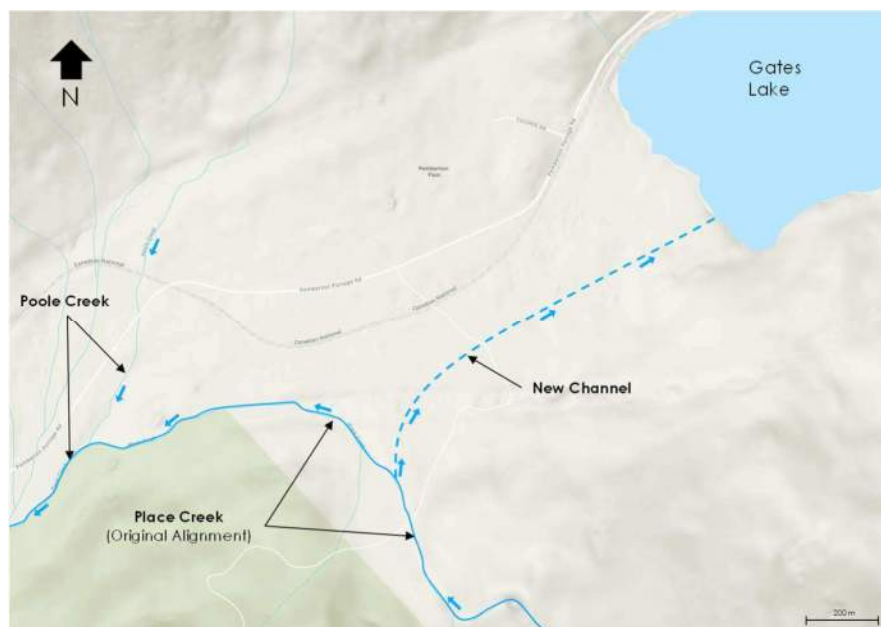
Figure 1: Map Sketch Illustrating Relevant Flow Paths Pre and Post Event (New Channel)

Prior to the Event, Place Creek flowed west into Poole Creek. However, the deposition of sediment and debris that occurred during the Event caused Place Creek to form a distributary channel, such that the majority of flow altered to draining east into a drainage channel and onwards to Gates Lake, rather than west into Poole Creek (Figure 1). The SLRD retained Stantec Consulting Ltd. to assess the new alignment of Place Creek and conduct a qualitative assessment to determine whether it posed geohazard, flood and debris flood hazards to the general public and structures situated along Gates Lake and immediately downstream of the lake along Gates River. This assessment found that a sufficient flood hazard was posed to the properties around Gates Lake to warrant immediate mitigative actions be taken.

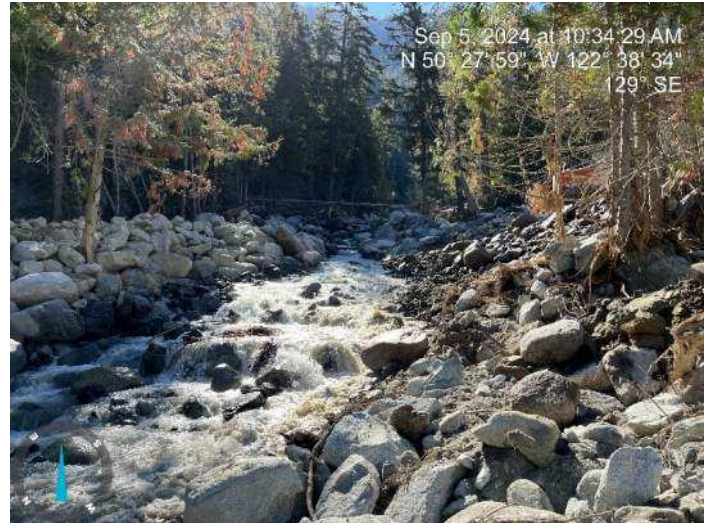
Image 15: Condition of right bank of the existing channel at 10:34 AM on 2024-09-05

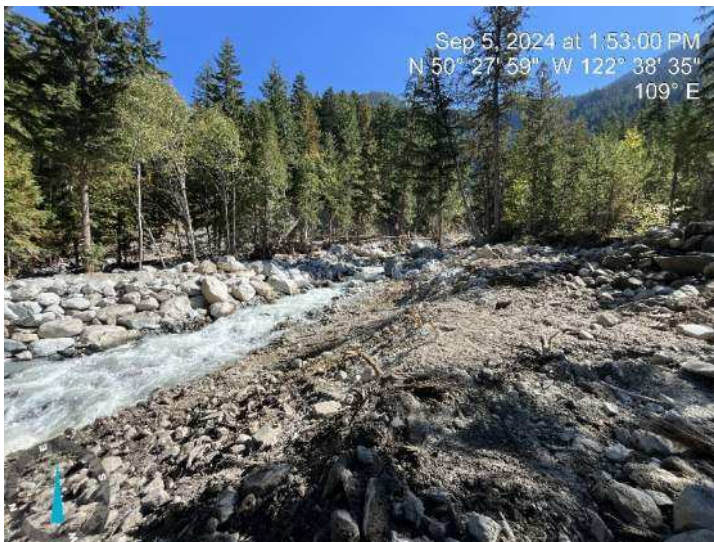
Image 22: Existing channel condition at time of departure (2024-09-05 @ 1:53 PM)

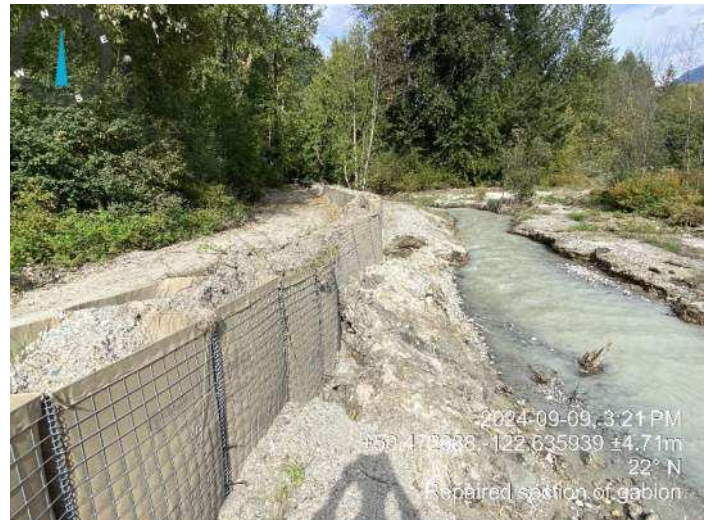
- The gabion bags that were previously repaired remain in stable condition and there has been negligible erosion of the channel bank beside them (Image 9).

Image 9: Looking downstream at the previously repaired section of gabion bags (2024-09-09 @ 3:21 PM)

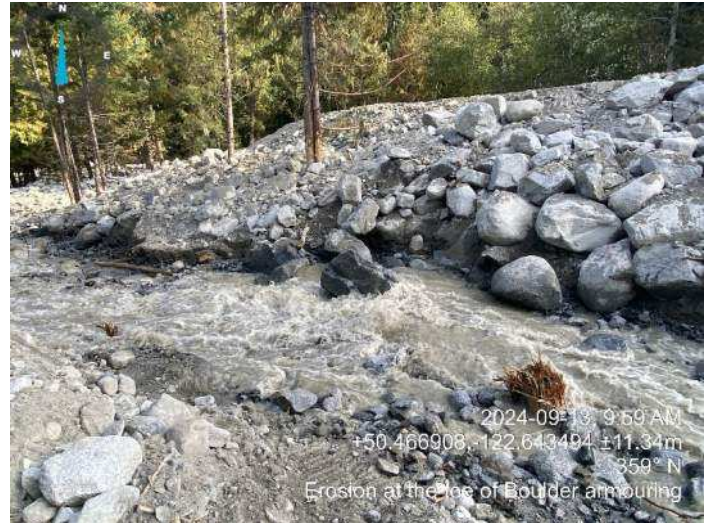
Image 11: erosion at the toe of the bank causing 1 boulder settle into the channel (2024-09-13 @ 9:59 AM)

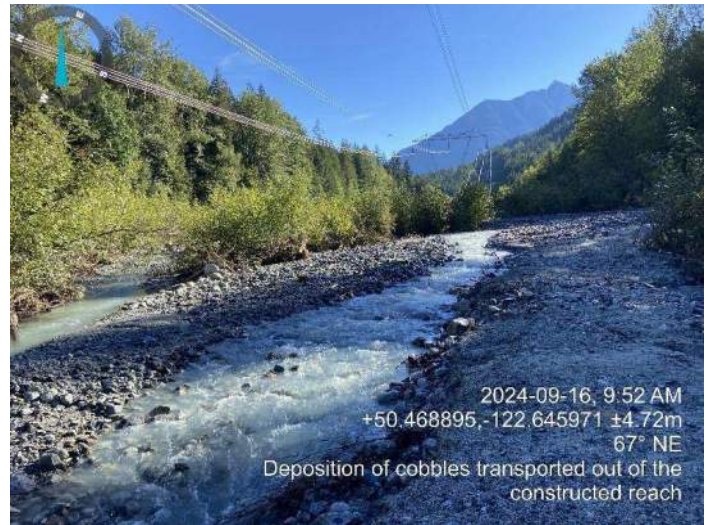
Image 7: deposition of cobble sized material in the hydro corridor (2024-09-16 @ 9:52 AM)

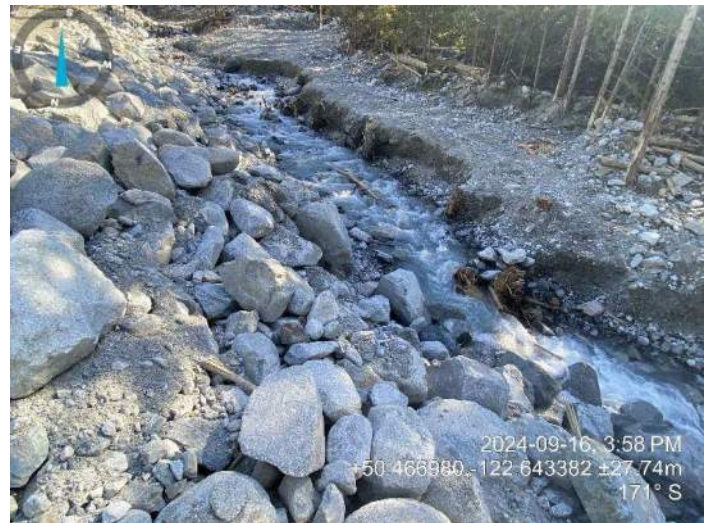
- The region received rainfall on Saturday which increased the discharge in Place Creek. This caused more erosion and downcutting of the channel bed material along the constructed reach. Much of the cobble-sized material on the channel bed was transported out of the steeper areas and deposited downstream in the hydro corridor (Image 6-9). Sediment erosion and deposition of this nature is expected as the channel continues to adjust, especially during higher flows. Several large boulders from the bank armouring were undermined and shifted into the creek. Minor adjustments can be made tomorrow when Cascade Environmental is on site to supervise instream works. Overall the reestablished channel is performing well and as intended.

Image 9: Exposed roots and vertical banks are evidence of channel downcutting after higher flows over weekend (2024-09-16 @ 3:58 PM)

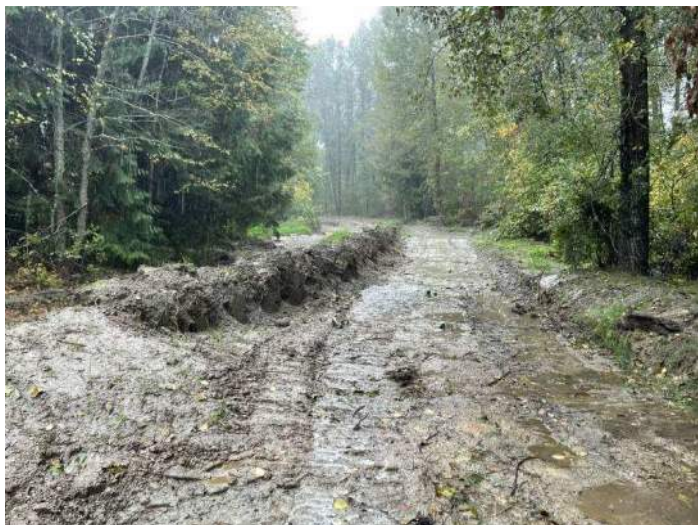
- Stantec arrived onsite at 11 AM, Contractor not onsite. Contractor arrived onsite 12:30PM.
- 12:30PM – 03:00PM: Emergency gabion baskets had been removed; however, fill material had been left piled along the emergency ditch top of bank (Image 1). Stantec noted to Contractor that the piled fill should be either backfilled into the emergency ditch (along portions that were not conveying groundwater flow) or along the access road. Contractor removed emergency gabion baskets from around the BC Hydro tower (Image 2 and 3).
- 03:00PM – Stantec left site (Image 4). Contractor confirmed to Stantec on Sept 26 that piled fill had been addressed.

Image 1: Fill from gabion baskets left piled along emergency ditch top of bank (looking west)(2024-09-25)
