**THURBER** ENGINEERING LTD.

August 31, 2022

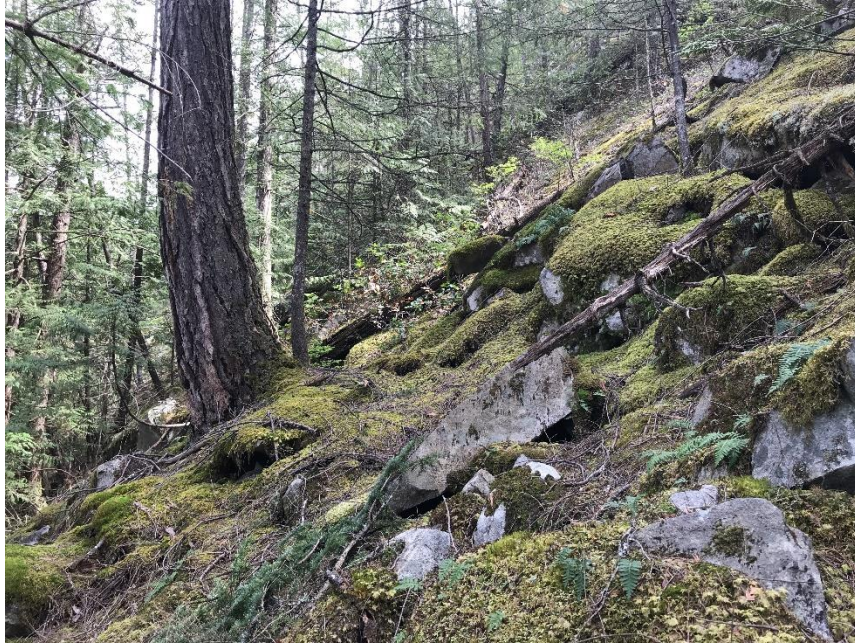
**PHOTO 1:** View of talus deposits in the Upper Benchlands area. (Photo taken by Thurber in May 2019).

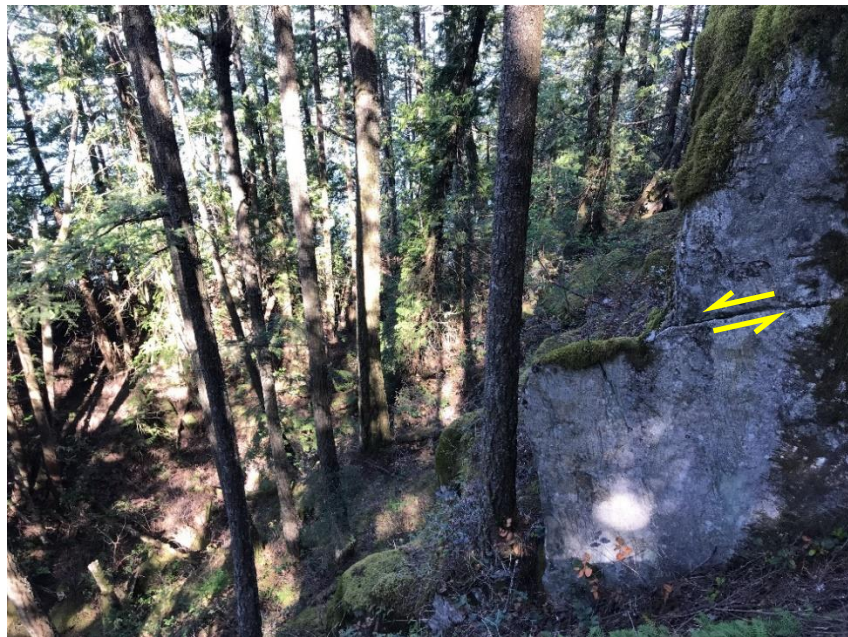
**PHOTO 8:** View of steep bedrock bluffs within the Northwest area. Yellow arrow indicates unfavourably oriented fracture plane dipping out of the slope. (Photo taken by Thurber in May 2019.)

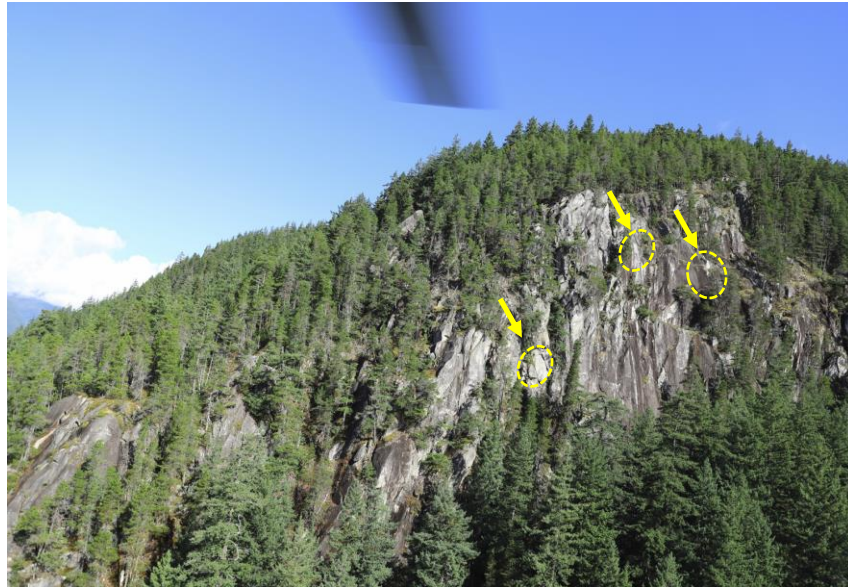
**PHOTO 9:** Aerial view of the Mountain Lands area, looking north. Yellow arrows show potential rock fall source areas from the more highly fractured areas of the bluff. (Photo taken by Thurber in September 2021).

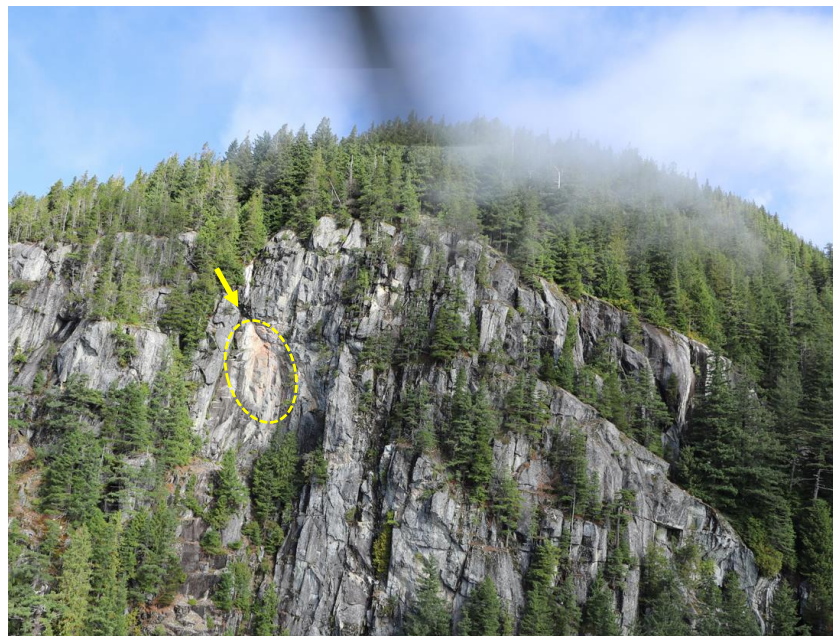
**PHOTO 10:** Aerial view of the north valley wall of Furry Creek approximately 2.5 km upstream of Highway 99, looking north from an elevation of about 900 m above sea level. Yellow arrow shows location of recent rock fall. (Photo taken by Thurber in September 2021).

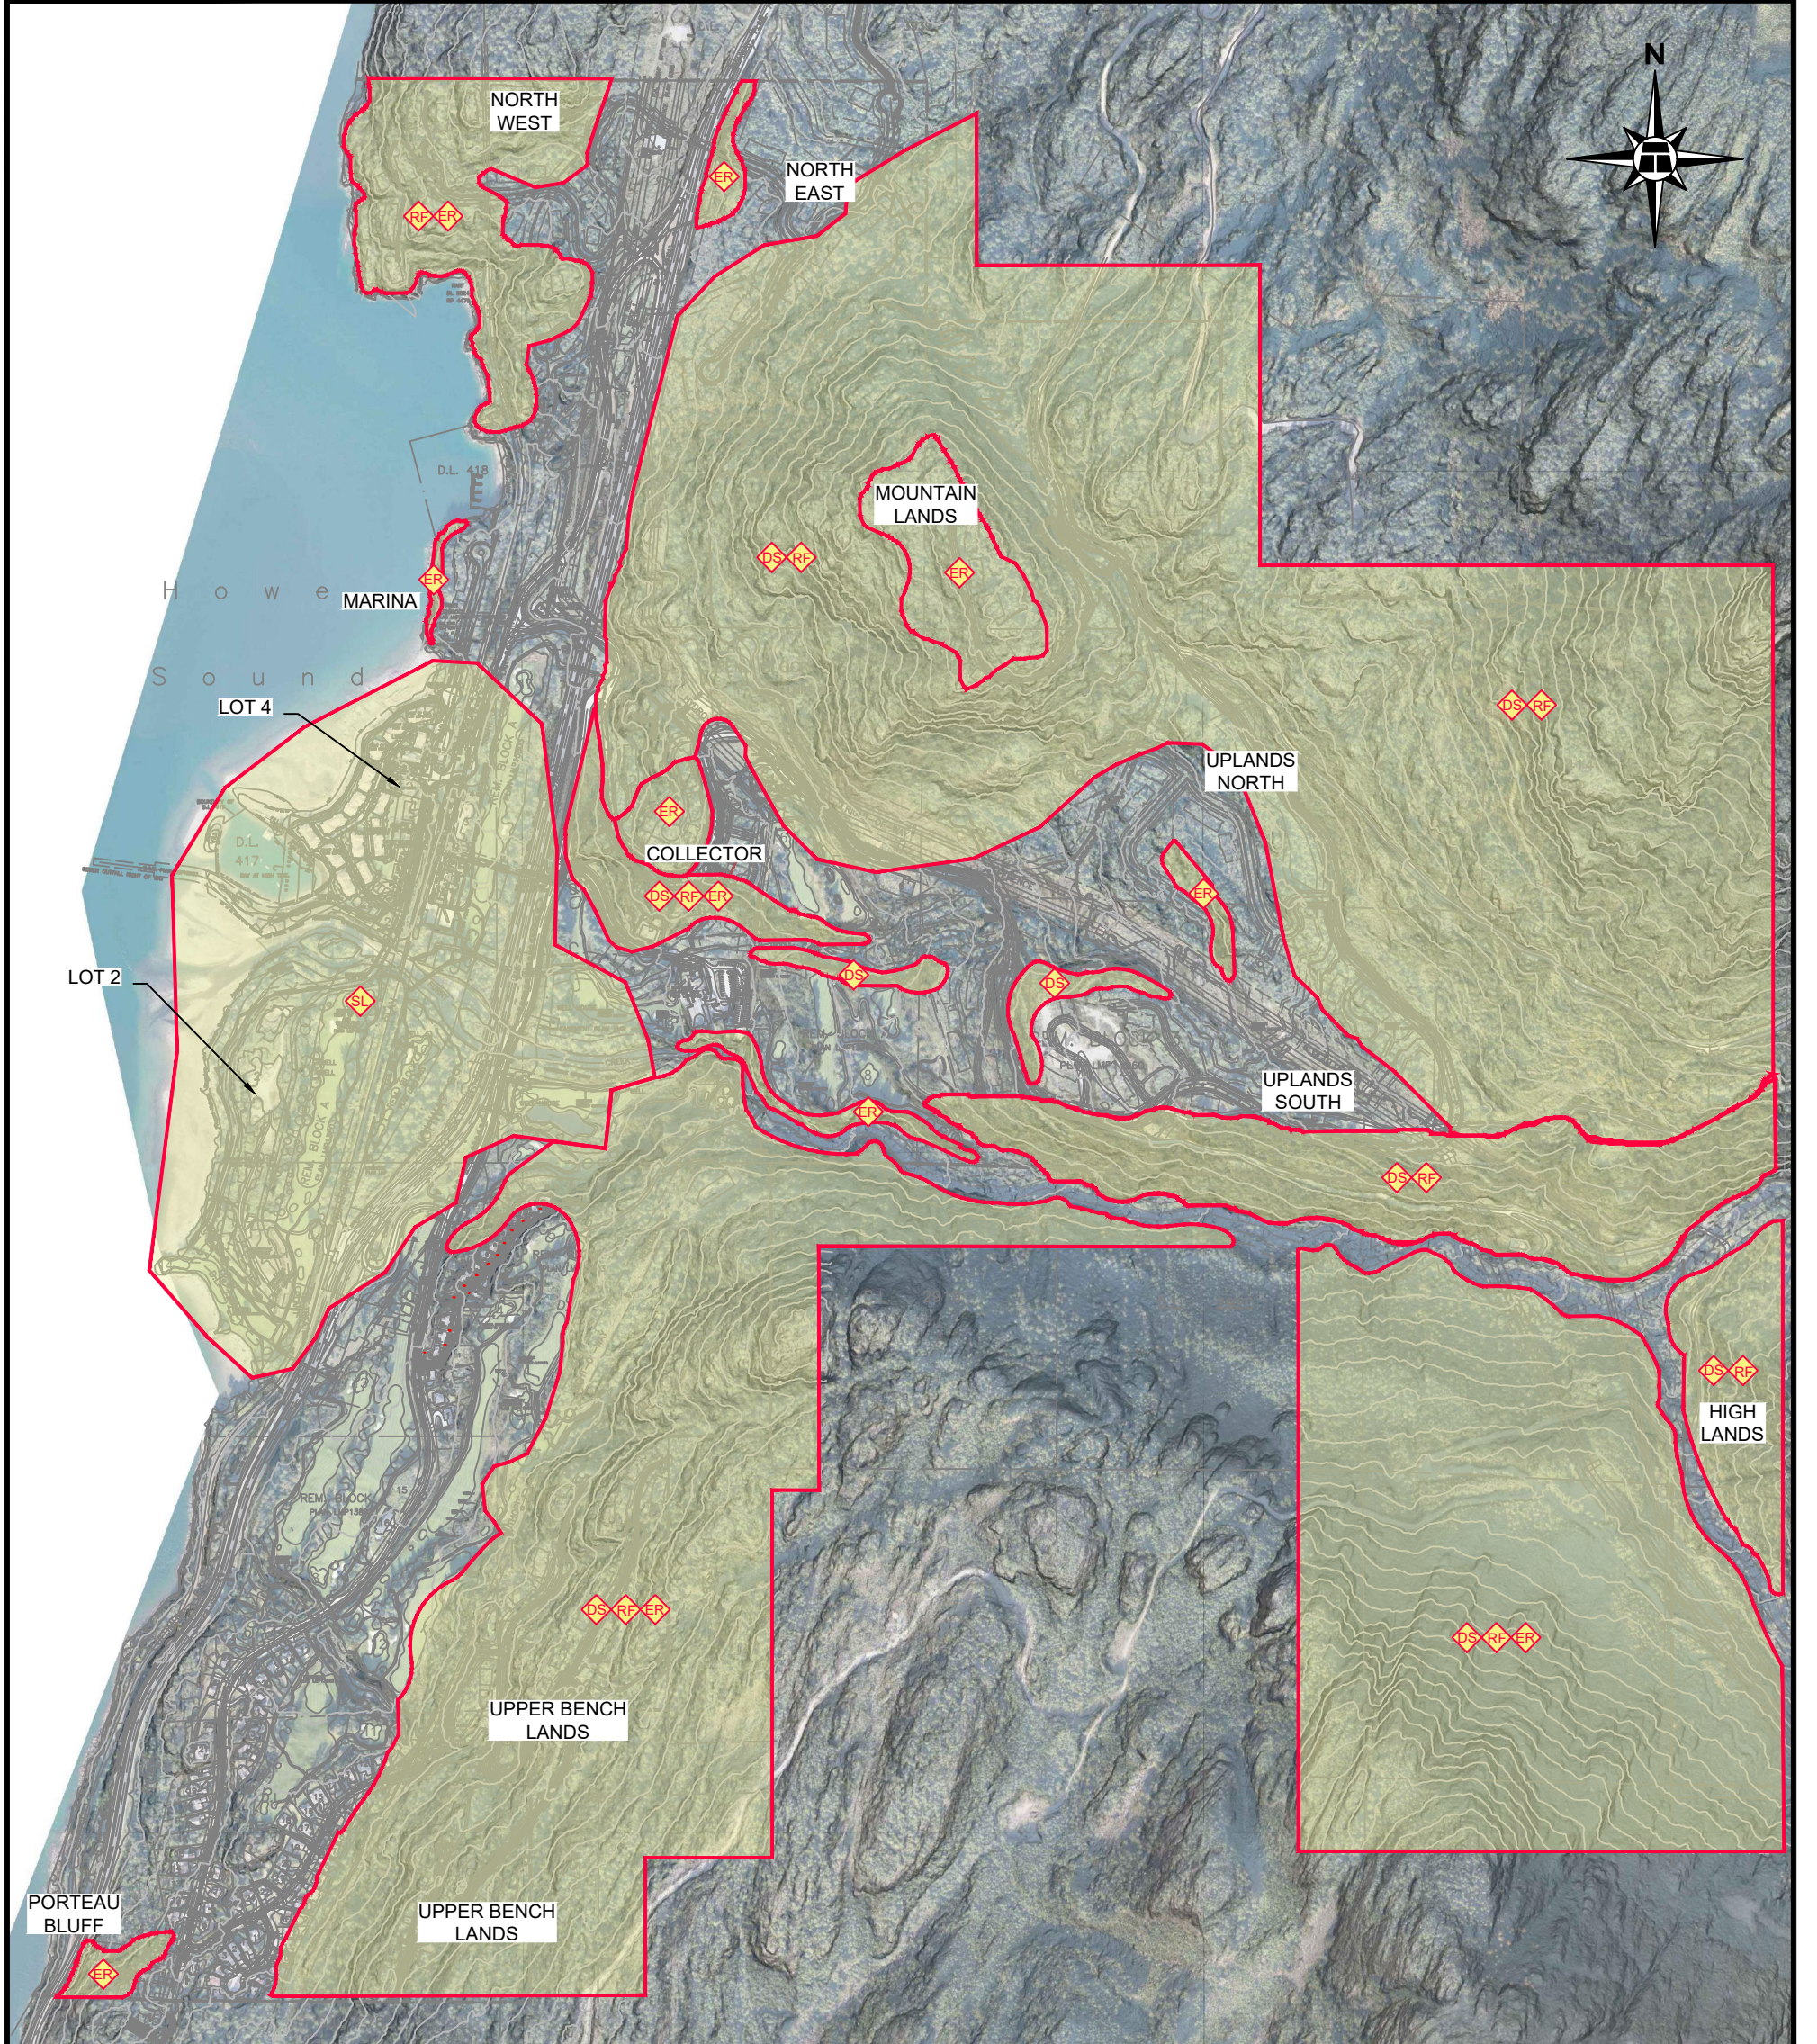
DESIGNED	JDP	DRAWN	JDP	APPROVED	DNR
DATE	08/12/2022		SCALE	AS SHOWN	
PROJECT No.	21452-30	FIG. No.	1	REV.	0

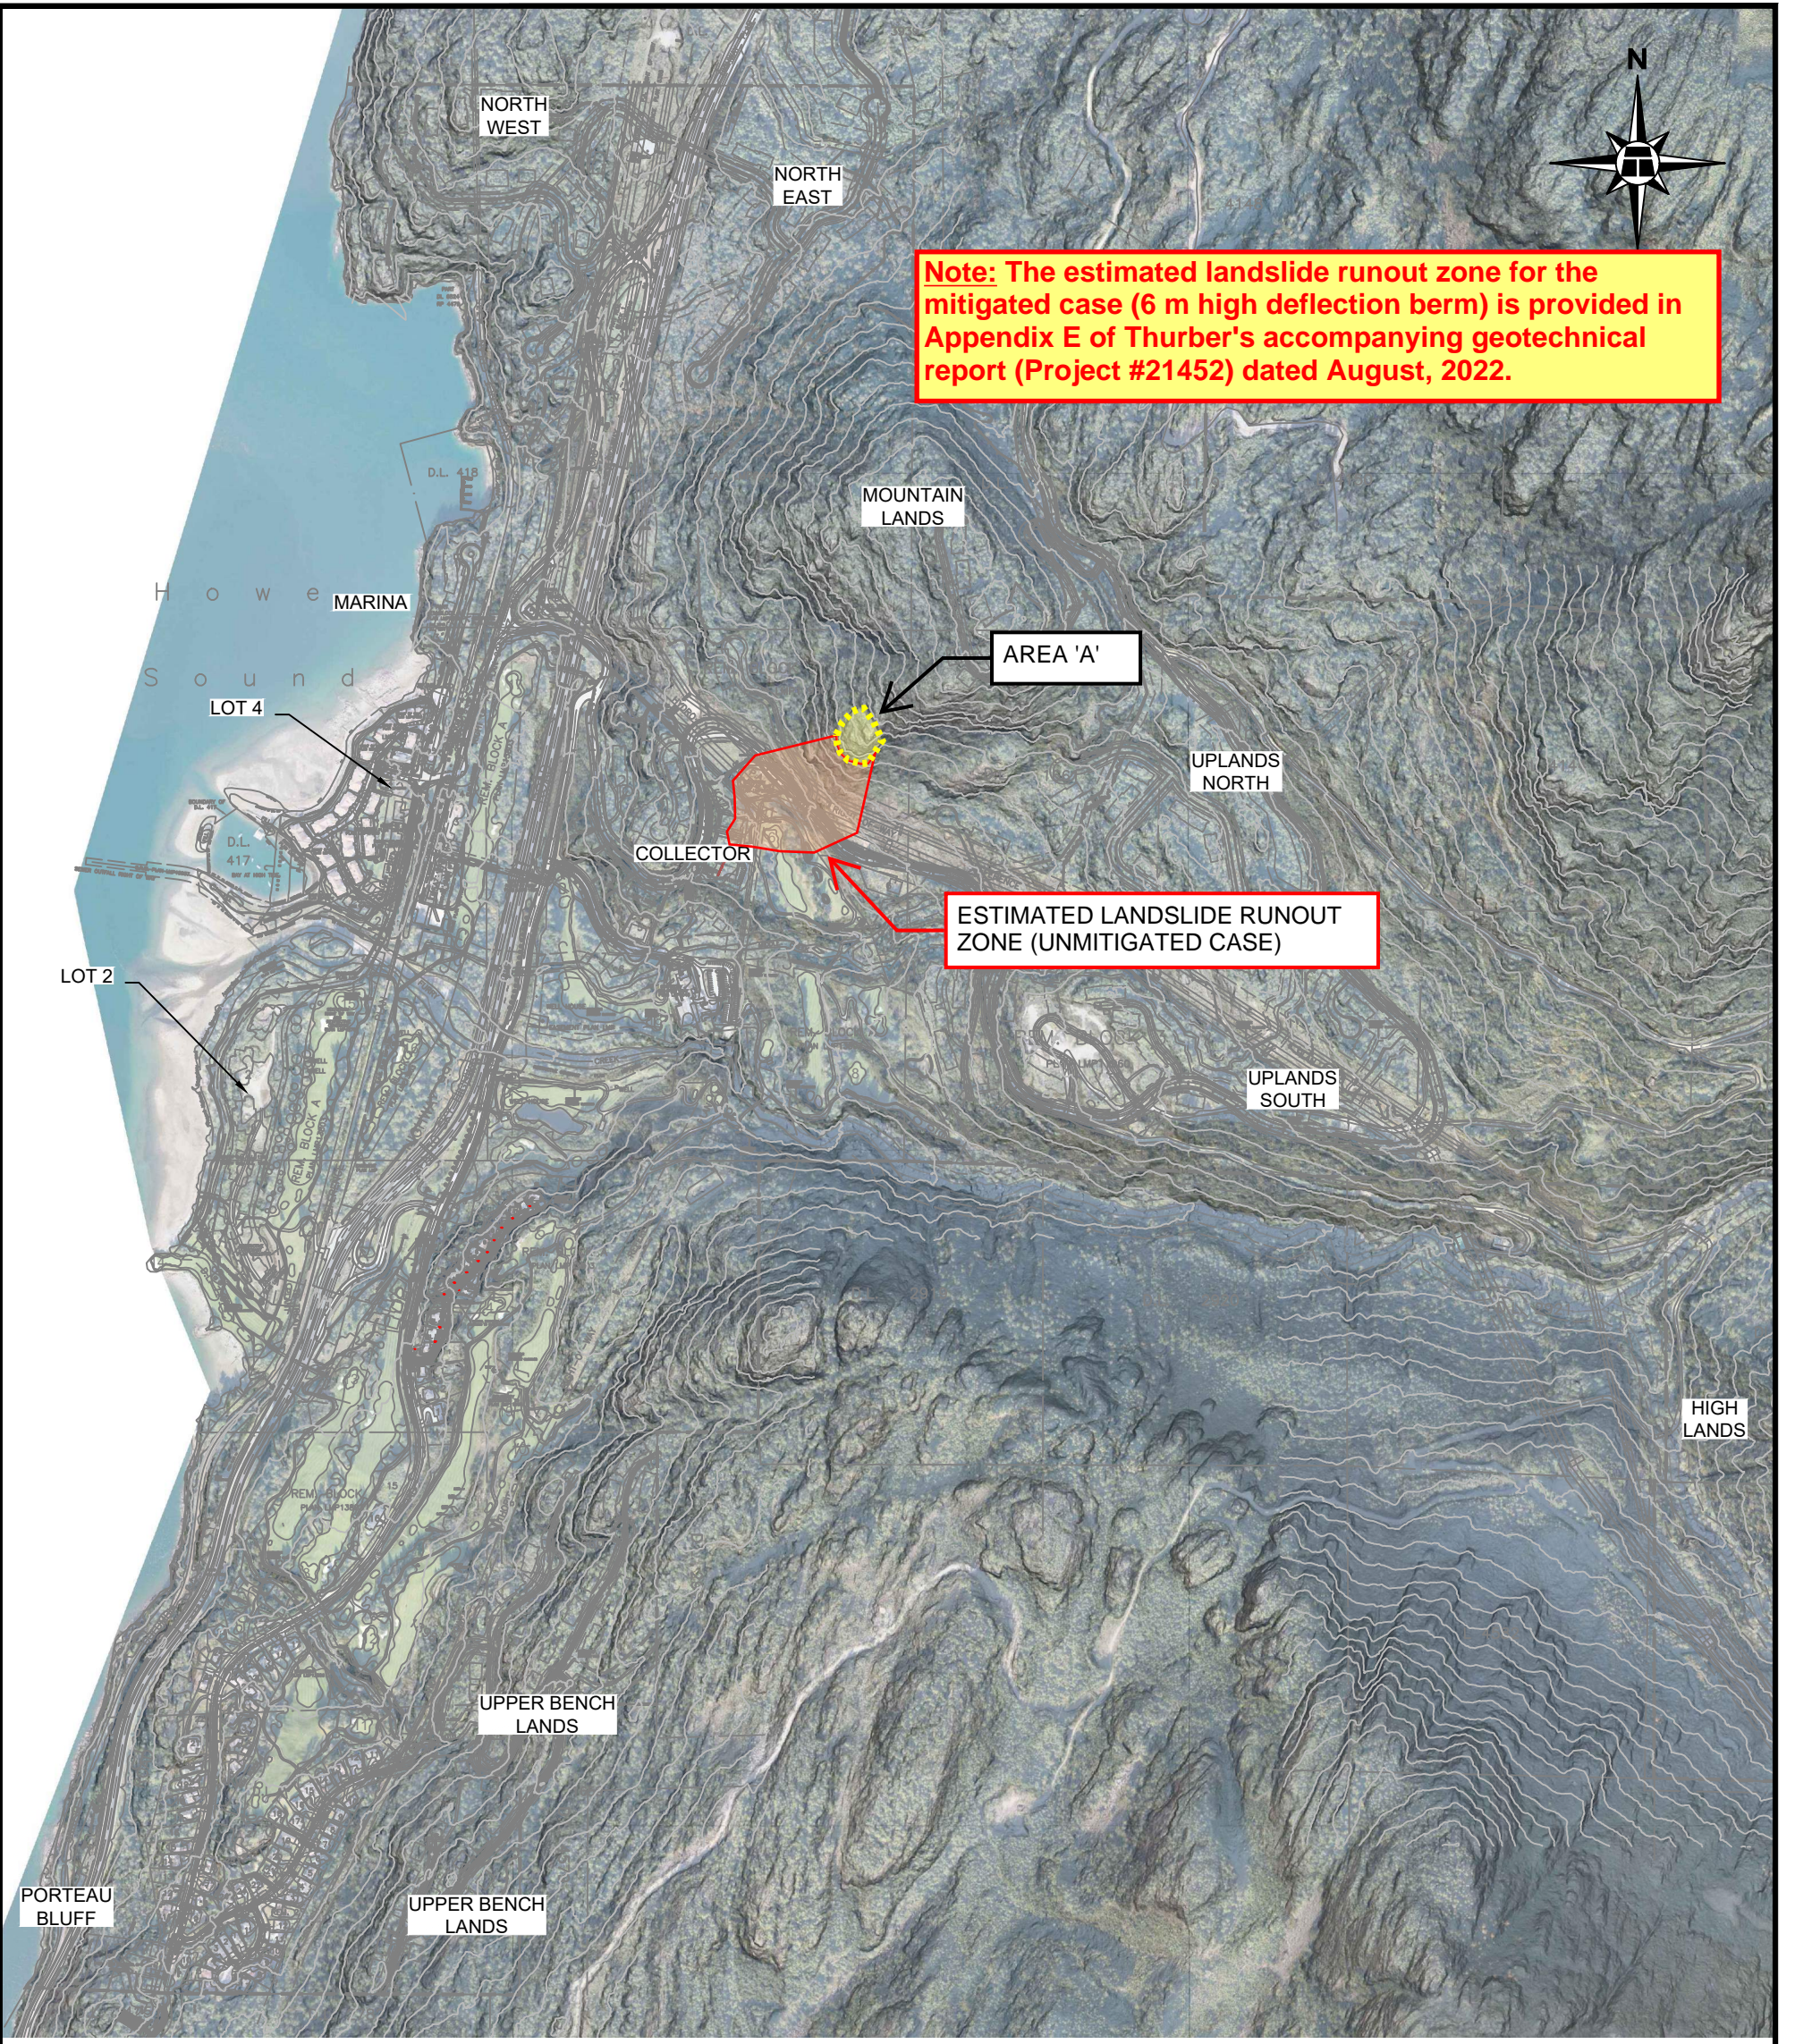
**Note:** The estimated landslide runout zone for the mitigated case (6 m high deflection berm) is provided in Appendix E of Thurber's accompanying geotechnical report (Project #21452) dated August, 2022.

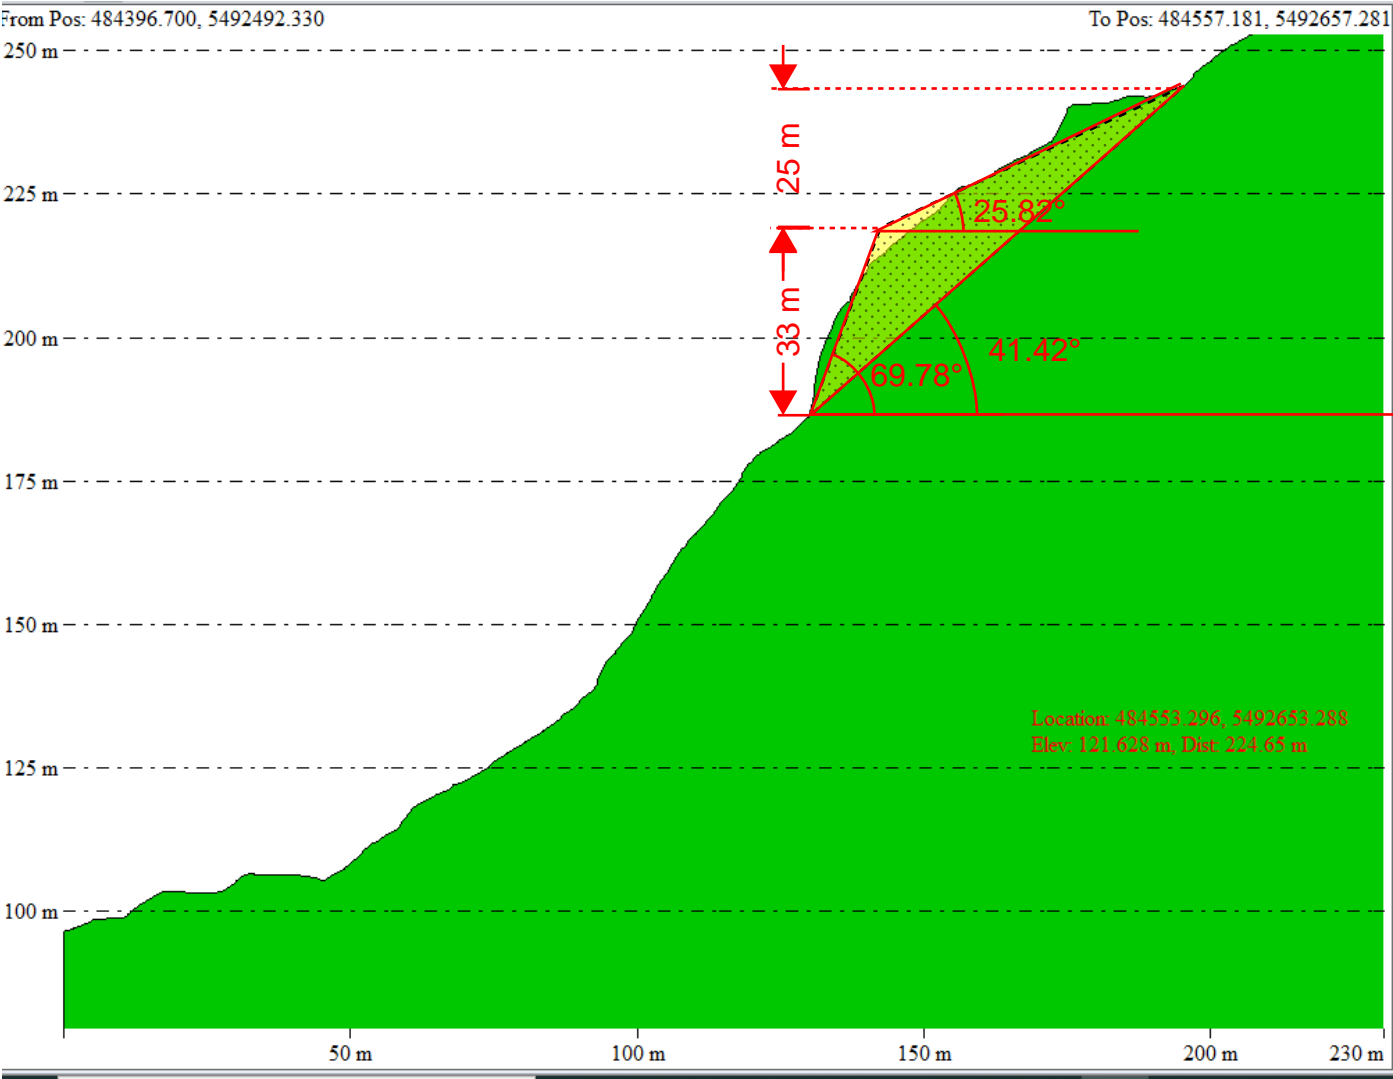
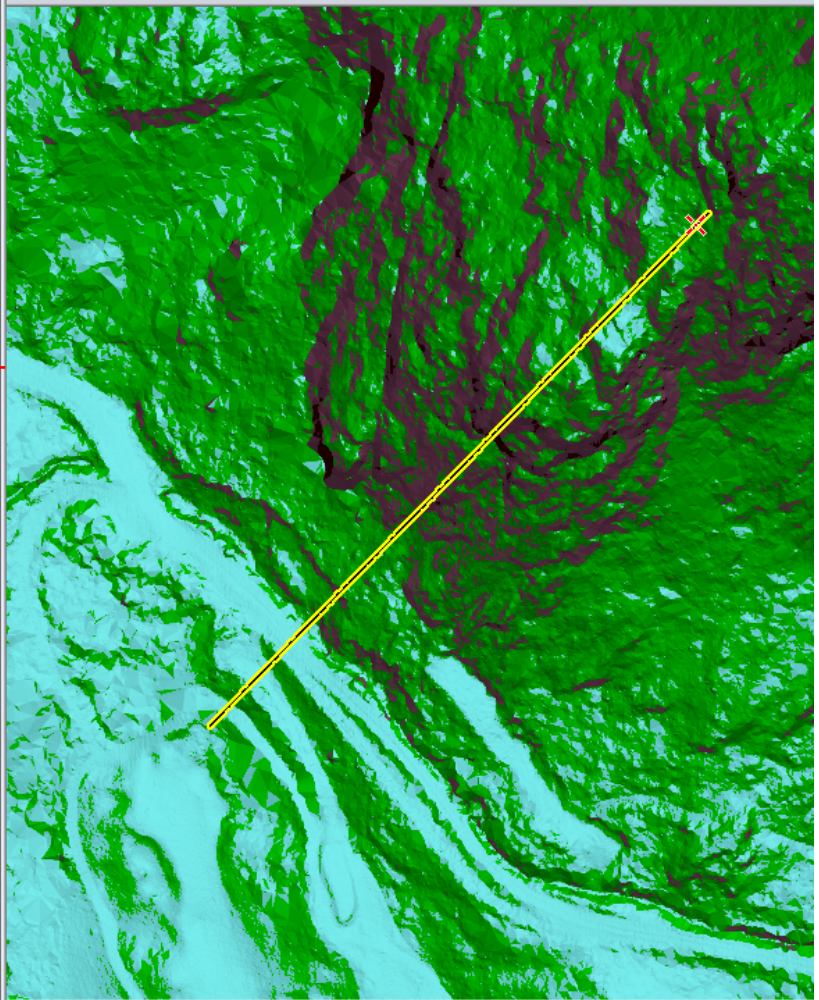
1:1690 UTM 10N ( NAD83\_CSRS ) ( 484534.607, 5492403.820, 123.749 m ) 49° 35' 02.4727" N, 123° 12' 50.2368" W

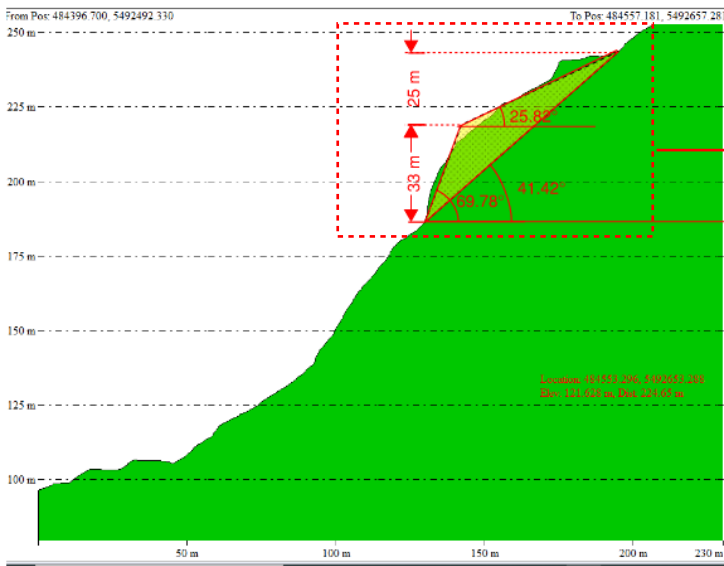
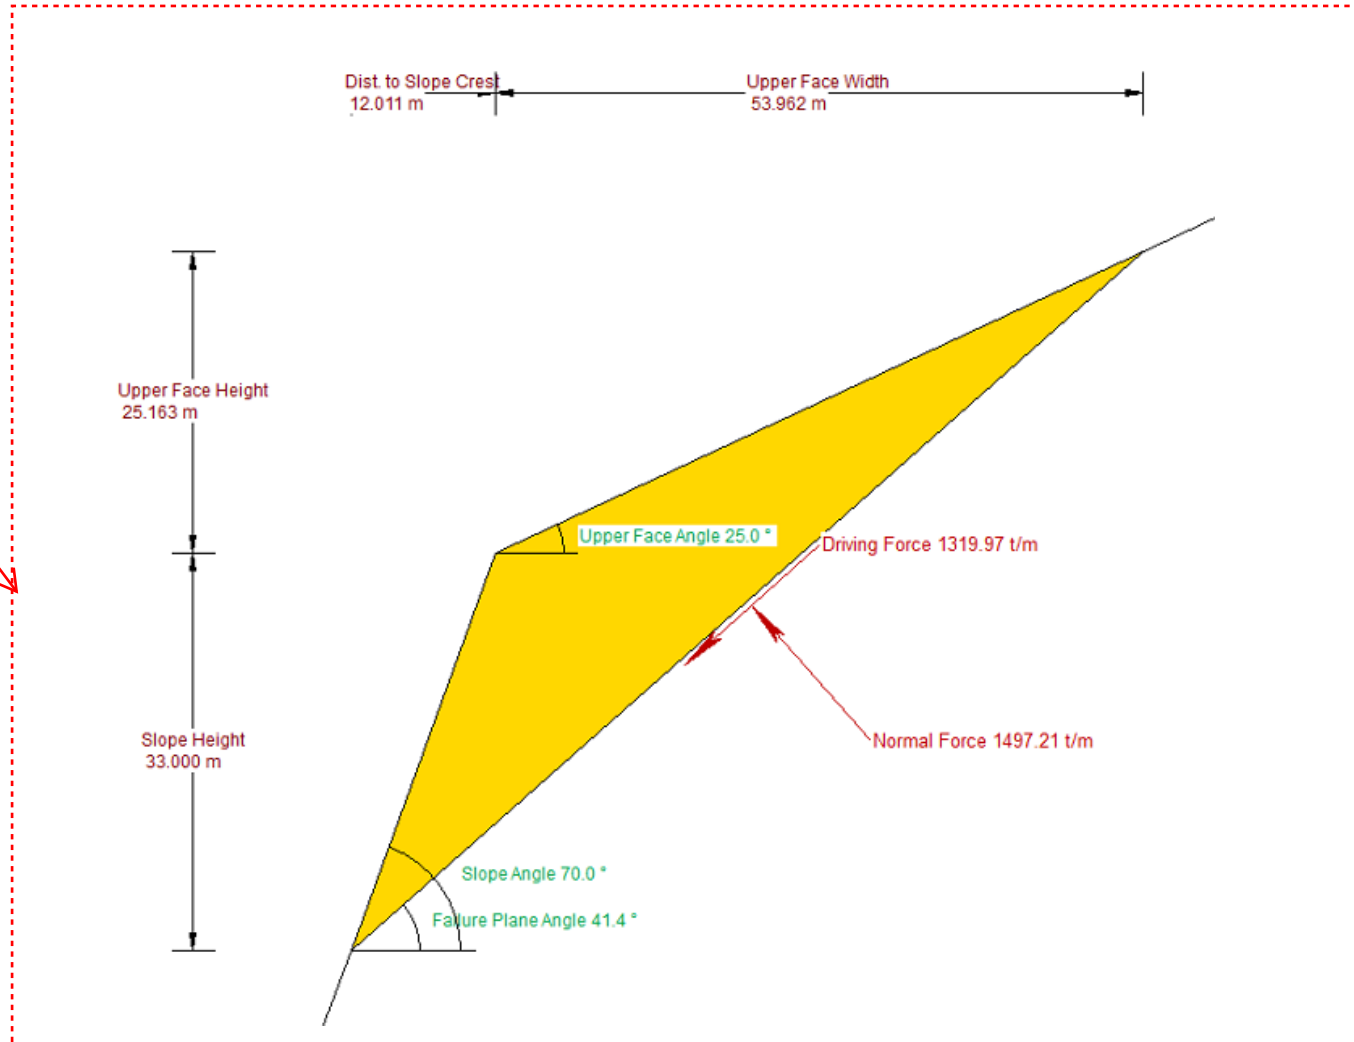
# Scenario 1: No tension crack; dry joint plane; static loading

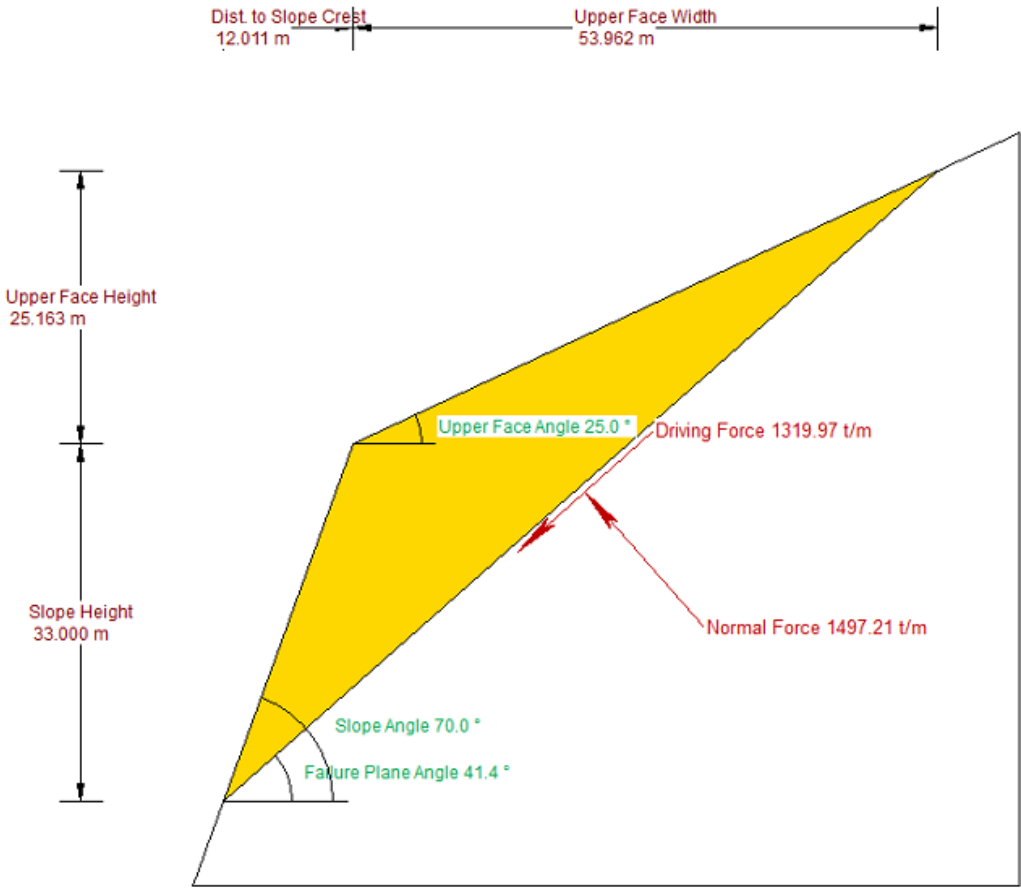
Factor of Safety	4.13
Driving Force	1319.97t/m
Resisting Force	5445.88t/m
Wedge Weight	1995.98t/m
Wedge Volume	739.25m <sup>3</sup> /m
Shear Strength	61.92t/m <sup>2</sup>
Shear Resistance	5445.88t/m
Normal Force	1497.21t/m
Plane Waviness	0.0°

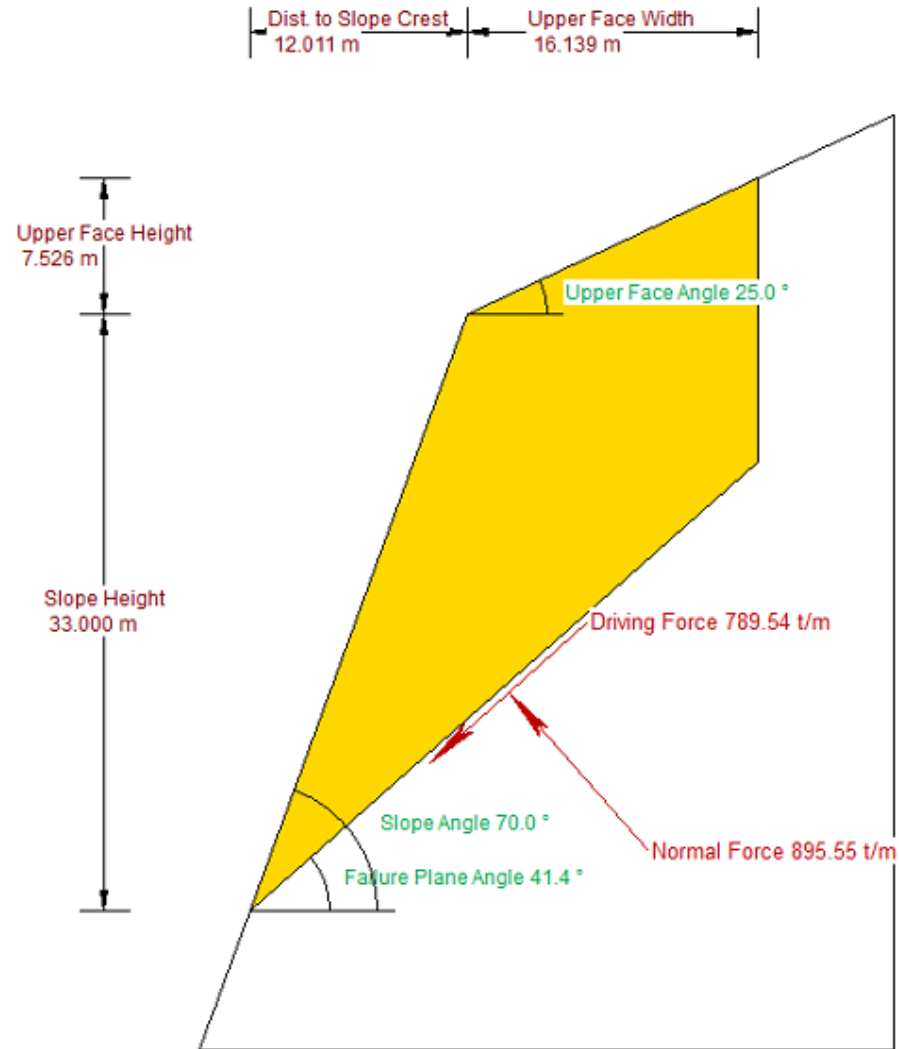
Factor of Safety	3.17
Driving Force	789.54t/m
Resisting Force	2503.43t/m
Wedge Weight	1193.89t/m
Wedge Volume	442.18m <sup>3</sup> /m
Shear Strength	66.71t/m <sup>2</sup>
Shear Resistance	2503.43t/m
Normal Force	895.55t/m
Plane Waviness	0.0°

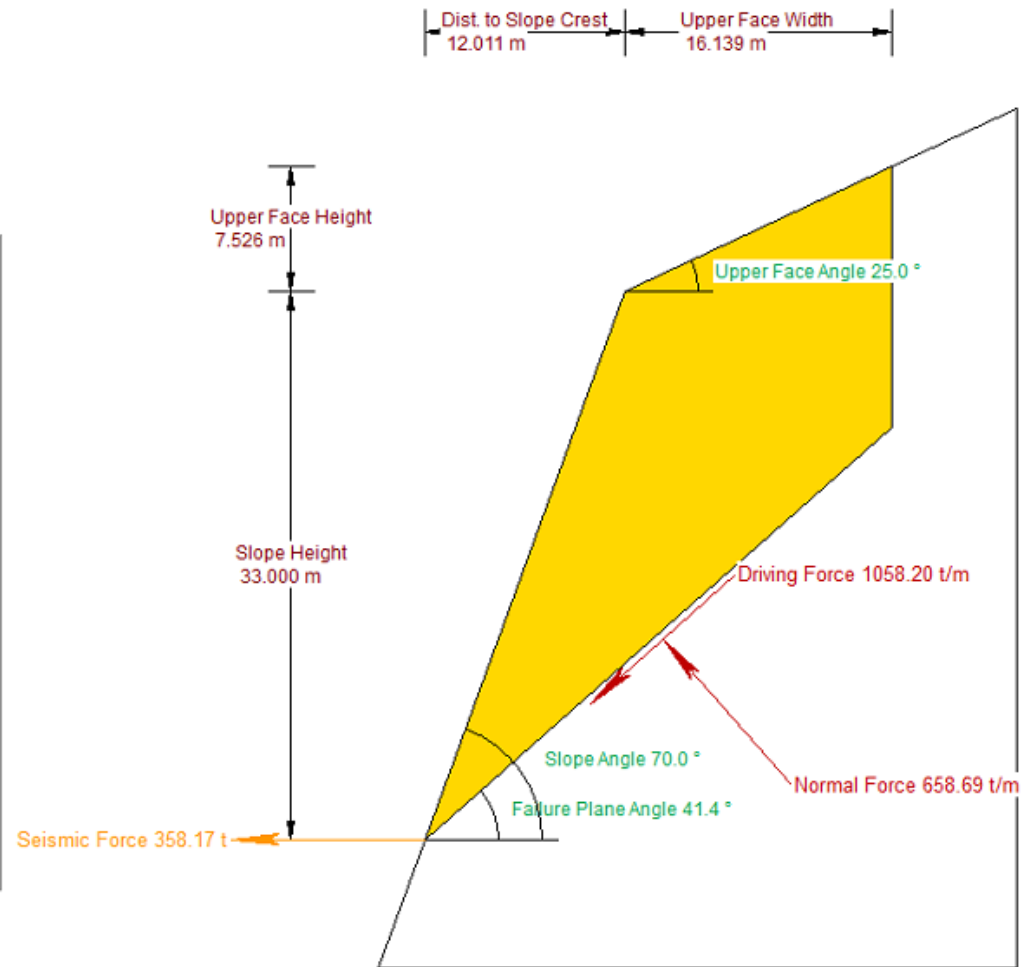
Factor of Safety	2.21
Driving Force	1058.20t/m
Resisting Force	2337.58t/m
Wedge Weight	1193.89t/m
Wedge Volume	442.18m <sup>3</sup> /m
Shear Strength	62.29t/m <sup>2</sup>
Shear Resistance	2337.58t/m
Normal Force	658.69t/m
Seismic Force	358.17t
Plane Waviness	0.0°

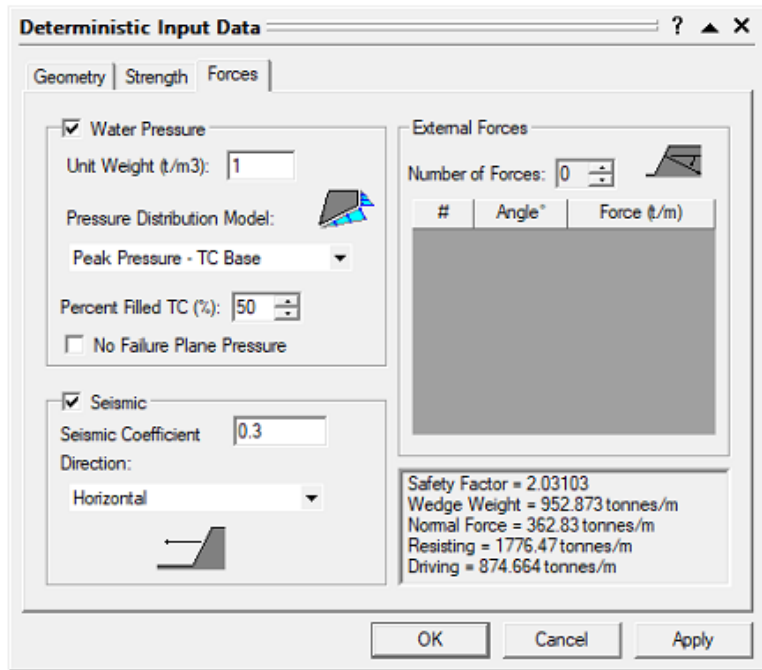
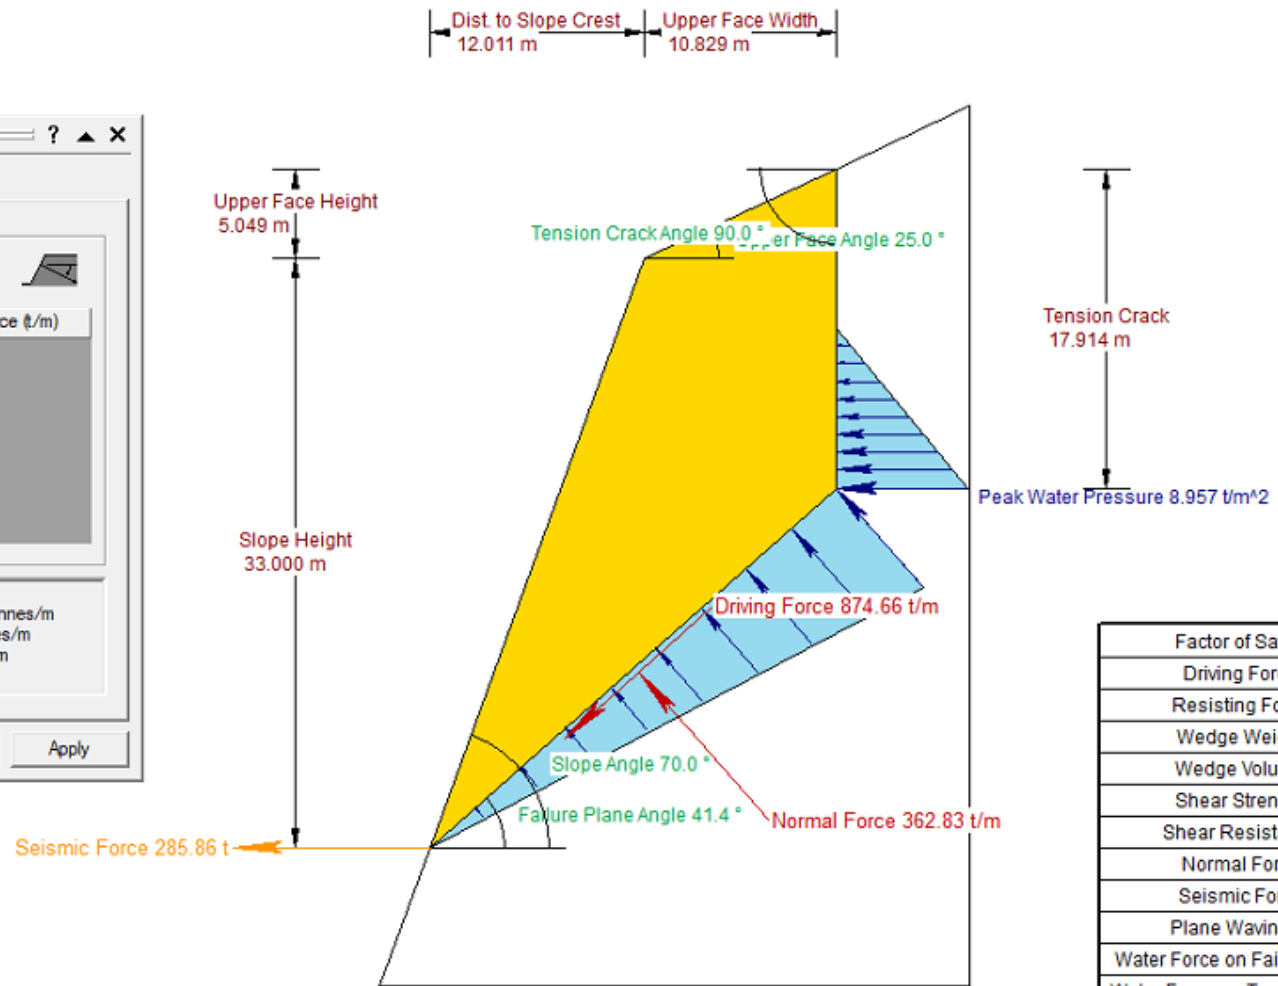
Factor of Safety	2.03
Driving Force	874.66t/m
Resisting Force	1776.47t/m
Wedge Weight	952.87t/m
Wedge Volume	352.92m <sup>3</sup> /m
Shear Strength	58.34t/m <sup>2</sup>
Shear Resistance	1776.47t/m
Normal Force	362.83t/m
Seismic Force	285.86t
Plane Waviness	0.0°
Water Force on Failure Plane	136.36t/m
Water Force on Tension Crack	40.11t/m

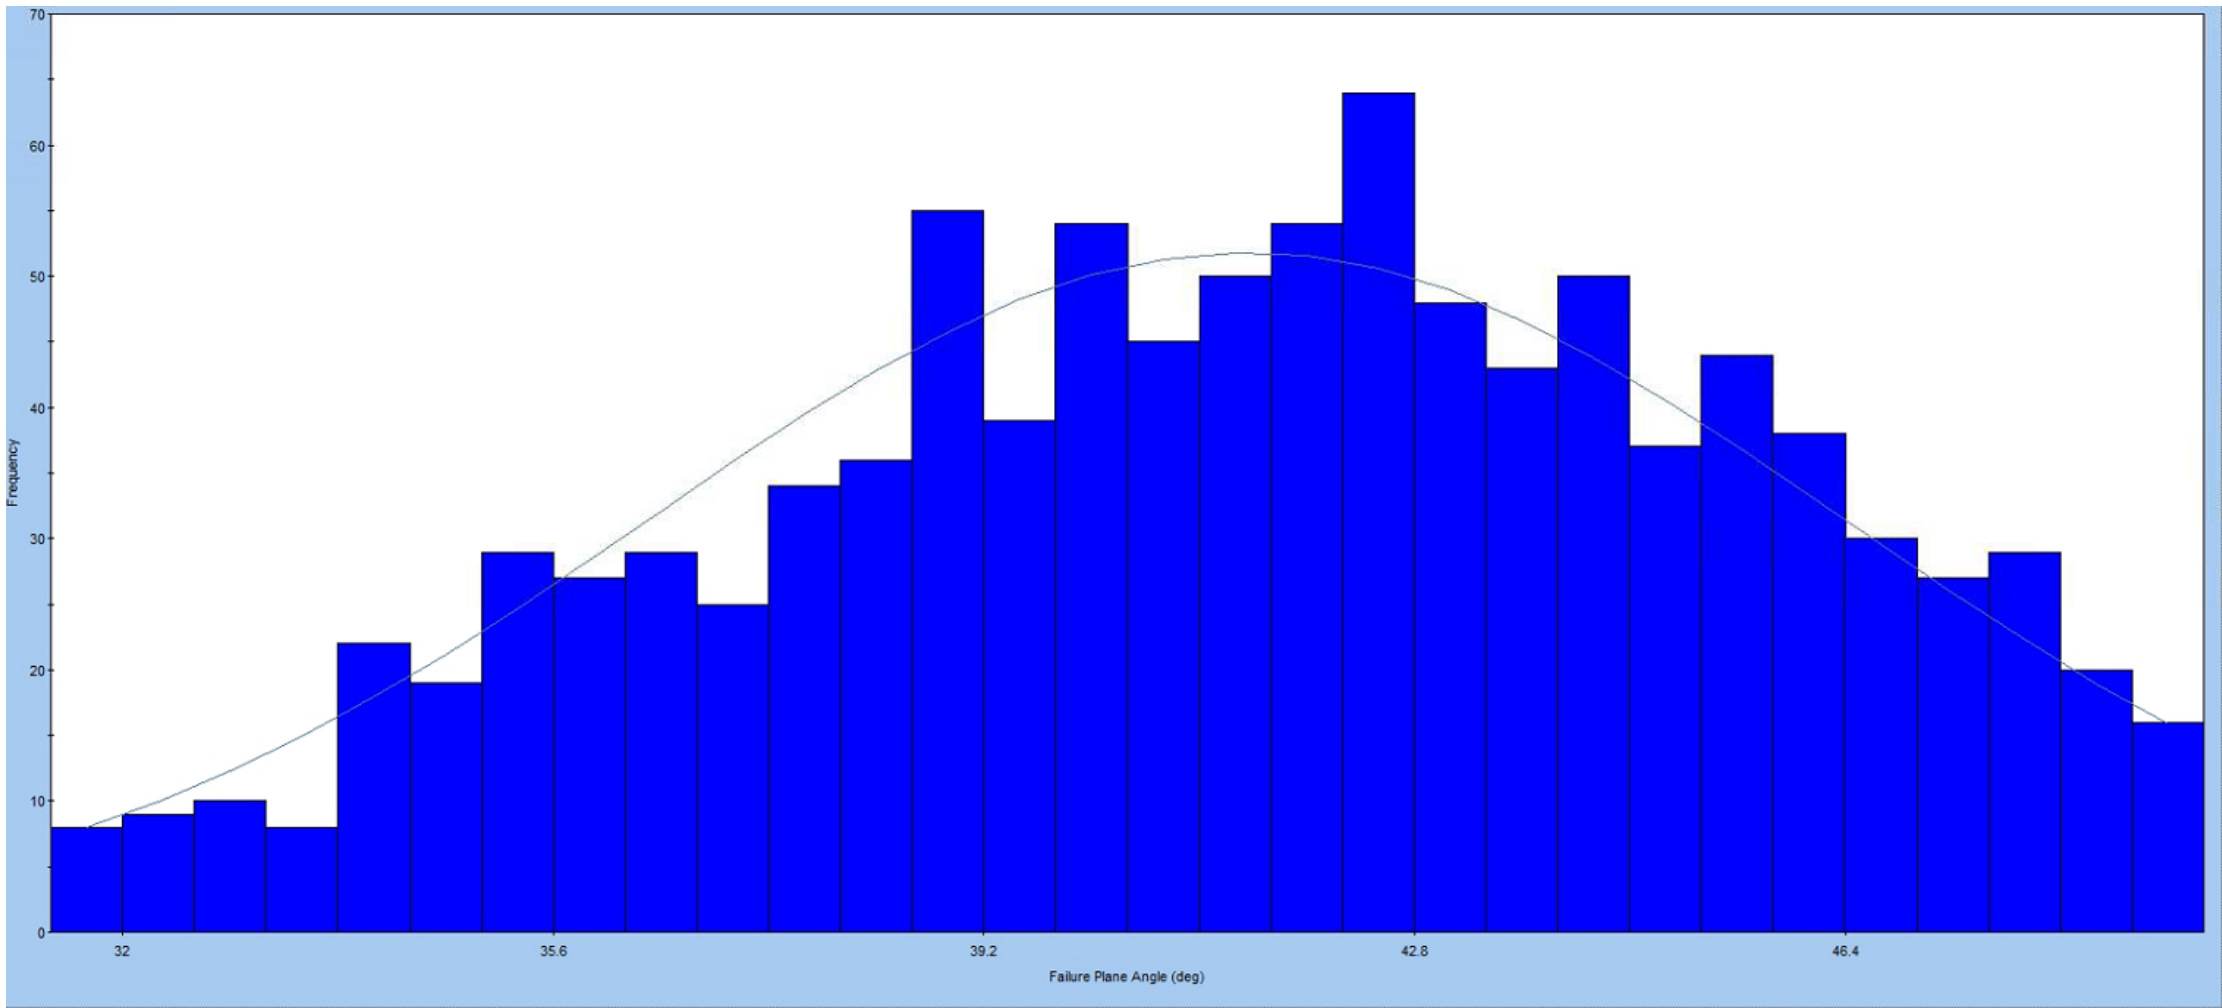
SAMPLED: mean=41.36 s.d.=4.143 min=31.42 max=49.39 PS=2.1 PF=2.1%  
INPUT: NORMAL mean=41.4 s.d.=5 min=31.4 max=49.4
