**THURBER** ENGINEERING LTD.

August 31, 2022

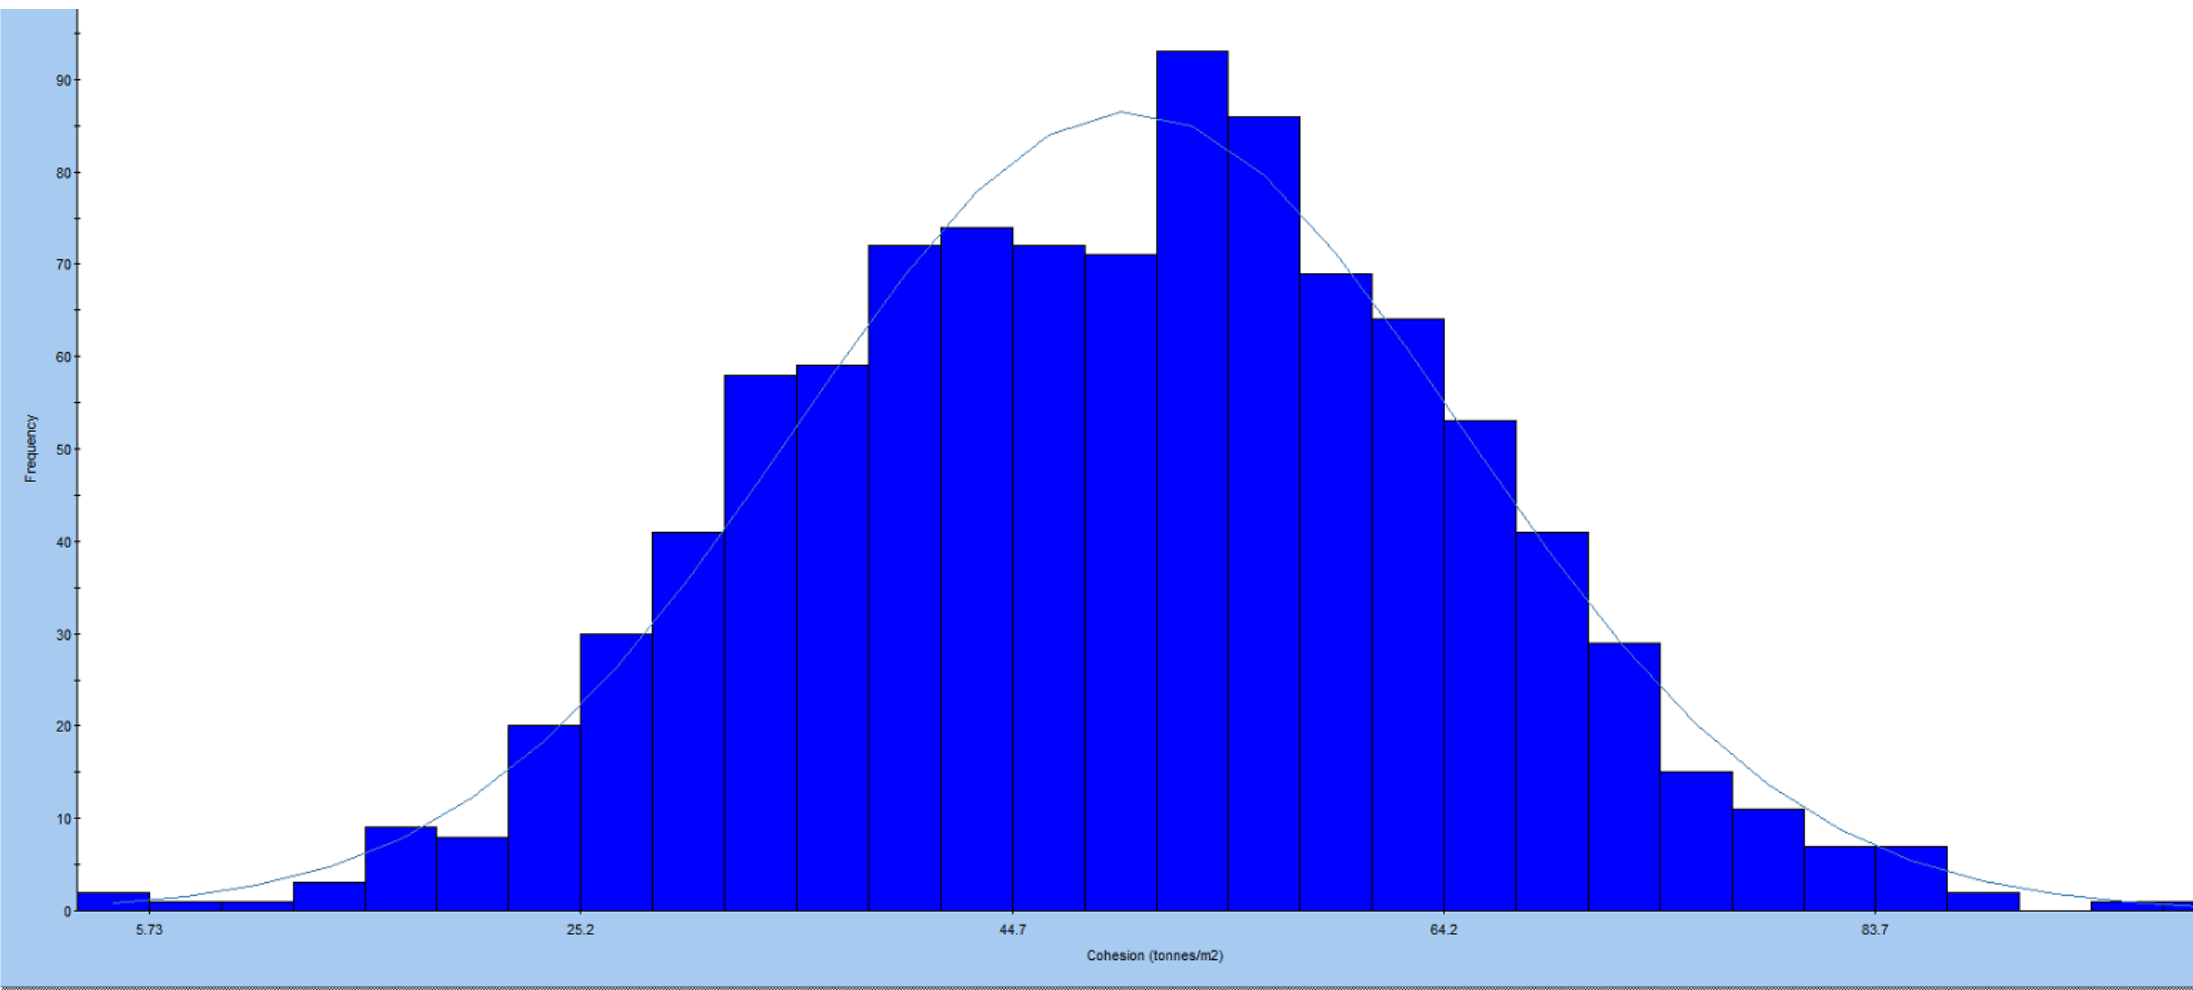
SAMPLED: mean=49.71 s.d.=14.76 min=2.483 max=99.97 PS=2.1 PF=2.1%  
INPUT: NORMAL mean=50 s.d.=15 min=0 max=100

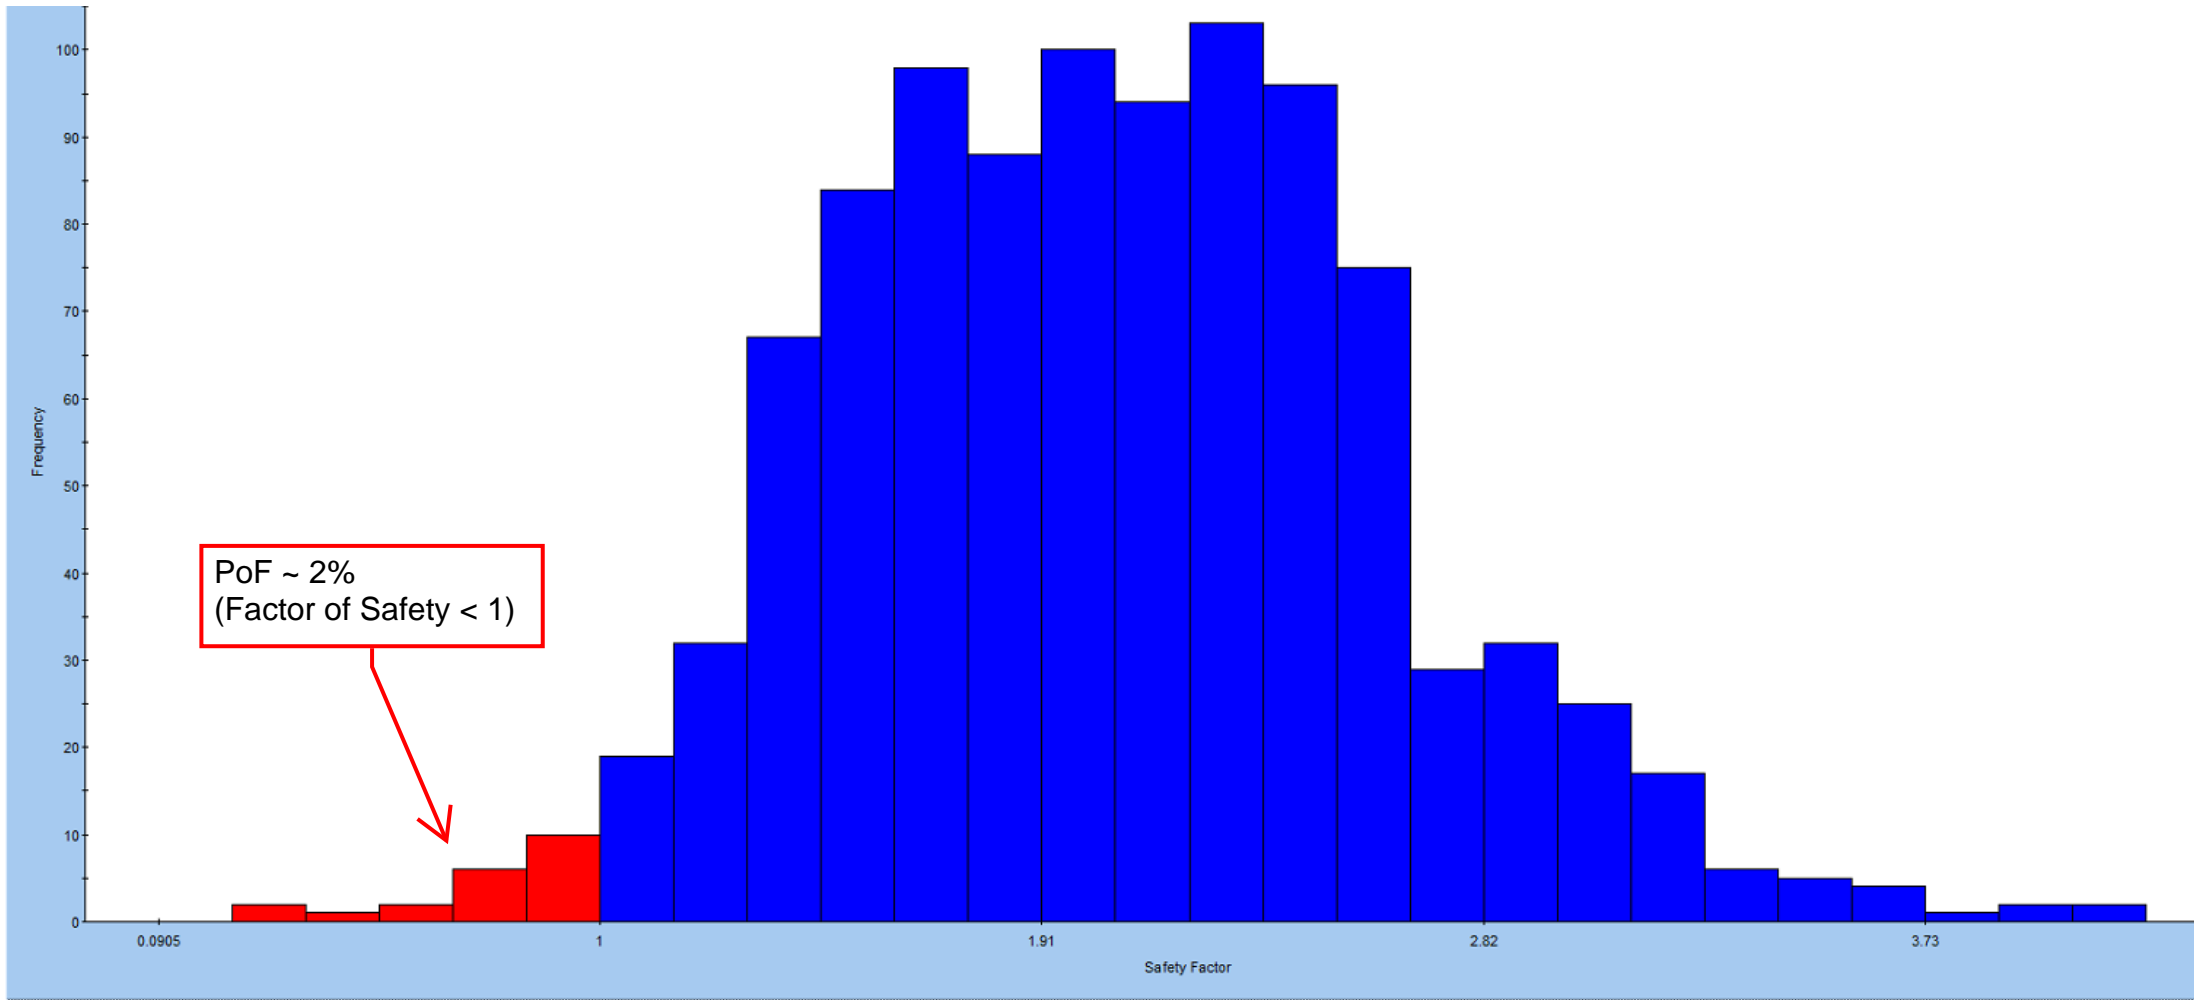
SAMPLED: mean=2.064 s.d.=0.5688 min=0.2432 max=4.156 PS=2.1 PF=2.1%

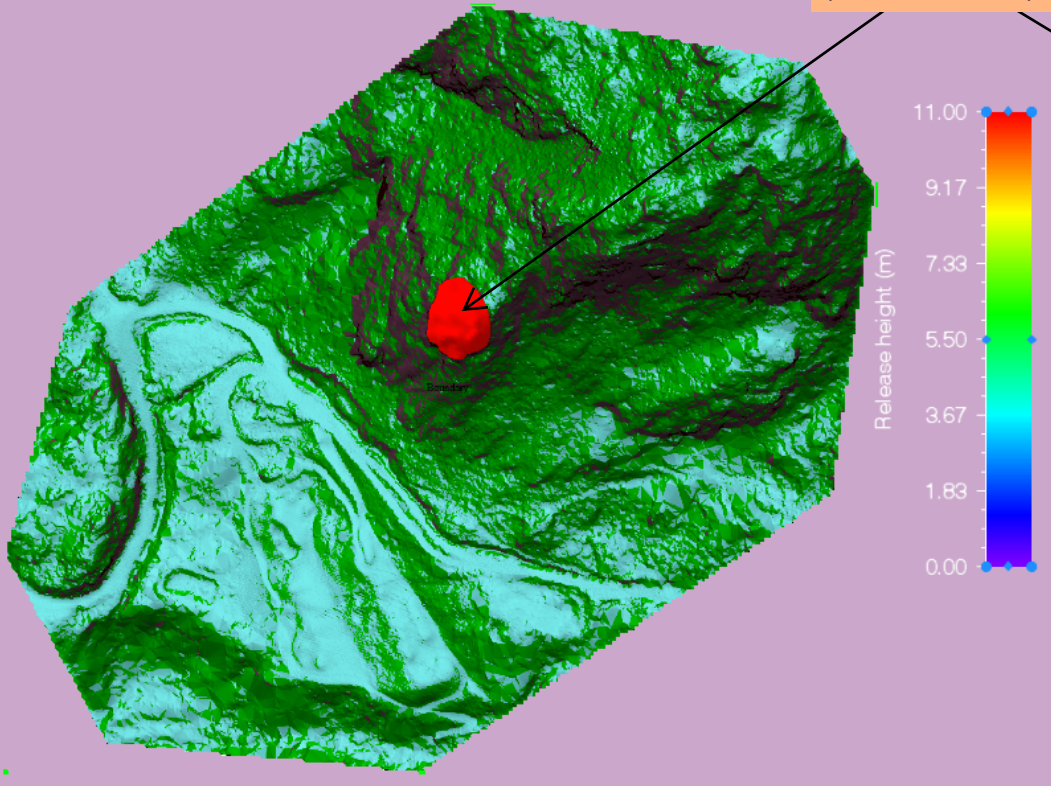
Initial failure mass  
(solid red area)

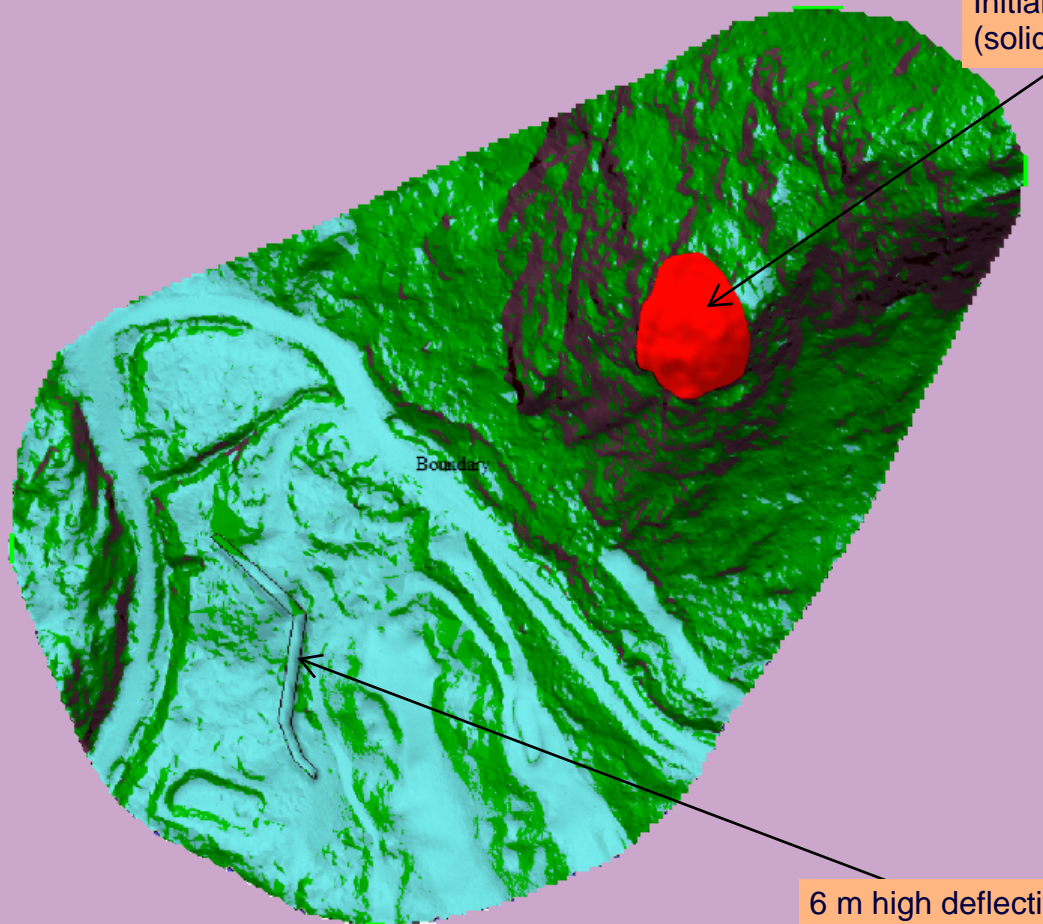
Initial failure mass  
(solid red area)

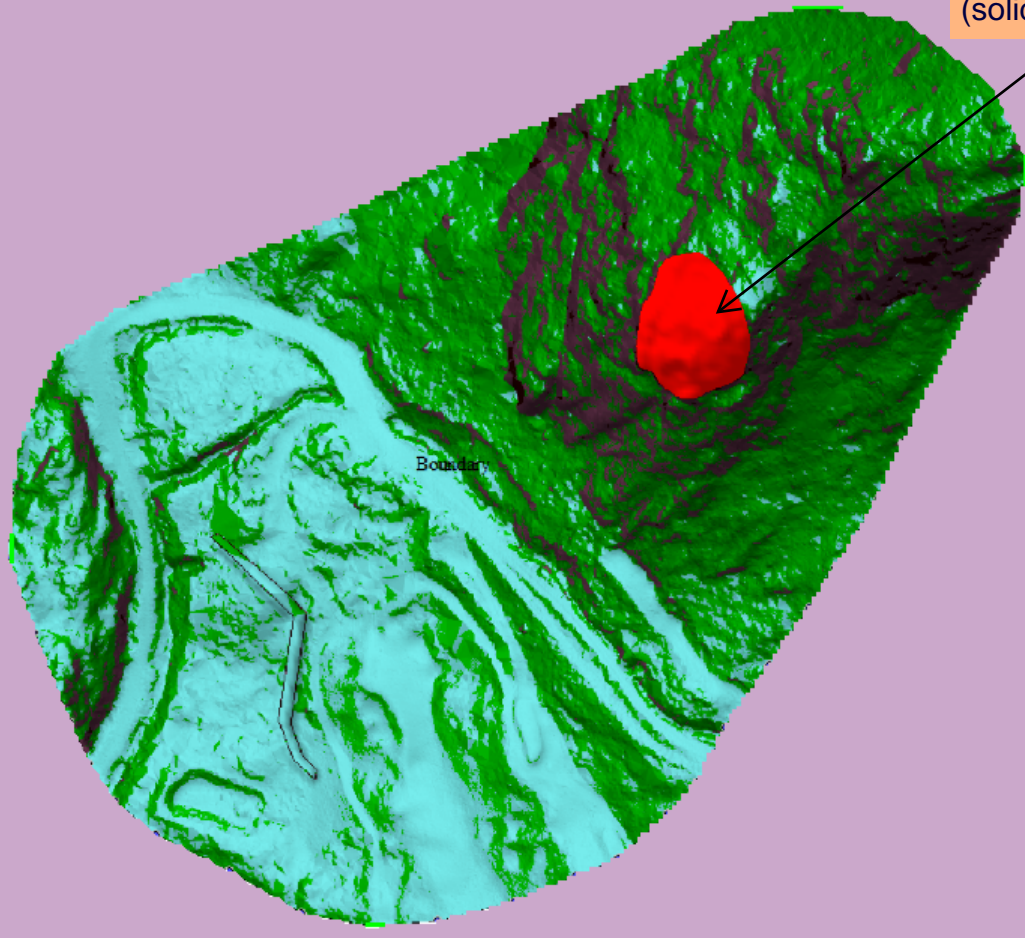
Friction coefficient: 0.4

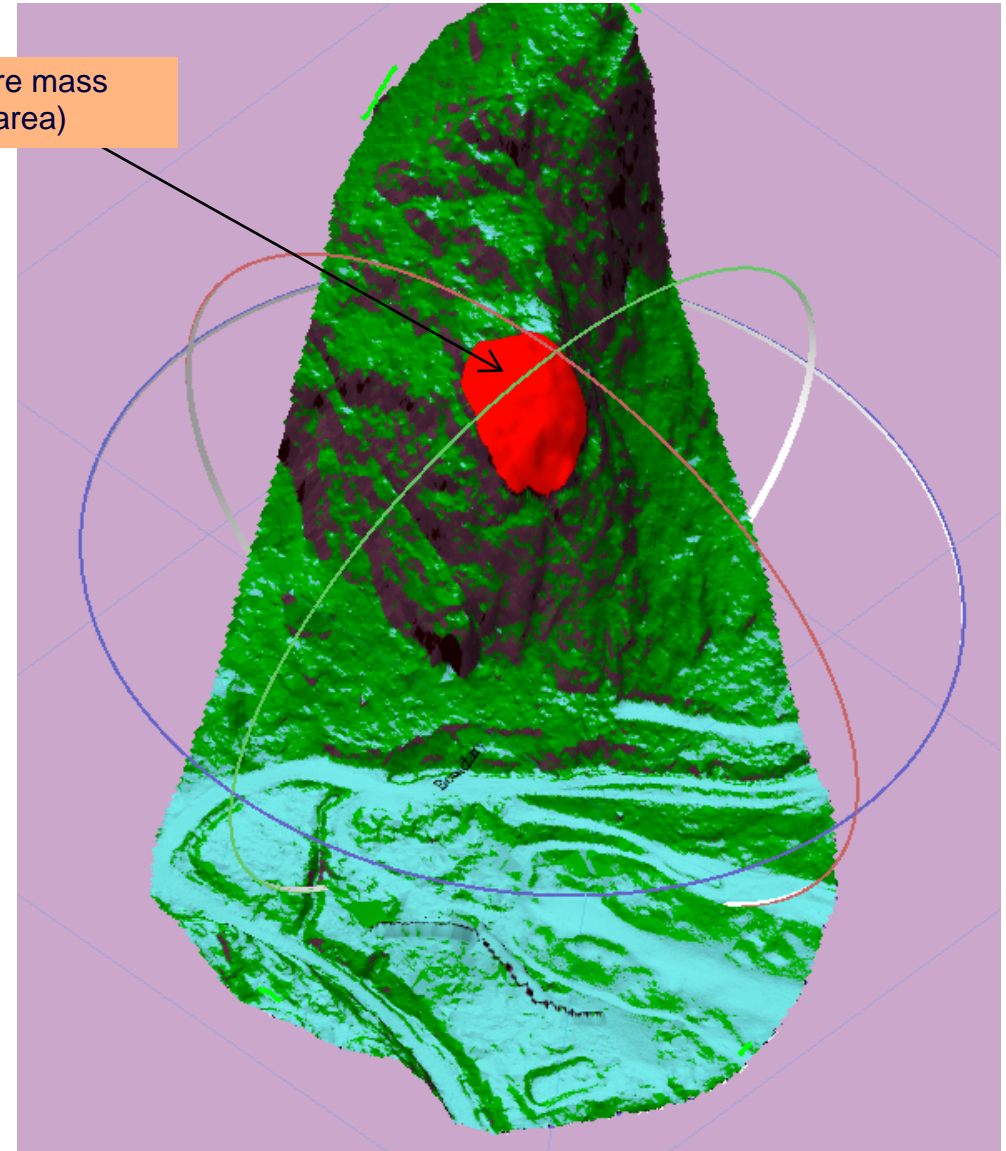
Initial failure mass  
(solid red area)

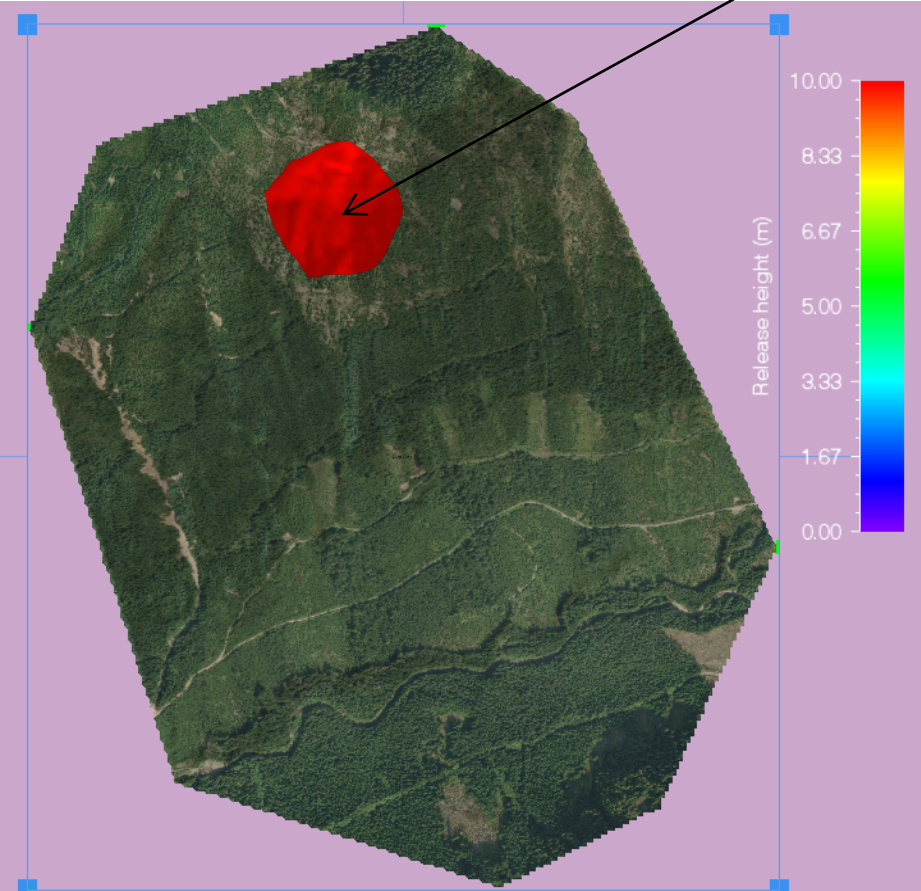
Initial failure mass  
(solid red area)

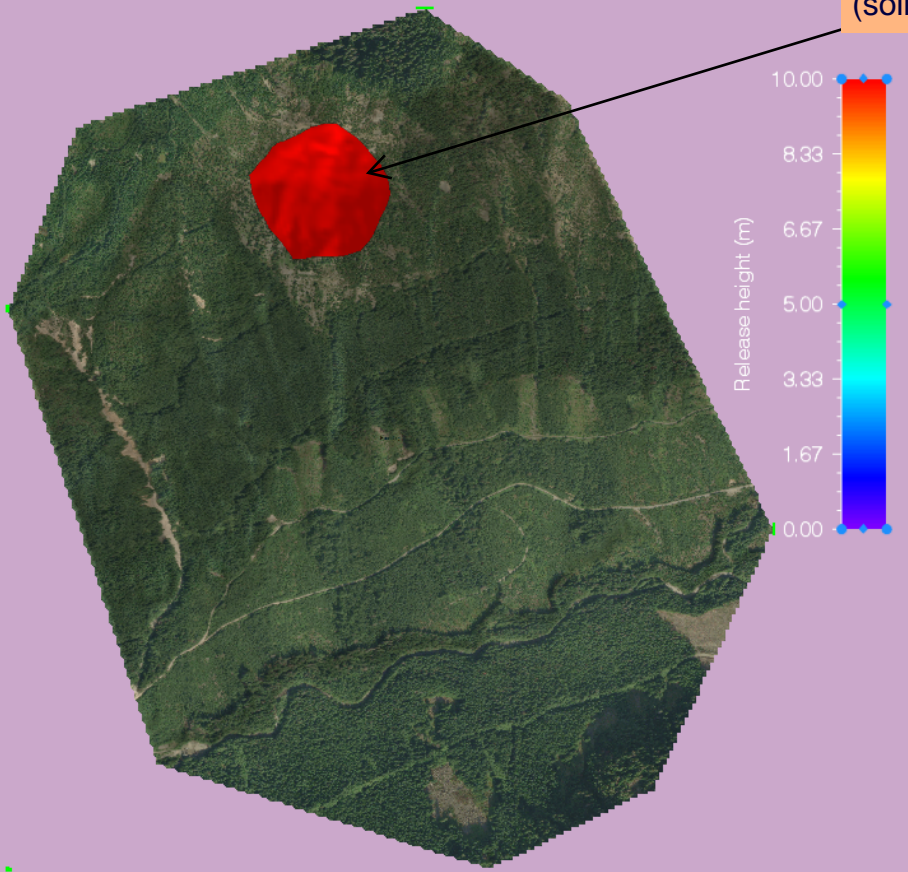
Initial failure mass  
(solid red area)
