SQUAMISH-LILLOOET REGIONAL DISTRICT

Quantitative Landslide Hazard and Risk Assessment – Reid Road Area, Electoral Area C

**Final
January 26, 2023**

BGC Project No.: 1358010

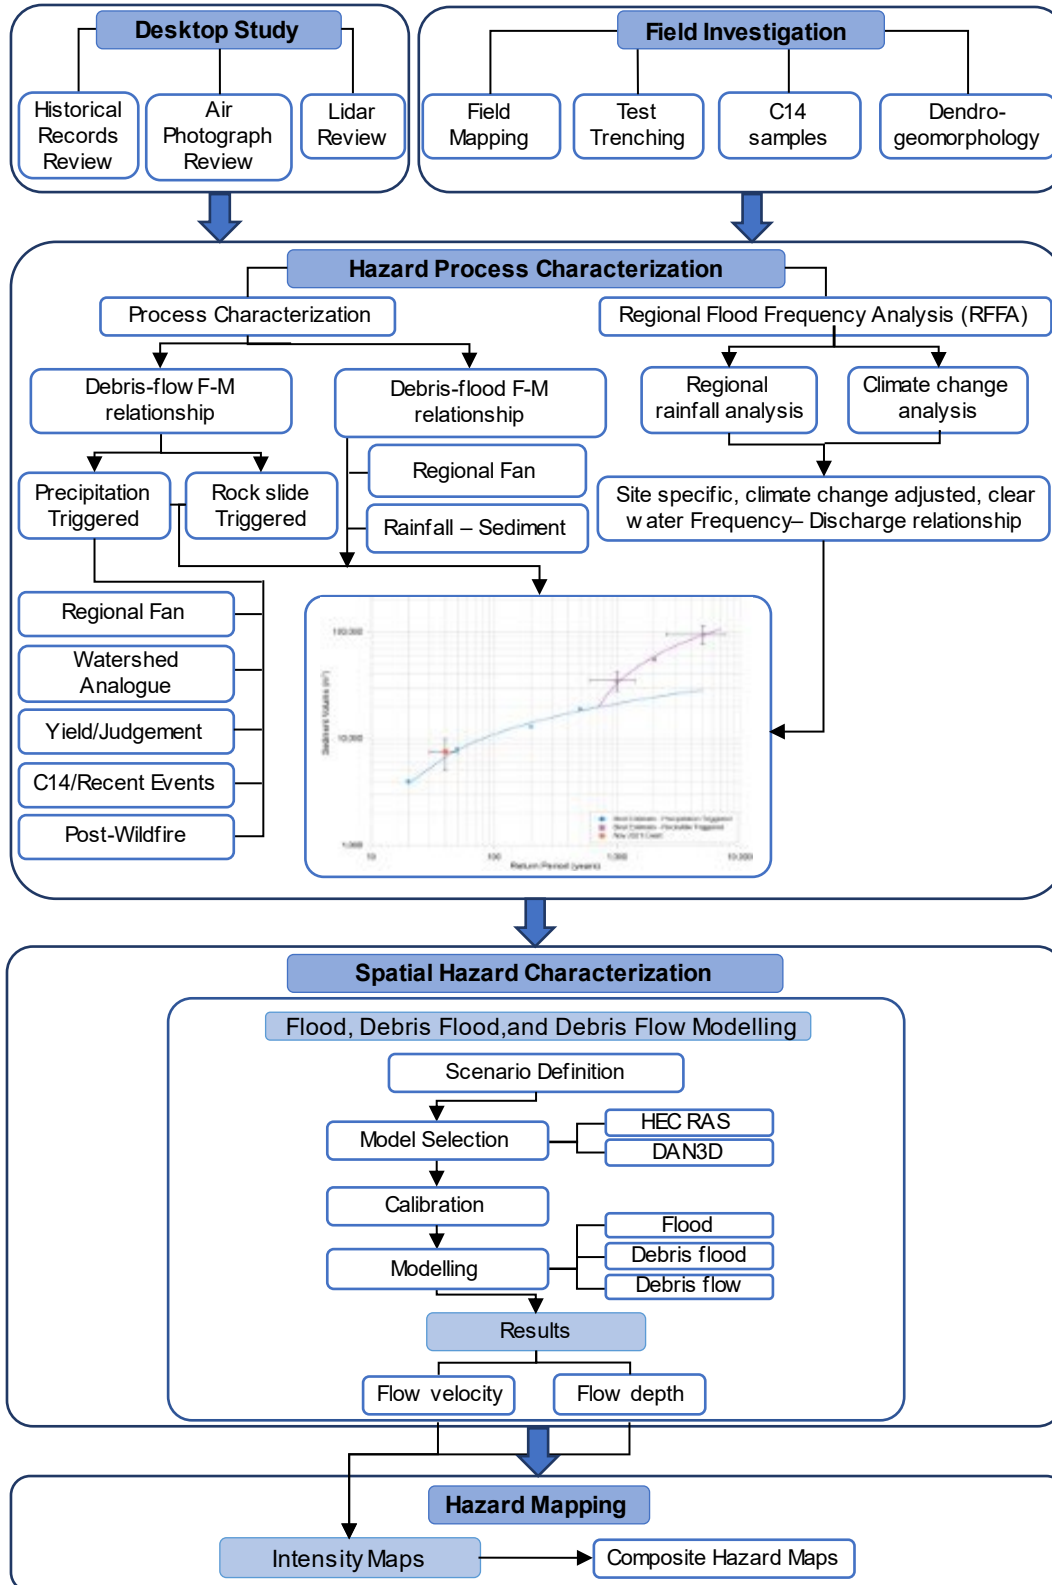
Figure 4-1. Steep creek assessment workflow (modified from Jakob et al., 2022) at Jason and Mungie Creeks.

In this study we consider steep creeks hazards with the potential to impact downstream developed areas and infrastructure and the potential influence for rock slope instability in the study watersheds. This section summarizes historical hazard events, results of the frequency-magnitude (F-M) analysis for each creek, and numerical modelling of hazard scenarios. The assessment methods applied are summarized in Figure 4-1. Additional details on the methods applied are provided in Appendices E through I.

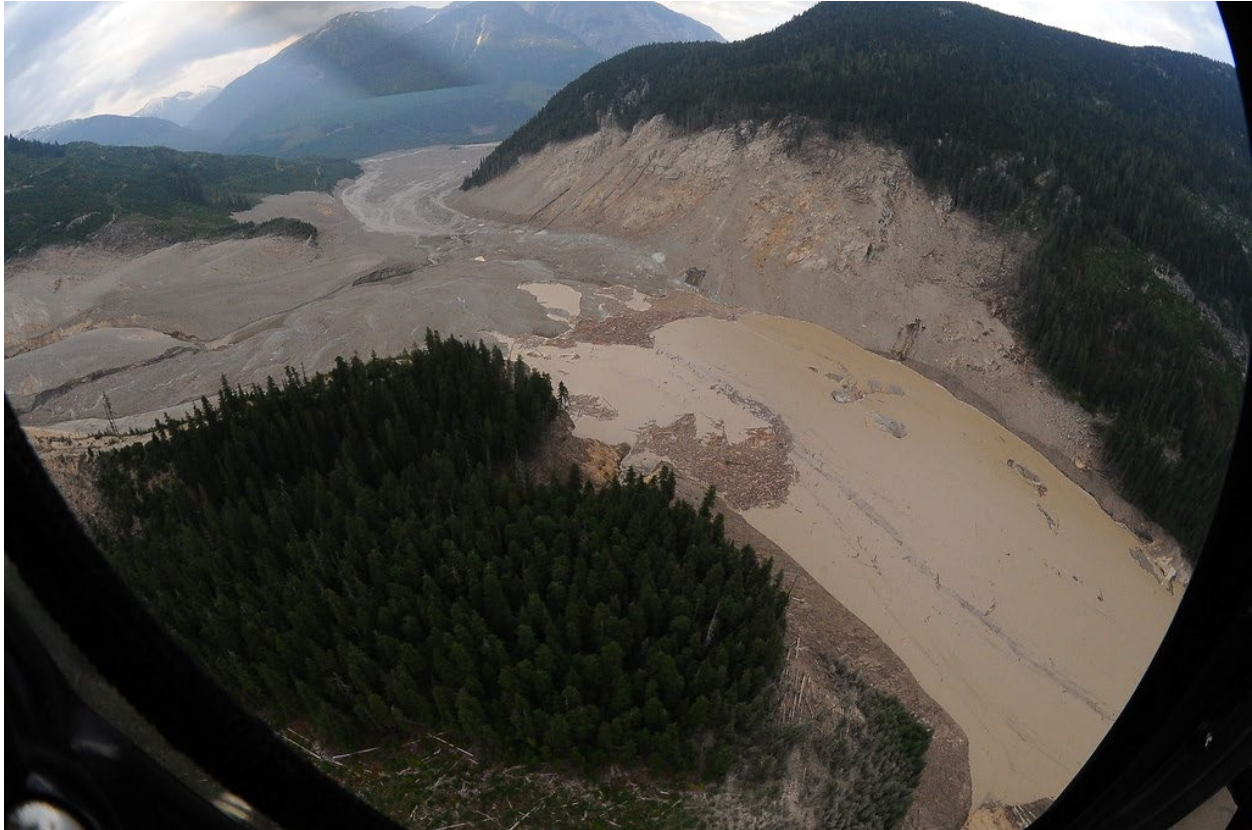
Figure B-7. Landslide dam on Meager Creek from the August 6, 2010 rockslide-debris flow from Capricorn Creek. The dam impounded Meager Creek for some time. Photo by D. Steers.

Some steep creek watersheds are prone to LDOFs, which could trigger flooding, debris floods, or debris flows with larger magnitudes than “typical” hazards. An example of this hazard in the Squamish Lillooet Regional District is landslides in the Mount Meager volcanic complex, which have generated several landslide dams along Meager Creek and Lillooet River (Figure B-7; Bovis & Jakob, 2000; Guthrie et al., 2012). LDOFs are not expected to occur on Jason or Mungye creeks and have not been included in the present assessment.

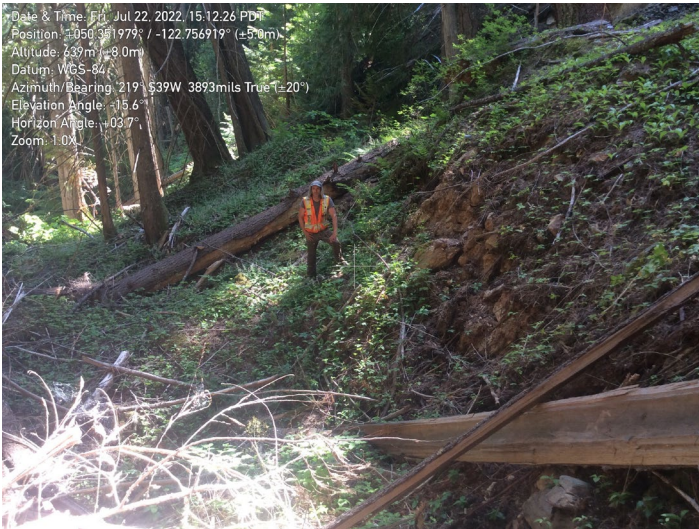
Photo 13.
Fresh tension crack with 1.5 m displacement in Jason Creek watershed. July 20, 2022

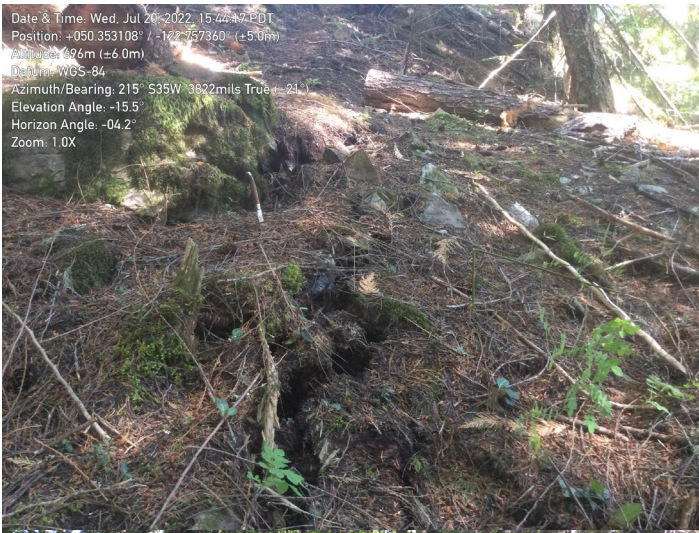
Photo 14.
Tension crack formed upstream of 2021 headscarp. July 20, 2022

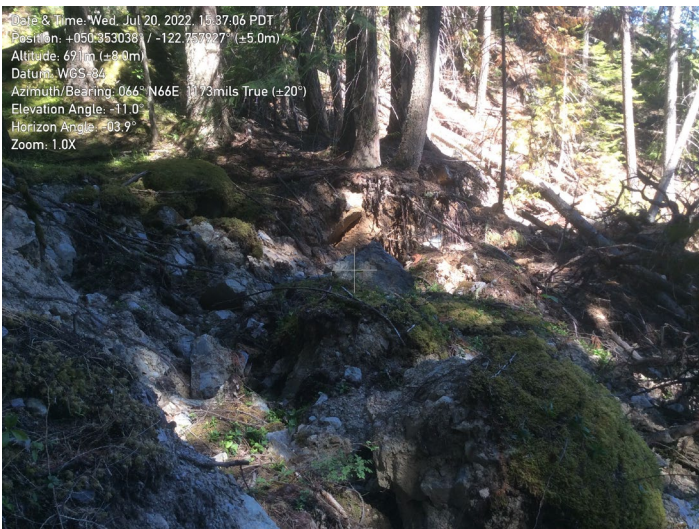
Photo 15.
Unstable slope on Jason Creek sidewall. Photo: July 20, 2022.

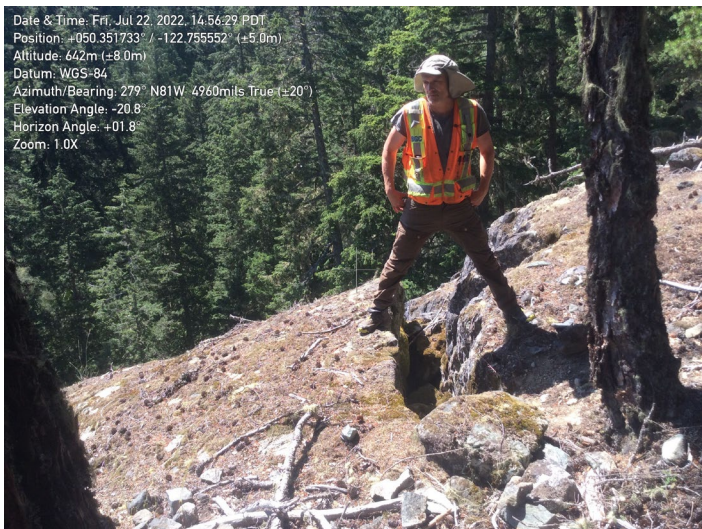
Photo 18.
Crack in rock in Jason Creek
watershed. Photo: July 22, 2022.
