# SQUAMISH – LILLOOET REGIONAL DISTRICT FLOOD HAZARD MAPPING AND RISK ASSESSMENT UPPER SQUAMISH

## FINAL REPORT

26 November 2018

**Northwest Hydraulic Consultants Ltd.**  
Vancouver, BC

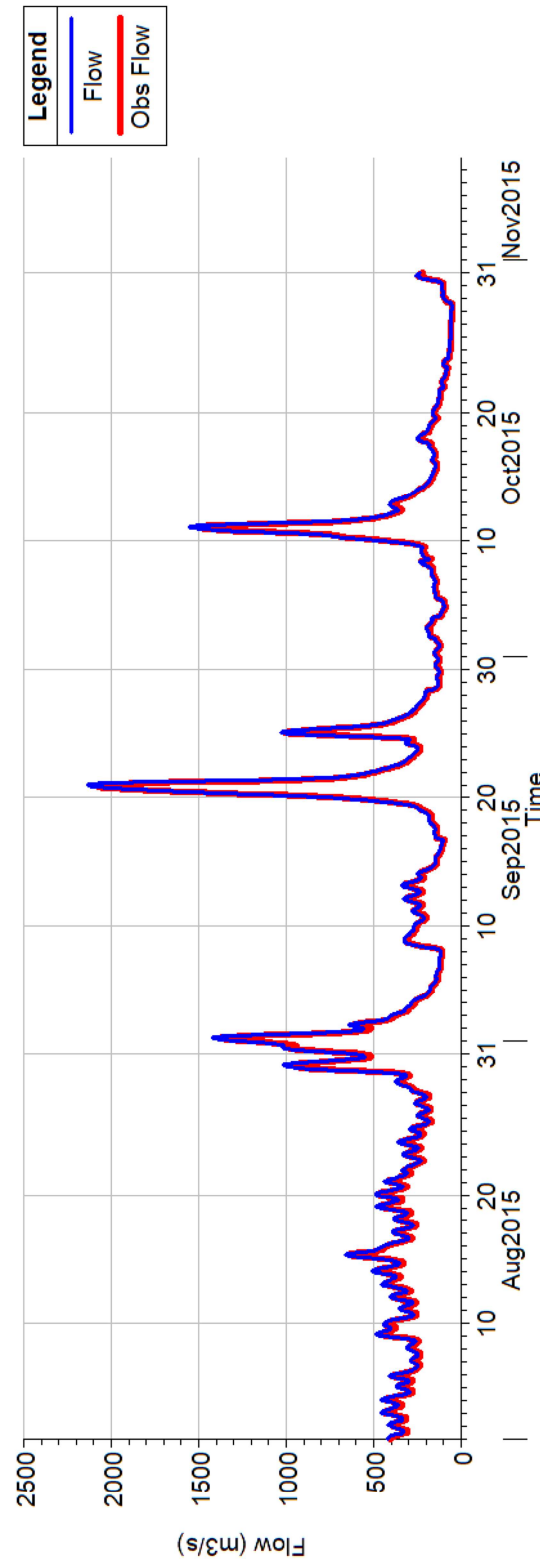
Figure 5 2015 observed and simulated flow

The event hydrograph figures show the comparison between observed and simulated stage and flow at the Brackendale gauge. The hydrograph timing of rising and falling periods matches well for both stage and flow. For the time series simulation of the three peak flow periods, simulated stage is slightly high at lower flows (order of tenths of meters) and a little low for highest peak flows (less than 0.5 m difference). Comparing the measured gauge rating curve to the simulation output showed similar results. Calibration was stopped at this point given the sparsity of observed high water data and thus rationale for any further modifications. Model calibration refinement should be conducted when data from high flow events are collected. Other uncertainties affecting the models ability to precisely represent the observed water surface include that the model assumes a fixed bed, that model geometry comes from bathymetric and topographic data dated from several different years (e.g. 2017 and 2018 bathymetric survey data and earlier dated LiDAR data), and therefore is an approximate representation of the real channel geometry, and this is a reach scale planning level model that does not represent the smaller scale details such as independent flow splits, large wood complexes affecting hydraulics, etc. The resulting model is suitable for identifying and assessing reach scale flood risk, but may require further refinement for localized hydraulic assessment or design.

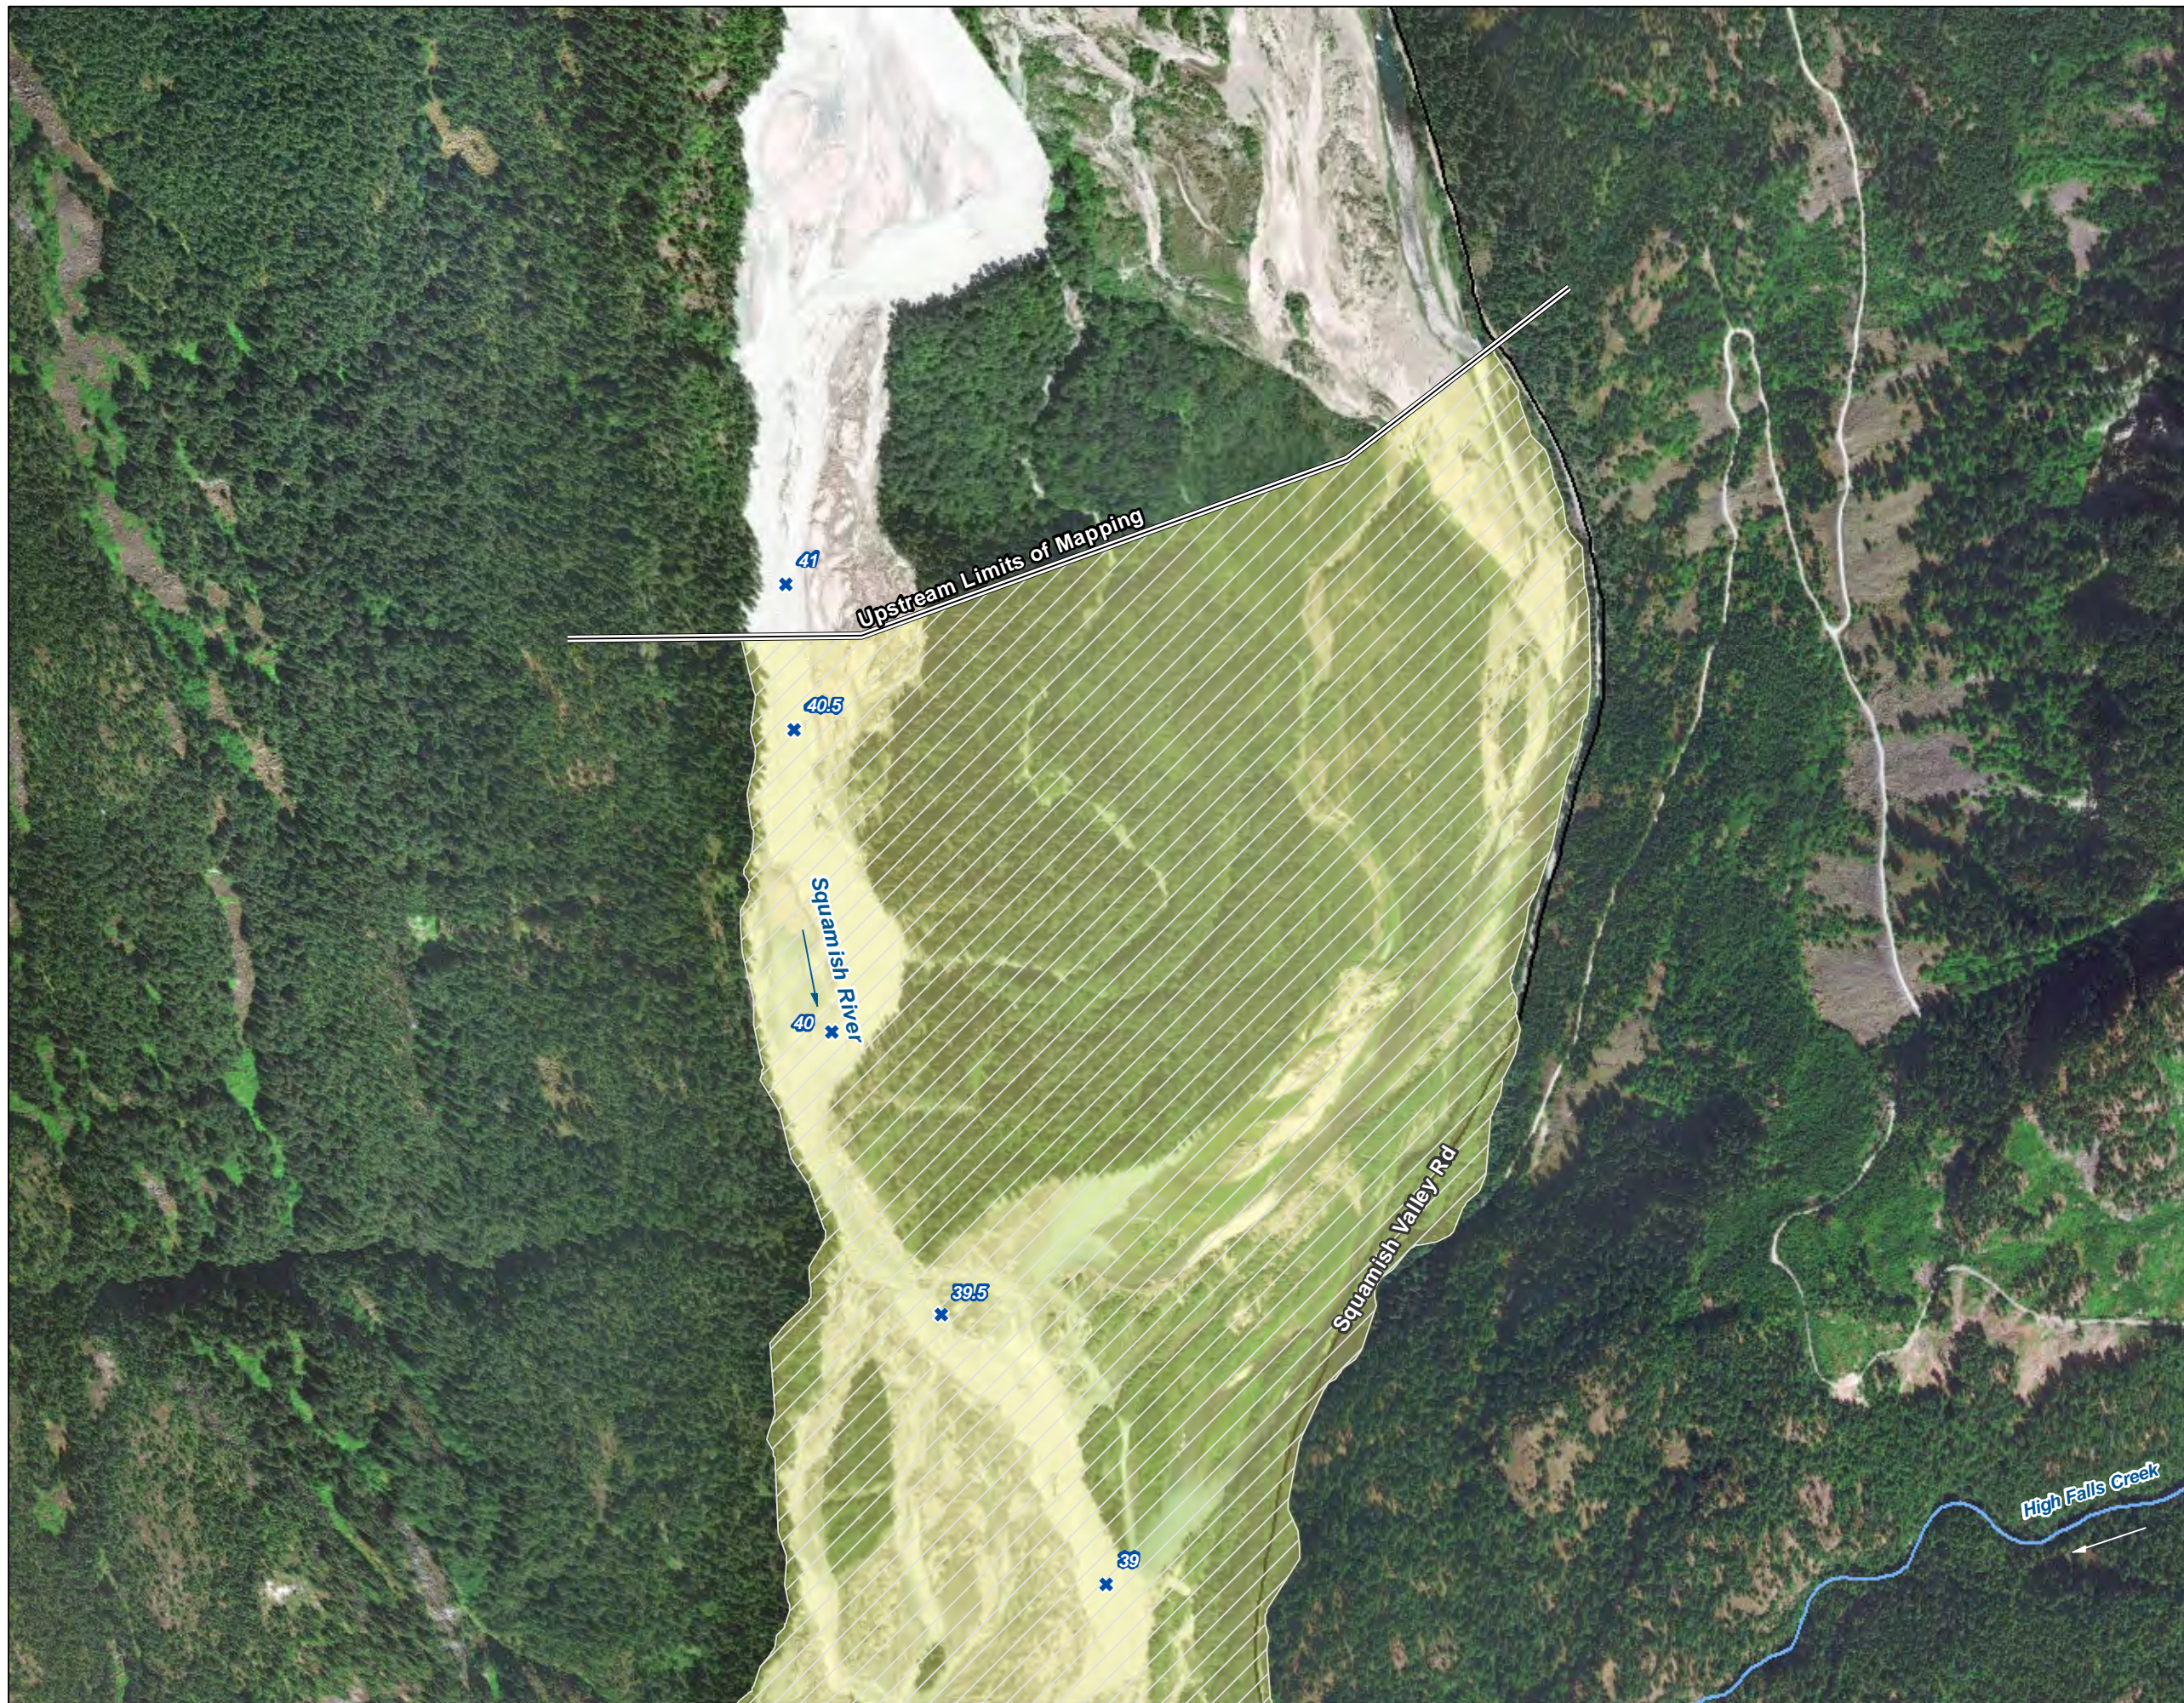
**DRAFT** PANEL 1 OF 9

- Legend**
- River Km
  - Road
  - Limits of Mapping
  - Tributary
  - Tributary Creek Fans
  - Modern Valley Bottom
  - Highest Hazard Zone

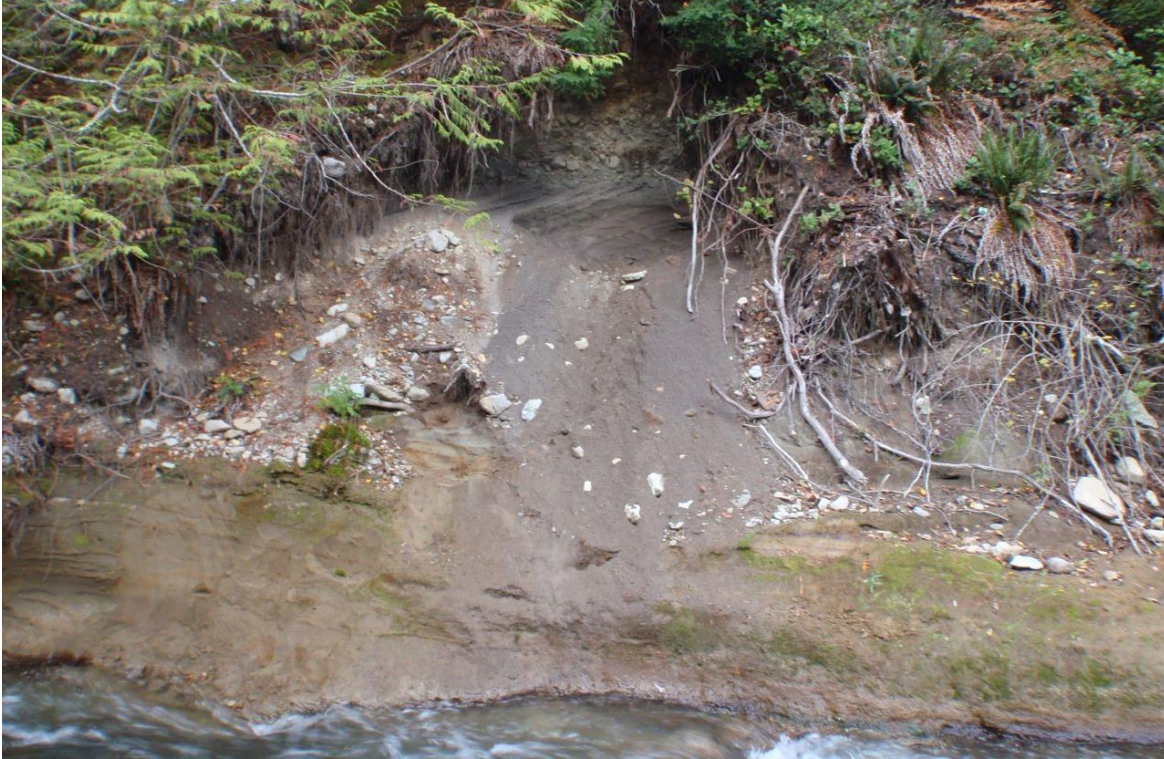
**Figure 14: View of left bank Cheakamus River, just upstream of Culliton Creek. Flow left to right. Note basal fines interpreted as backwater sediments, dated to  $4020 \pm 30$  yr BP, overlain by upstream dipping foreset beds and capped by topset alluvial fan gravels.**

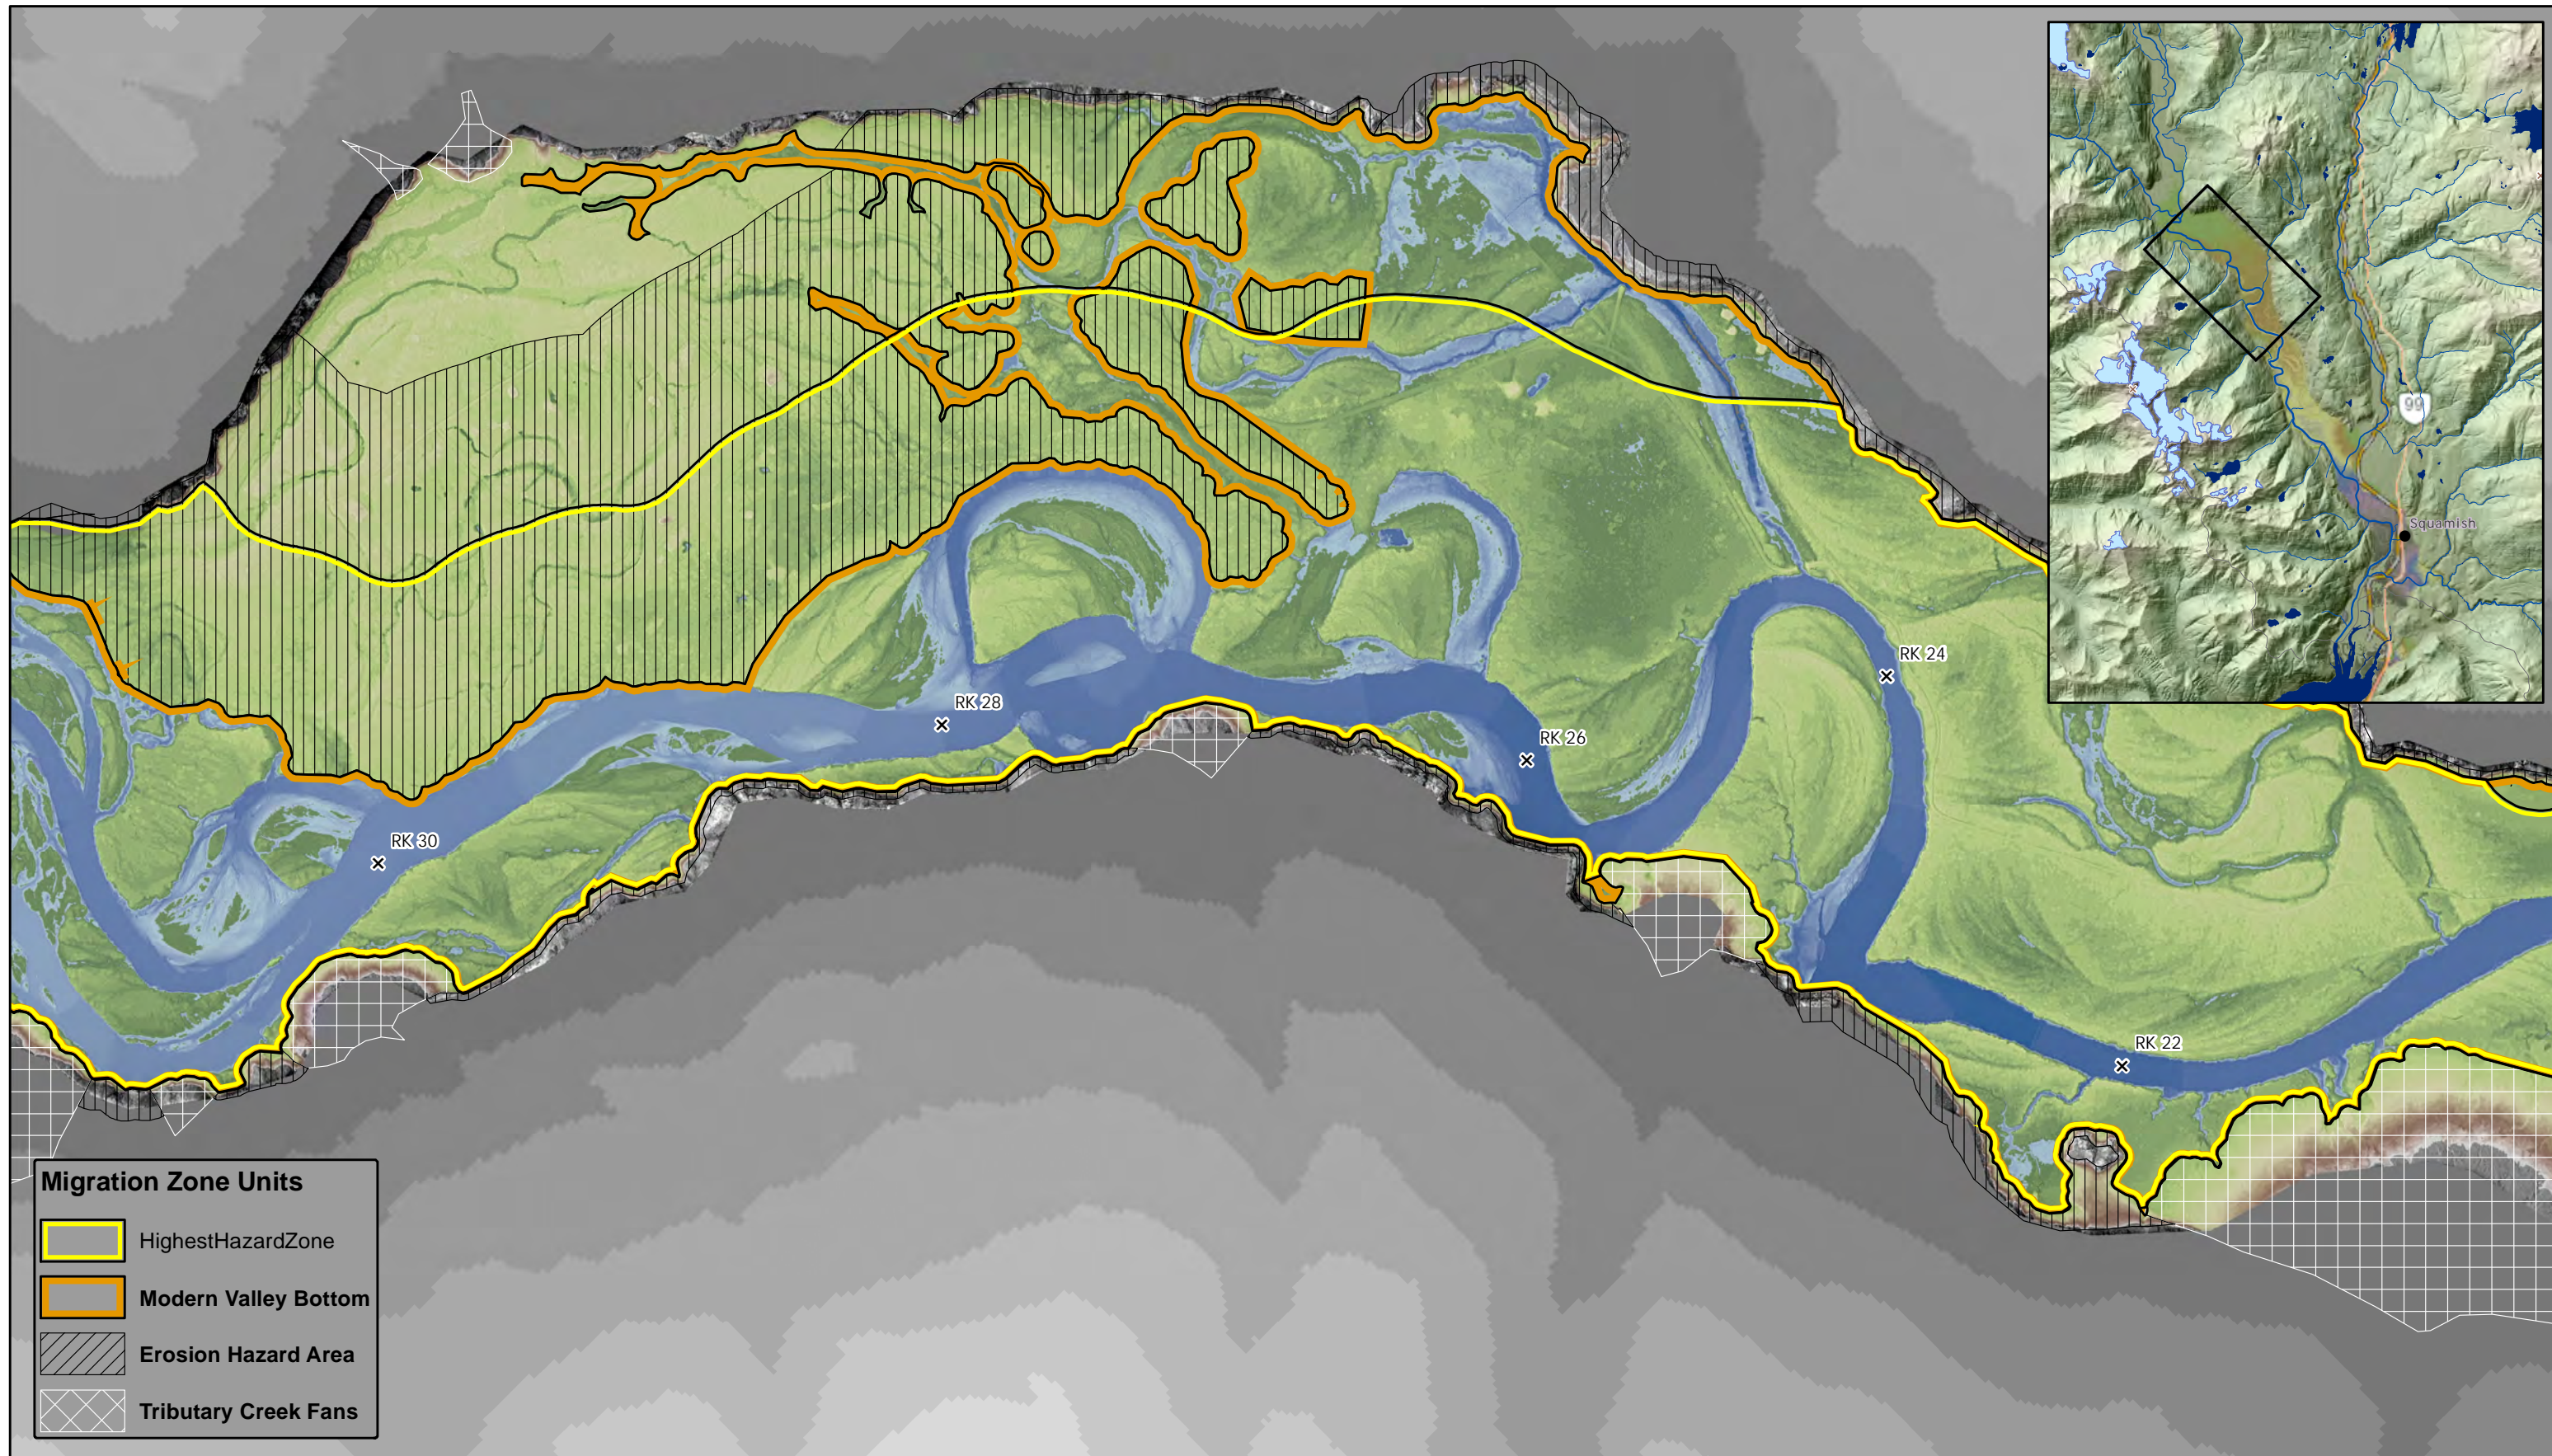
*Squamish River Geomorphology*  
*Wandering Reach*  
*pCMZ*

**Migration Zone Units**
