August 9, 2024

Project/File: 111700815

Reference: Gates Lake Flood, Debris Flood, and Geohazard Preliminary Hazard Assessment

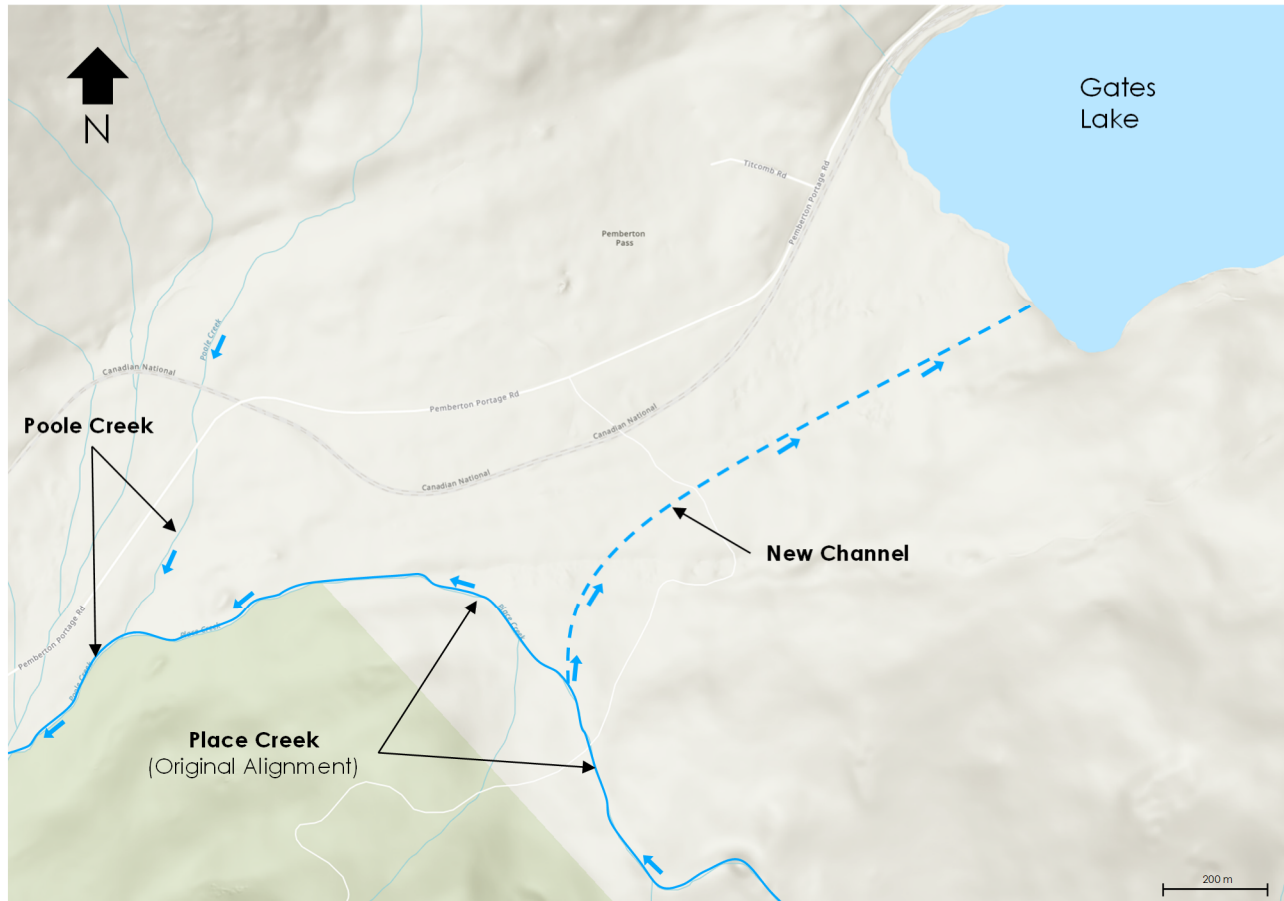
Prior to the Event, Place Creek flowed west into Poole Creek. However, the deposition of sediment and debris that occurred during the Event caused Place Creek to form a distributary channel, such that the majority of flow now drains east into an unnamed channel and onwards to Gates Lake, rather than west into Poole Creek (Figure 1). The SLRD retained Stantec Consulting Ltd. to assess the new alignment of Place Creek and determine whether it poses geohazard, flood and debris flood hazards to the general public and structures situated along Gates Lake and immediately downstream of the lake along Gates River.

Figure 1: Map Sketch Illustrating Relevant Flow Paths Pre and Post Event

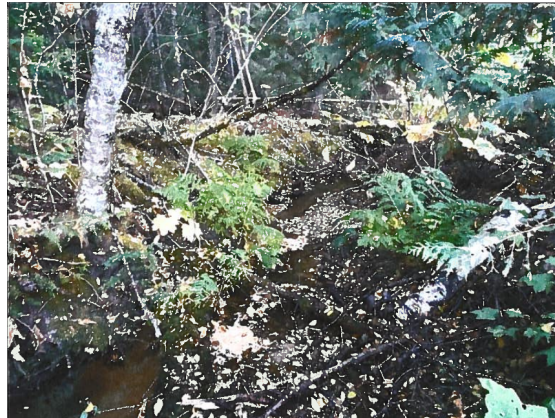
Several residential properties are located along the south-west end of Gates Lake (9126, 9122, 9118, 9102 Pemberton Portage Rd) along with two BC Hydro high voltage power line right of way (ROW). Two constructed drainage ditches (approximately 1 m deep) cut across the BC Hydro ROW, 9102 and 9122 Pemberton Portage Rd properties outletting into Gates Lake (Figure 3 - Kontur, 2022).

Figure 3 - Drainage Ditch through 9102 Pemberton Portage Road Prior to Event (Kontur, 2022)

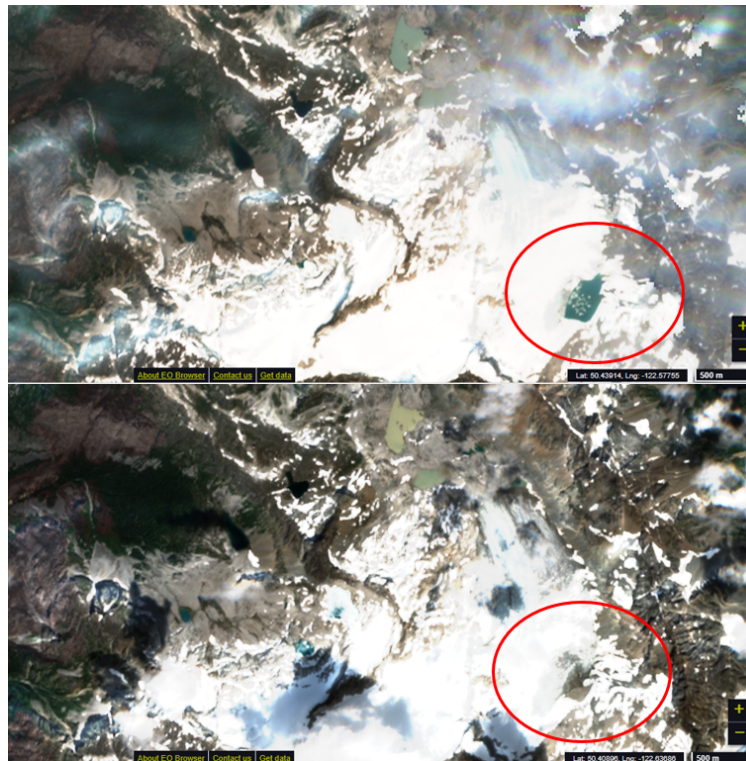
On July 21st, 2024 a sudden and large volume of water flowed from Place Glacier into Place Creek. Based on available satellite imagery from before and after July 21st (Figure 5), a glacial lake appears to have fully drained (outburst). This sudden outburst of water entrained sediment and debris as it flowed down Place Creek precipitating in a debris flood event that deposited large volumes of sediment within Place Creek and along the Pemberton Pass (Figure 6). An avulsion² of the Place Creek channel occurred in response to the debris flood with the new alignment now conveying the majority of Place Creek flow into the existing constructed drainage ditches and into Gates Lake (Figure 6, Figure 7).

Figure 5 - Satellite Imagery of Glacial Lake within Place Glacier (Top Image July 17, 2024; Bottom Image July 23, 2024 - provided by Sentinel Hub EO)

During the flight, the upper elevations of the glacier were flown. As visible in satellite imagery presented in Figure 5, there were two discernable lakes in the cirque prior to the Event. Based on the imagery it was inferred that the upper lake had drained rapidly causing the outburst and flood event to occur in the lower lake.

During the aerial assessment, collapsed cavity openings along the basal ice surface in the dried upper lakebed were observed. No evidence of overland flow along the ice surface was observed. Based on these observations, in conjunction with the satellite imagery, it was inferred that the lake drained along the basal surface of the ice to the lower lake causing the outburst event. At the time of the inspection, no flow into the dried upper lakebed was observed (i.e., the lake was not visibly recharging). The lower lake in the cirque was full relative to levels identified in Figure 5. Based on the extent and volume of ice remaining on the Place Glacier, it is possible for the upper lake to impound water again over time.

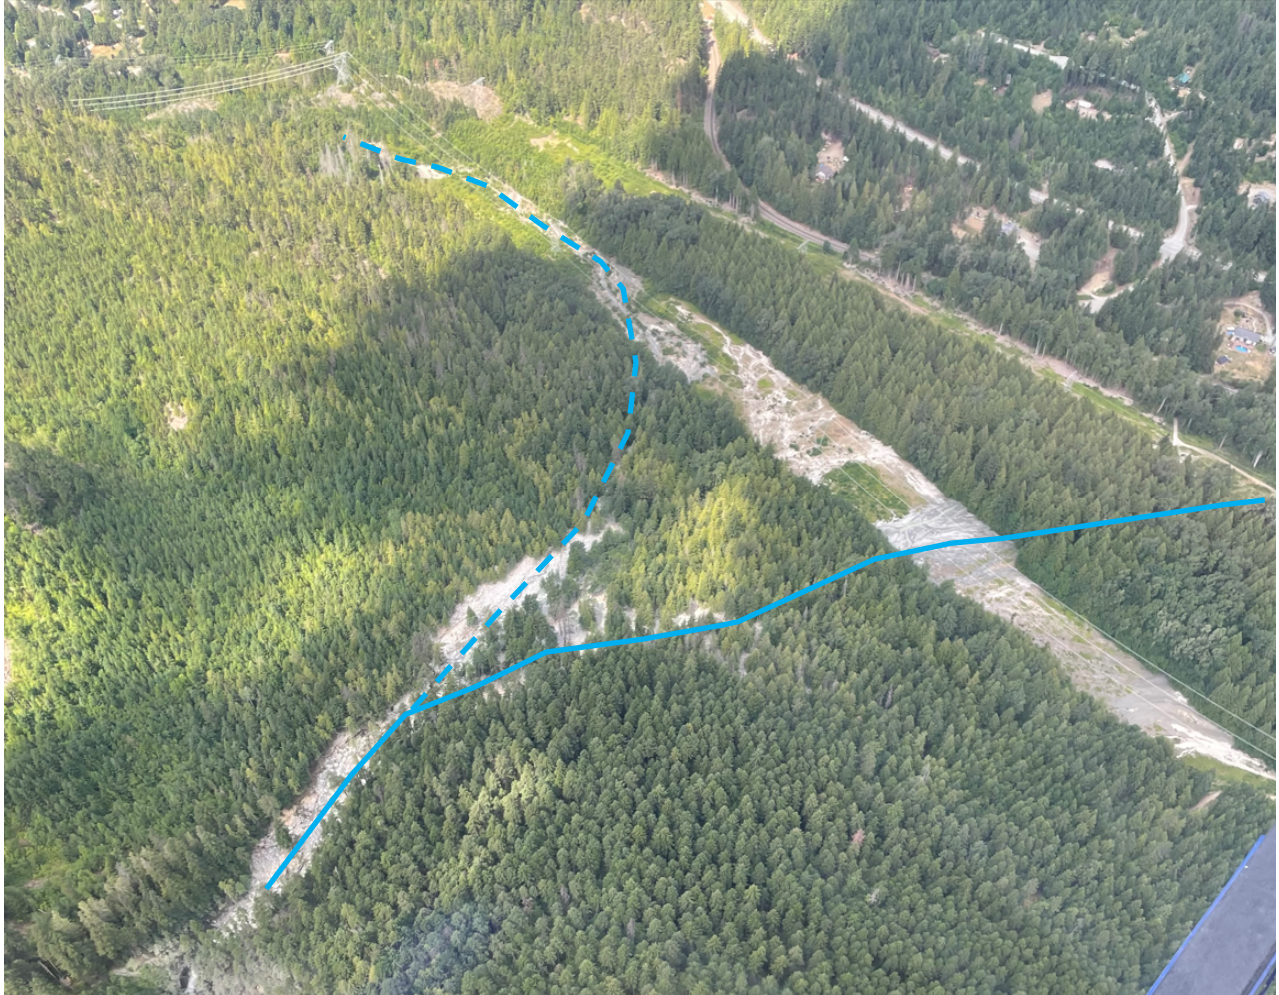
Figure 6 - Place Creek Post-Event (Solid Line) and Pre-Event (Dashed Line) Alignments (Stantec, July 24, 2024)

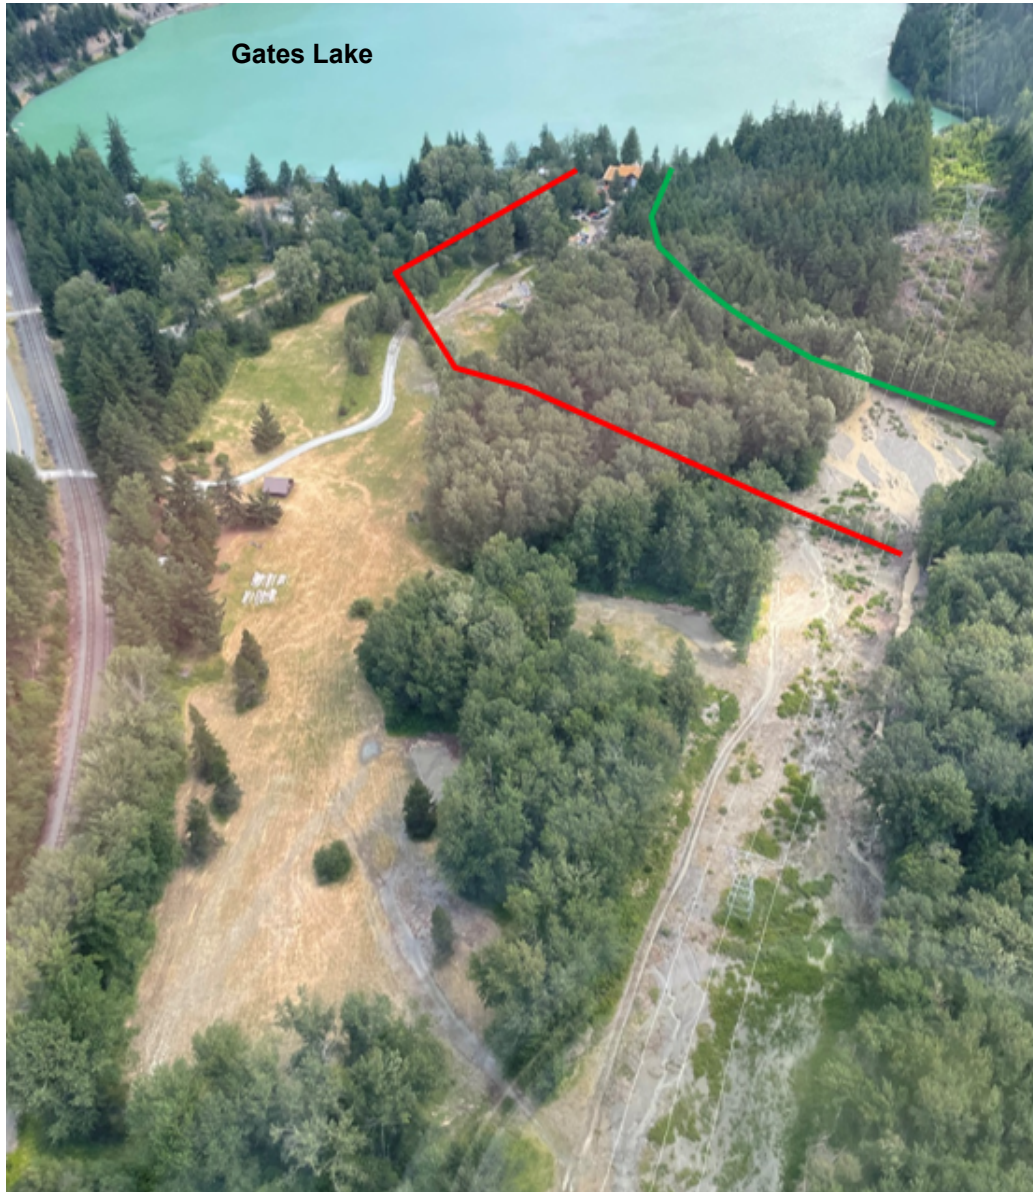
Figure 7 - Post Event Place Creek Flow Conveyed Through Man-Made Drainage Ditches (Red and Green Solid Lines - Stantec, July 24, 2024)

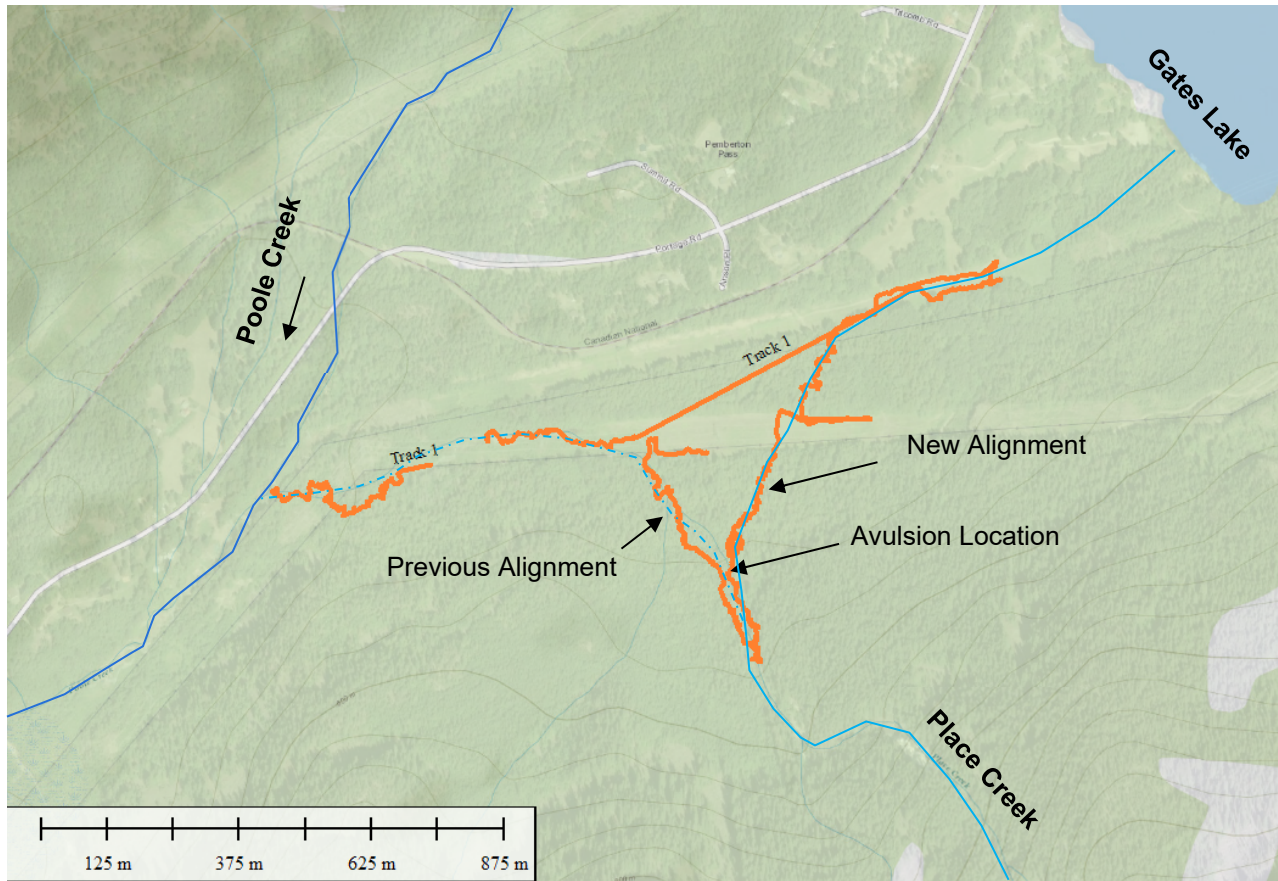
On July 30, 2024 Stantec walked the new and previous alignments of Place Creek to assess for debris flood hazards (Figure 10).

Figure 10 - Track Lines from Stantec Visual Assessment (Orange Solid Line) - July 30, 2024
