January 31, 2024  
 File: SLRD24001

**Re:** Emergency hazard assessment, Jason Creek at Reid Road, near Pemberton, BC.

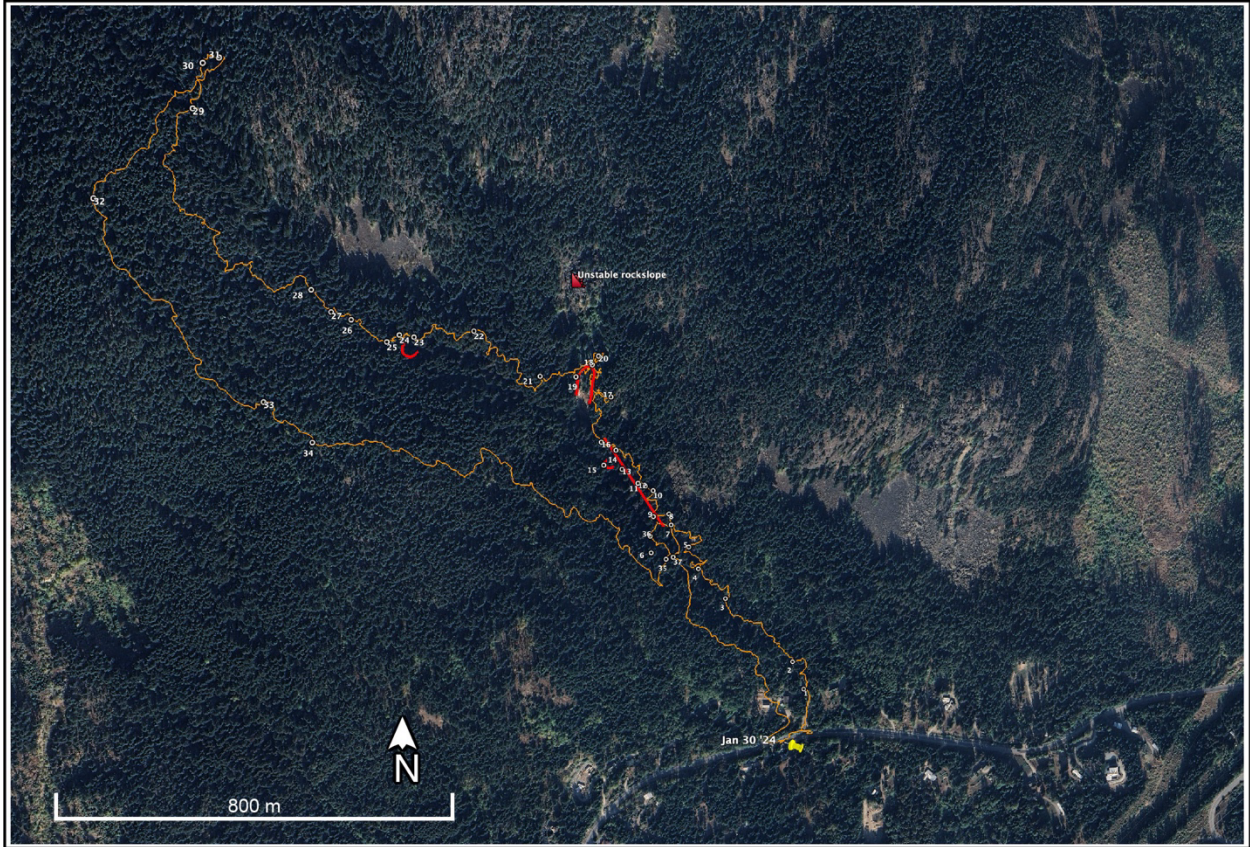
**Figure 3.** January 30, 2024 field-traverse of the incised reach of Jason Creek. Numbered waypoints are provided in Appendix 1.
