Place Creek Emergency Response Completion Report

Prepared for:
Squamish-Lillooet Regional District

Prepared by:
Stantec Consulting Ltd.

Project/File:
111700815

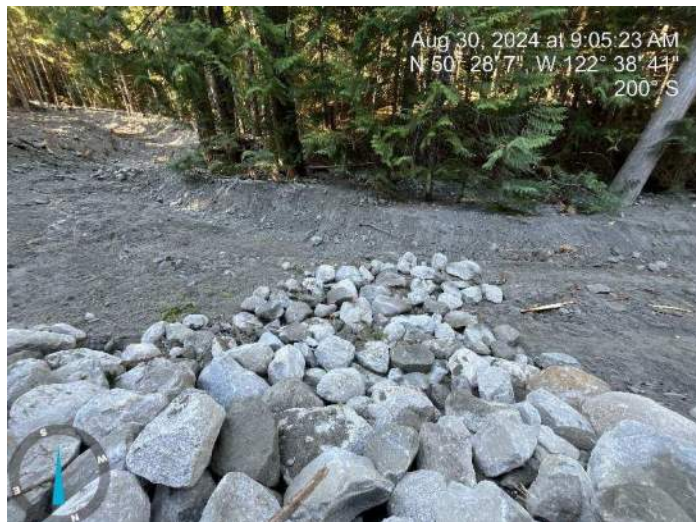
- 9:05 AM – 12:00 PM, the 250 excavator continued to excavate the proposed channel within the mountainous area. While the 350 excavator was still placing riprap along the right channel bank looking downstream (Images 8, 9, 10, 11, 12 & 13).

Image 9: Riprap placed along the right channel bank looking downstream (2024-08-30 @ 9:05 AM)

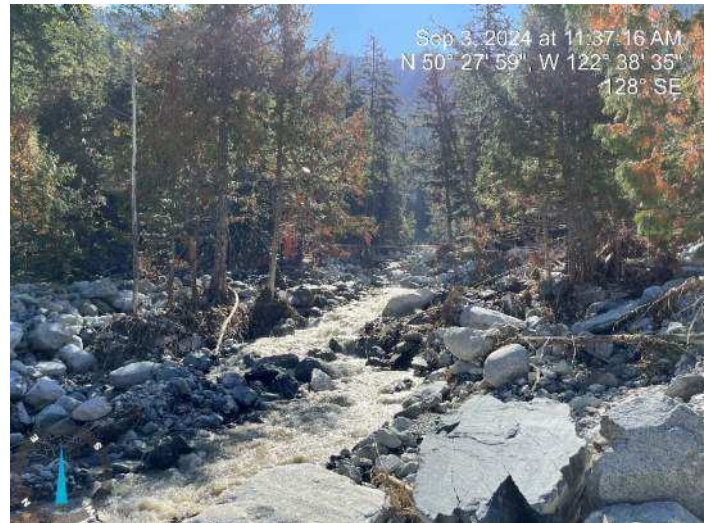
Image 7: 350 excavator completed blocking the side channel that was along the left bank (looking upstream) (2024-09-03 @ 11:37 AM)

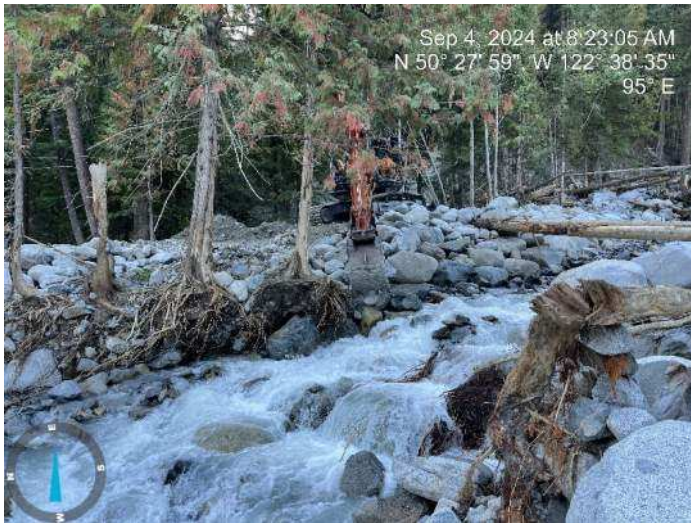
Image 6: 350 excavator continued to reinforce the toe of the proposed embankment (2024-09-04 @ 8:23 AM)

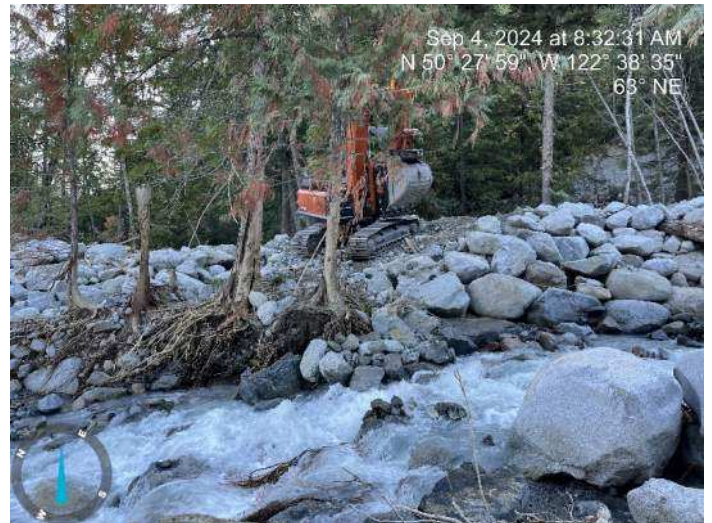
Image 7: 350 excavator continued to reinforce the toe of the proposed embankment (2024-09-04 @ 8:32 AM)

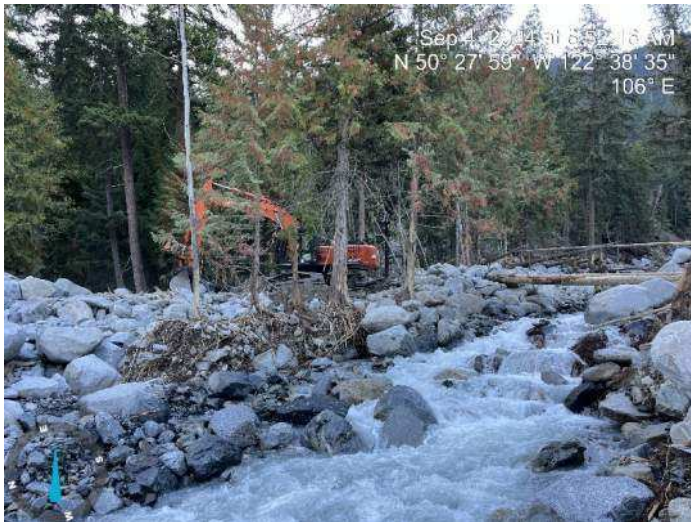
Image 8: 350 excavator continued to reinforce the toe of the proposed embankment (2024-09-04 @ 8:52 AM)

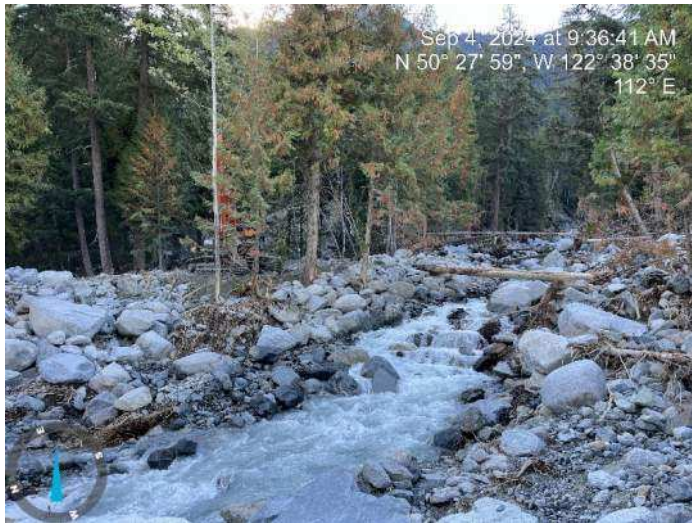
Image 10: Riprap placed on the toe of the proposed embankment along the left bank (looking upstream) of the existing Place Creek channel (2024-09-04 @ 9:36 AM)

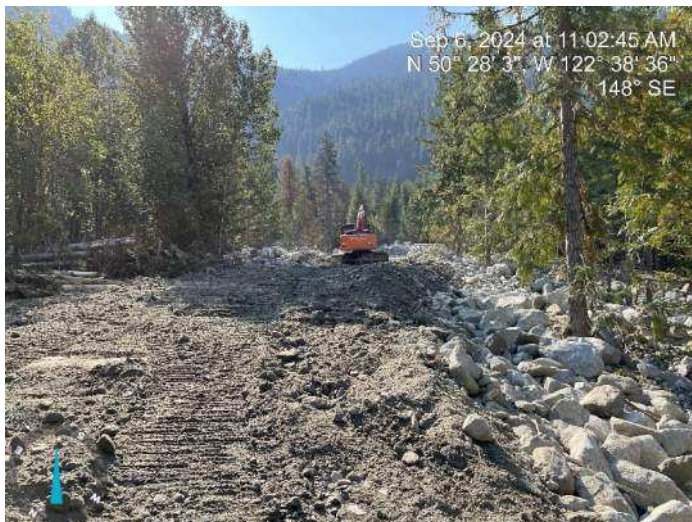
Image 9: 350 excavator was still out of service and under assesment/repair (2024-09-06 @ 11:14 AM)

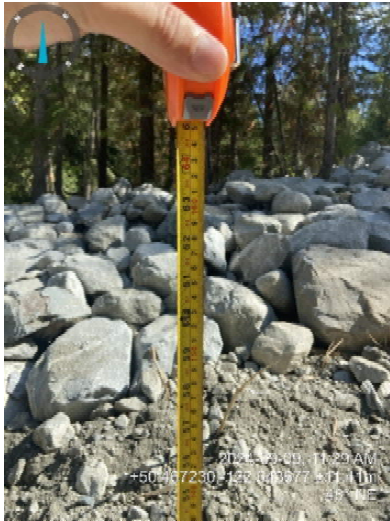
Image 6: channel depth measured to be 1.6 m (2024-09-09 @ 11:29 AM)

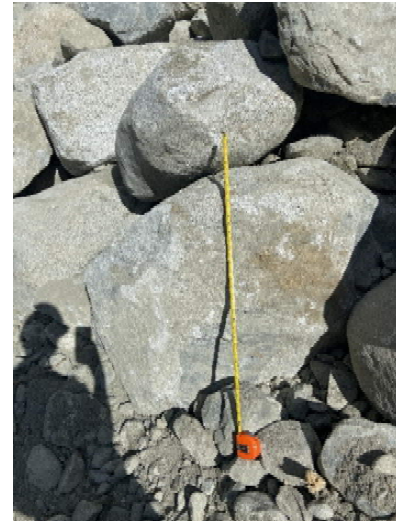
Image 7: typical size of large boulders at base of channel bank armouring. 1.0 m tape measure for scale. (2024-09-09 @ 12:56 PM)

- Overall construction progress of embankment re-establishment: 55% complete.
- Armouring of the embankment and channel is progressing well. Large diameter boulders are being used at the bottom and being keyed to a depth equivalent to the D100. These boulders have a b-axis diameter that is generally in the range of 500-1000 mm.

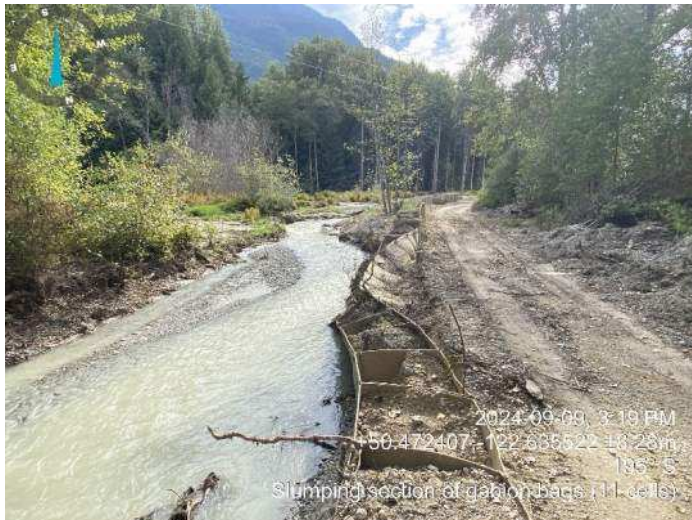
- Approximately 11 gabion bags have slumped into the drainage ditch just downstream from the edge of the hydro corridor (Image 8). The gabions have retained some of the soil inside and are still providing some degree of erosion and flood protection. Repairs are not recommended at this time, based on current/anticipated flow conditions and timeline for diversion of Place Creek back to the original alignment.

Image 8: Approximately 11 gabion bags have slumped into the drainage ditch, just downstream of the edge of the hydro corridor. (2024-09-09 @ 3:19 PM)

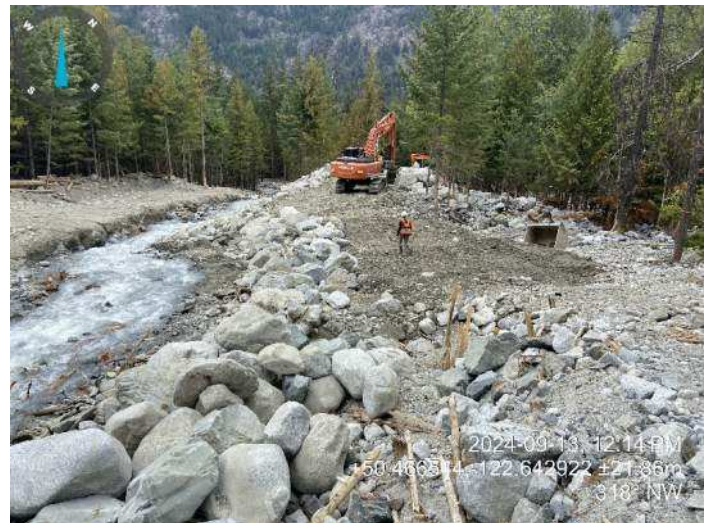
Image 9: 350 excavator grading the embankment near the diversion point after all flow has been diverted (2024-09-13 @ 12:14 PM)

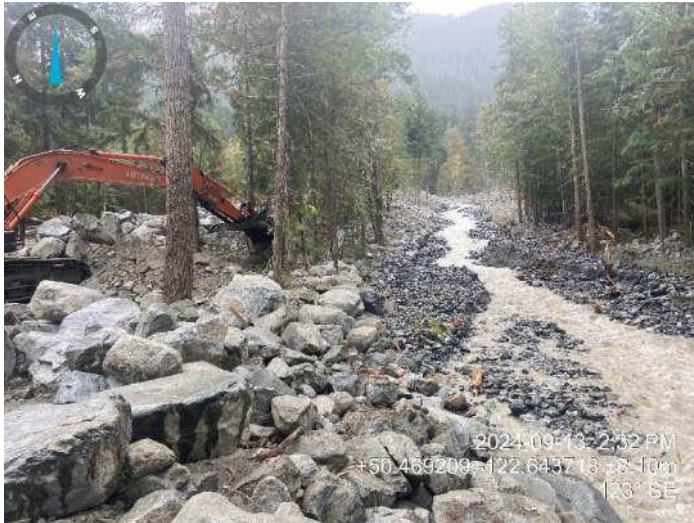
Image 10: 210 excavator adding boulders to the channel bank (2024-09-13 @ 2:32 PM)

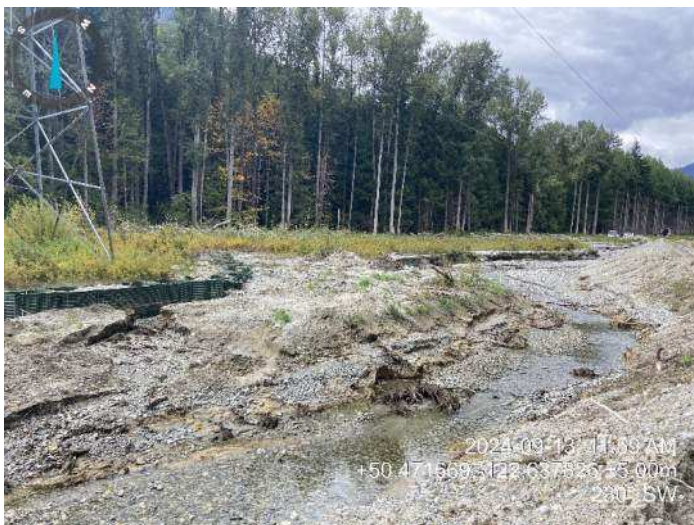
Image 10: ditch constructed as part of the early emergency works (2024-09-13 @ 11:59 AM)

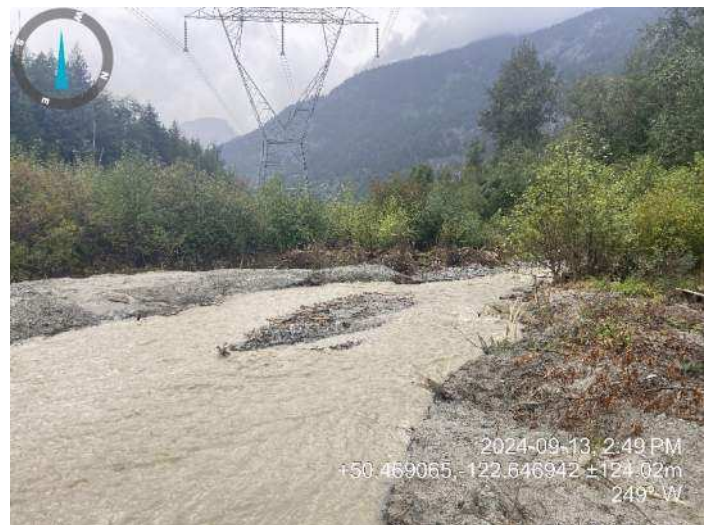
Image 11: Flow in the reestablished channel beneath the hydro corridor after diverting flow (2024-09-13 @ 2:49 PM)

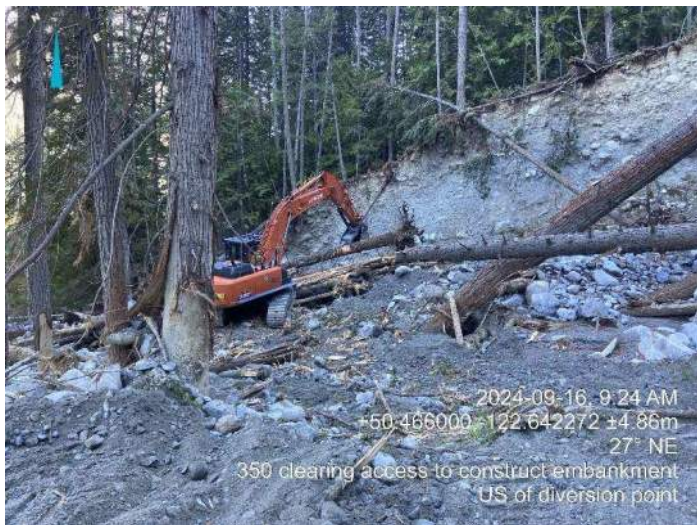
Image 2: 350 excavator moving fallen trees to establish access to construct the embankment (2024-09-16 9:24 AM)

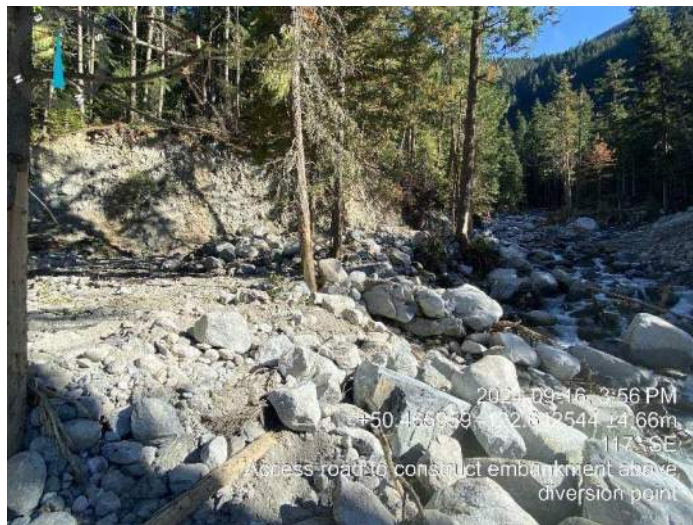
Image 3: access route to construct embankment upstream of diversion point (2024-09-16 @ 3:56 PM)

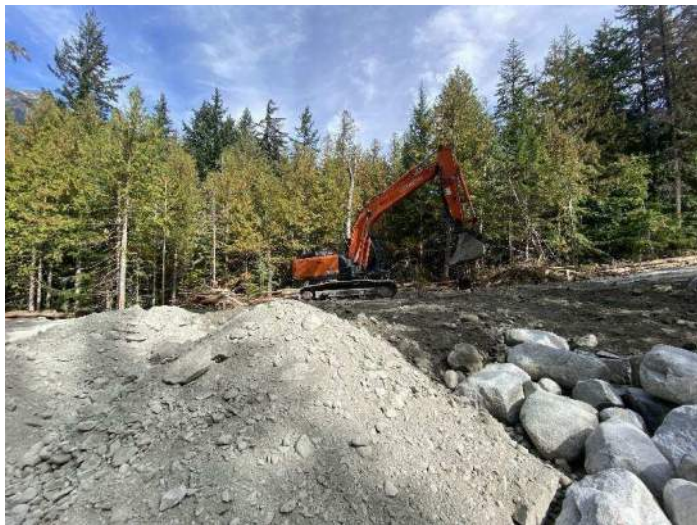
Image 4: 210 excavator working on the embankment downstream of the diversion point. (2024-09-16 @ 1:22 PM)

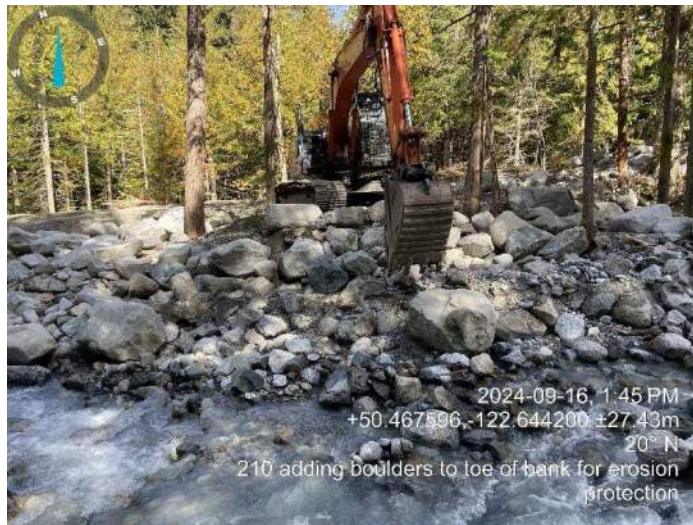
Image 5: 210 excavator adding boulders to the channel bank (2024-09-16 @ 1:45 PM)

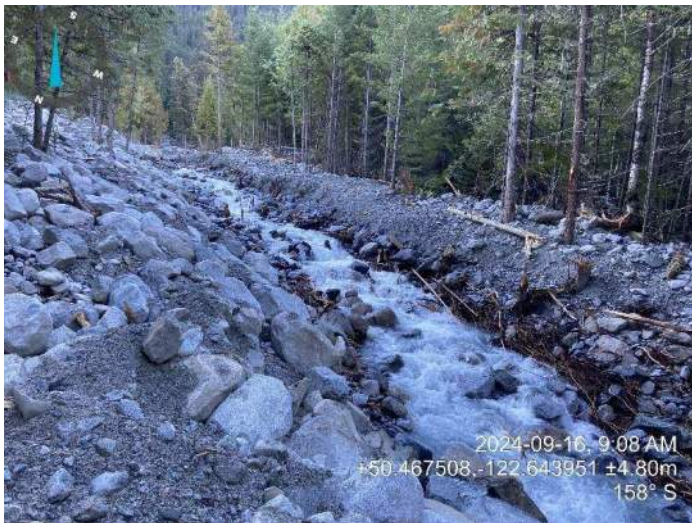
- The region received rainfall on Saturday which increased the discharge in Place Creek. This caused more erosion and downcutting of the channel bed material along the constructed reach. Much of the cobble-sized material on the channel bed was transported out of the steeper areas and deposited downstream in the hydro corridor (Image 6-9). Sediment erosion and deposition of this nature is expected as the channel continues to adjust, especially during higher flows. Several large boulders from the bank armouring were undermined and shifted into the creek. Minor adjustments can be made tomorrow when Cascade Environmental is on site to supervise instream works. Overall the reestablished channel is performing well and as intended.

Image 8: Exposed roots and vertical banks are evidence of channel downcutting after higher flows over weekend (2024-09-16 @ 9:08 AM)

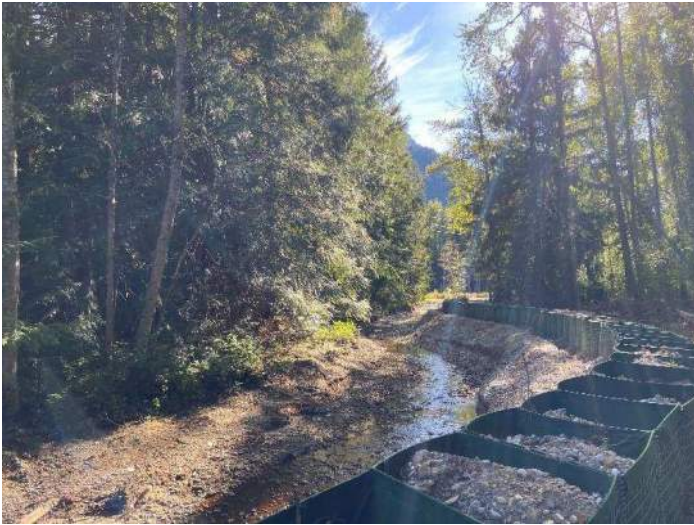
- Turbidity in the creek was back to baseline conditions (based on visual observations).
- Groundwater is still seeping into the drainage ditch that was constructed as part of the initial emergency response (Image 10). This may create turbidity when backfilling the ditch. Flow management or sediment control measure may need to be considered to complete this work.

Image 10: Low flow from groundwater seepage in the diversion ditch (2024-09-16 @ 15:38 AM)

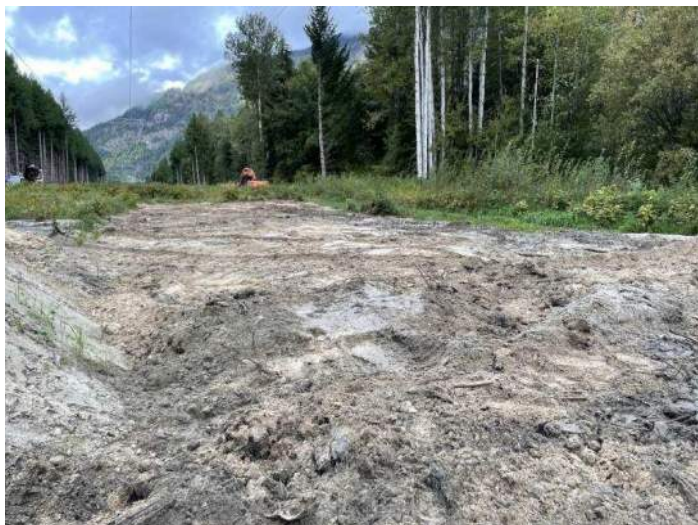
Image 1: Upstream extent of emergency ditch filled in with emergency bank material (looking west)(2024-09-23)

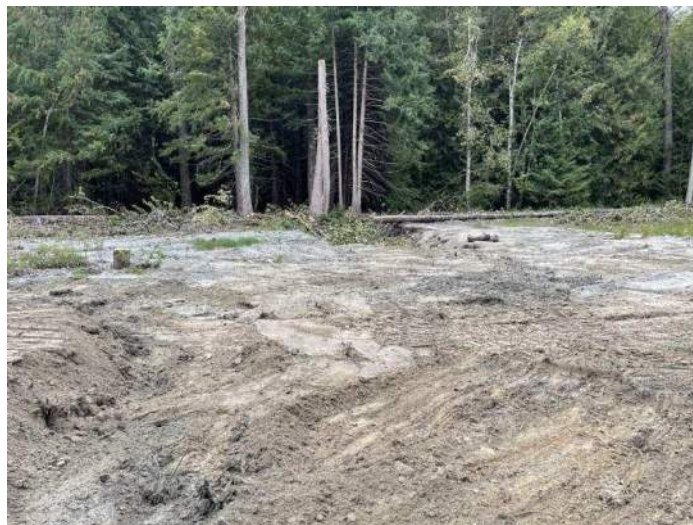
Image 2: upstream extent of emergency ditch that extended across BC Hydro ROW tying into flood channel plugged with emergency bank material (looking south) (2024-09-23)

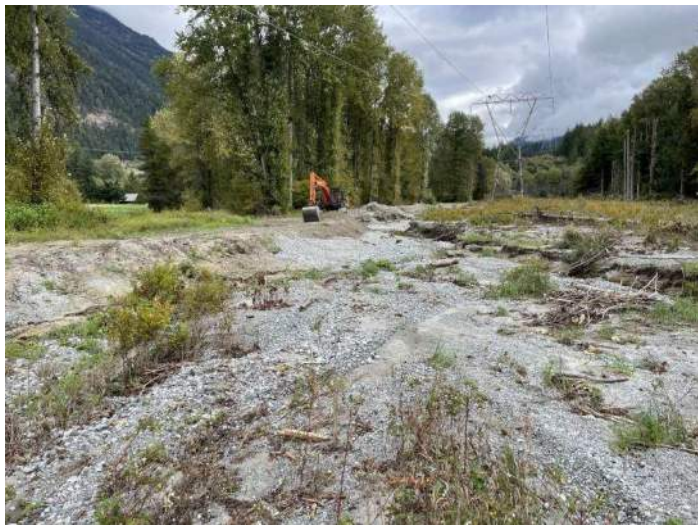
Image 3: Emergency berm removed with material infilling emergency ditch (looking east) (2024-09-23)

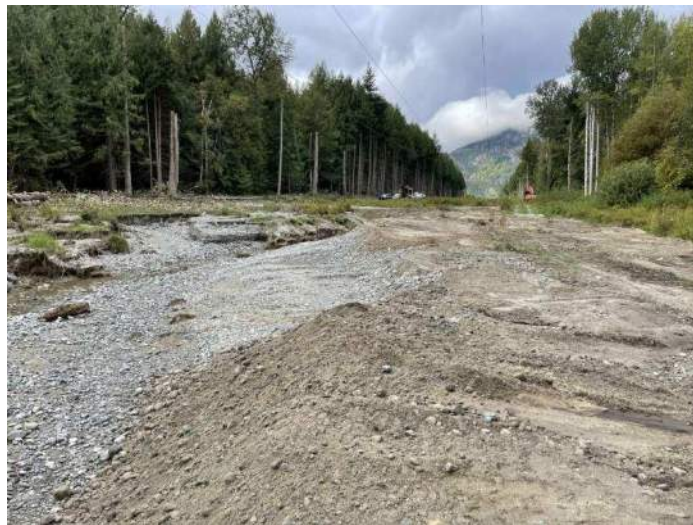
Image 4: Emergency berm removed with material placed over access road (looking west) (2024-09-23)

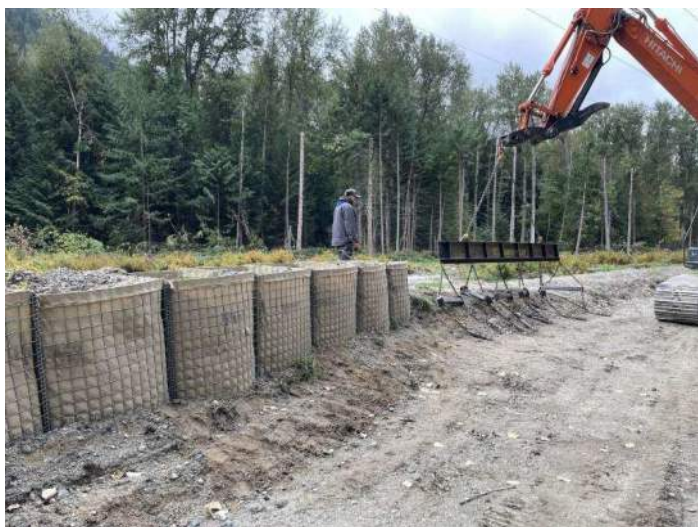
Image 5: Removing emergency gabion baskets (2024-09-23)

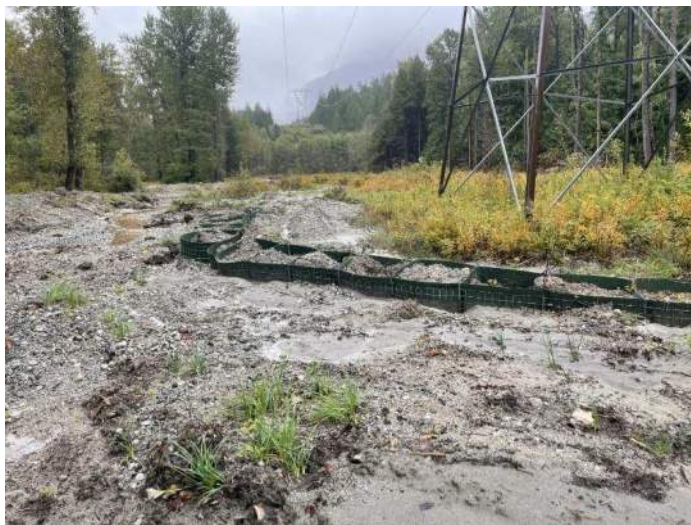
Image 2: BC Hydro tower prior to gabion basket removal (looking east) (2024-09-25)

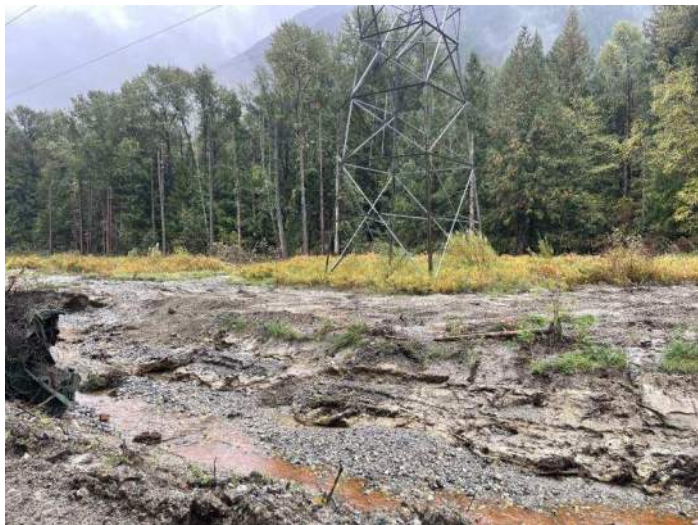
Image 3: BC Hydro tower following removal of gabion baskets (looking south) (2024-09-25)

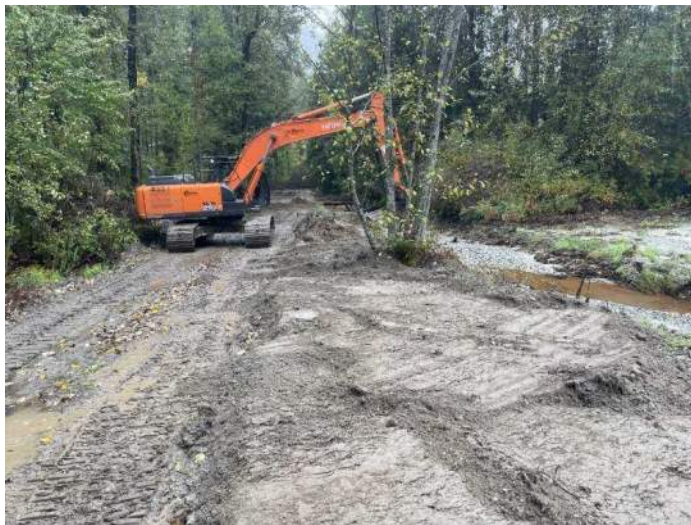
Image 4: Ongoing removal of piled fill at time of Stantec departure from site (looking east) (2024-09-25)

- Stantec arrived onsite at 11 AM, Contractor not onsite. Contractor arrived onsite 12:30PM.
- 12:30PM – 03:00PM: Emergency gabion baskets had been removed; however, fill material had been left piled along the emergency ditch top of bank (Image 1). Stantec noted to Contractor that the piled fill should be either backfilled into the emergency ditch (along portions that were not conveying groundwater flow) or along the access road. Contractor removed emergency gabion baskets from around the BC Hydro tower (Image 2 and 3).
- 03:00PM – Stantec left site (Image 4). Contractor confirmed to Stantec on Sept 26 that piled fill had been addressed.

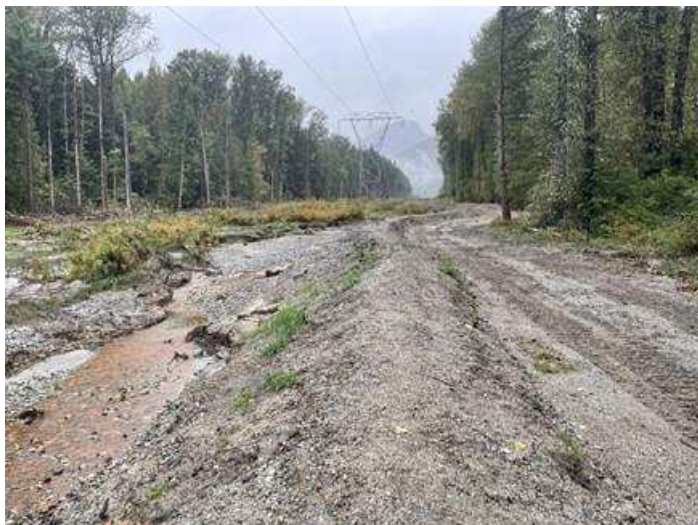
Image 5: Portion of emergency berm left in place (looking west) (2024-09-25)
