Place Creek Emergency Response Completion Report

Prepared for:
Squamish-Lillooet Regional District

Prepared by:
Stantec Consulting Ltd.

Project/File:
111700815

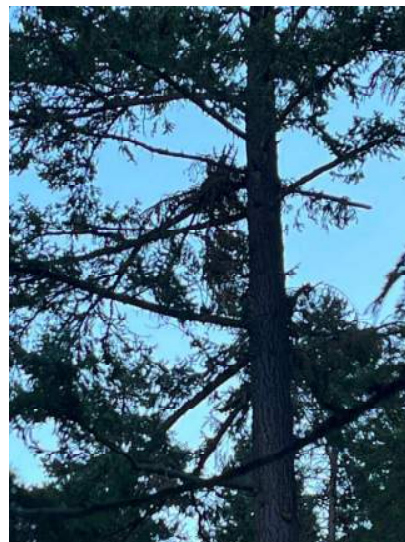
Image 7: Close-up view of the tree with the potential eagle nest (2024-08-30)

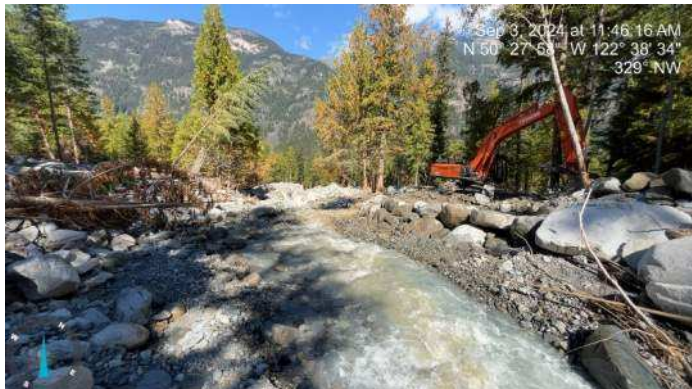
Image 8: Existing Place Creek channel after the side channel has been blocked off – looking downstream (2024-09-03 @ 11:46 AM)

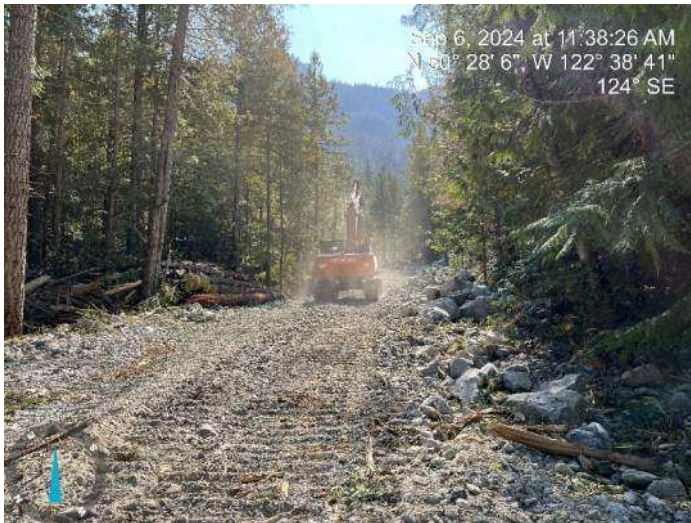
Image 10: 350 excavator went back into operation at around 11:38 AM (2024-09-06 @ 11:38 AM)
